BMW 3er
320d Touring Aut.

VIN NO WBA11DZ010FN01274

Inspection Report Summary

Customer	BCA Online	Report Number	P20250815133110
Inspection Date / Place	2025-08-15 / BCA Heidenheim	Cosmetic Grade	3

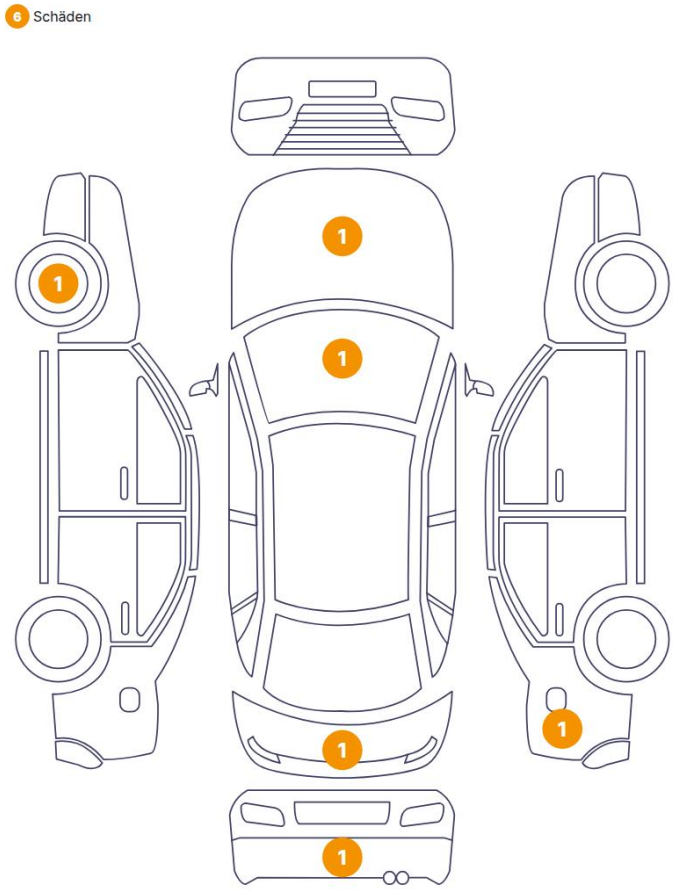
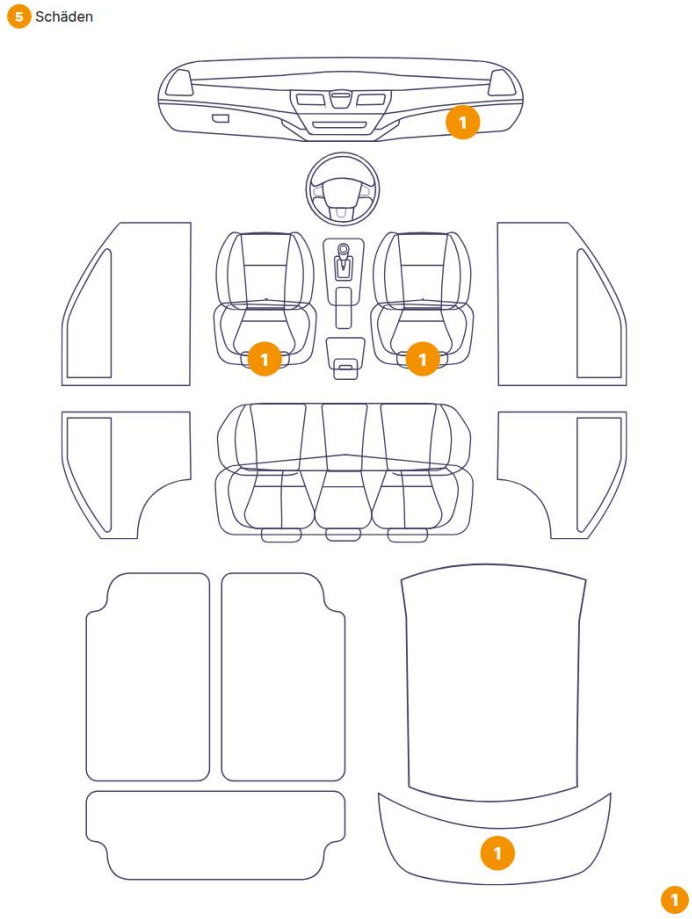
Cosmetic Damage

Component	Damage	Comments
1	Ignition Key	Interior / Worn - out	
2	Center Console	Interior / Scraped	
3	Backrest Cover / Front Left	Interior / Scratched	
4	Trunk Upholstery / Back	Interior / Scraped	
5	Windshield / Front	Glass Break / Impact	
6	Side Panel / Back Right	Paint / Poor Previous Repair	
7	Tailgate	Paint / Poor Previous Repair	
8	Rim / Front Left	Out of Bodywork / Scratch	
9	Hood	Paint / Stone Chip	
10	Bumper / Back	Paint / Scratch / Scuff	
11	Backrest Cover / Front Right	Interior / Scratched

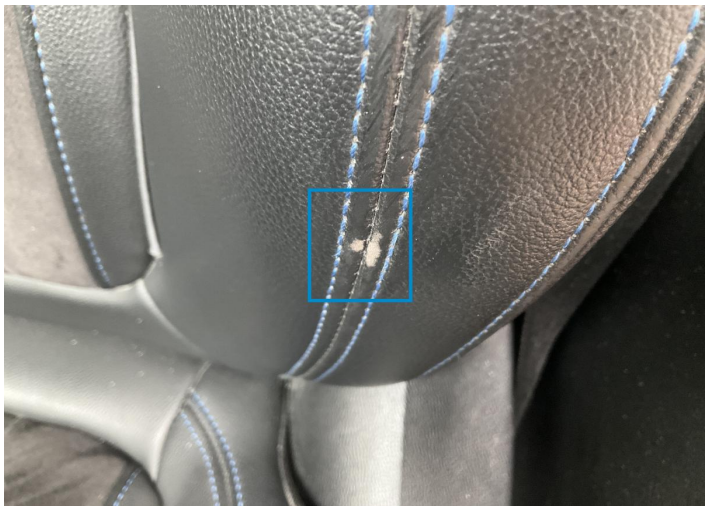
1. Ignition Key
Interior / Worn - out -

2. Center Console
Interior / Scraped -

3. Backrest Cover / Front Left
Interior / Scratched -

4. Trunk Upholstery / Back
Interior / Scraped -

5. Windshield / Front
Glass Break / Impact -

6. Side Panel / Back Right
Paint / Poor Previous Repair -

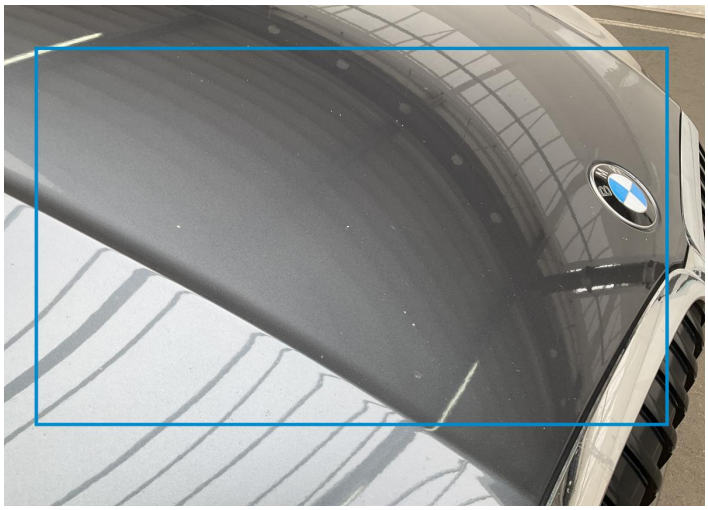
7. Tailgate
Paint / Poor Previous Repair -

8. Rim / Front Left
Out of Bodywork / Scratch -

9. Hood
Paint / Stone Chip -

10. Bumper / Back
Paint / Scratch / Scuff -

11. Backrest Cover / Front Right
Interior / Scratched -
