BMW 3er
320d Touring xDrive Aut.

VIN NO WBA31DZ000FN21458
Registration Number 000FN21458

Inspection Report Summary

Customer	BCA Online	Report Number	P20250813134251
Inspection Date / Place	2025-08-13 / BCA Oberndorf	Cosmetic Grade	2

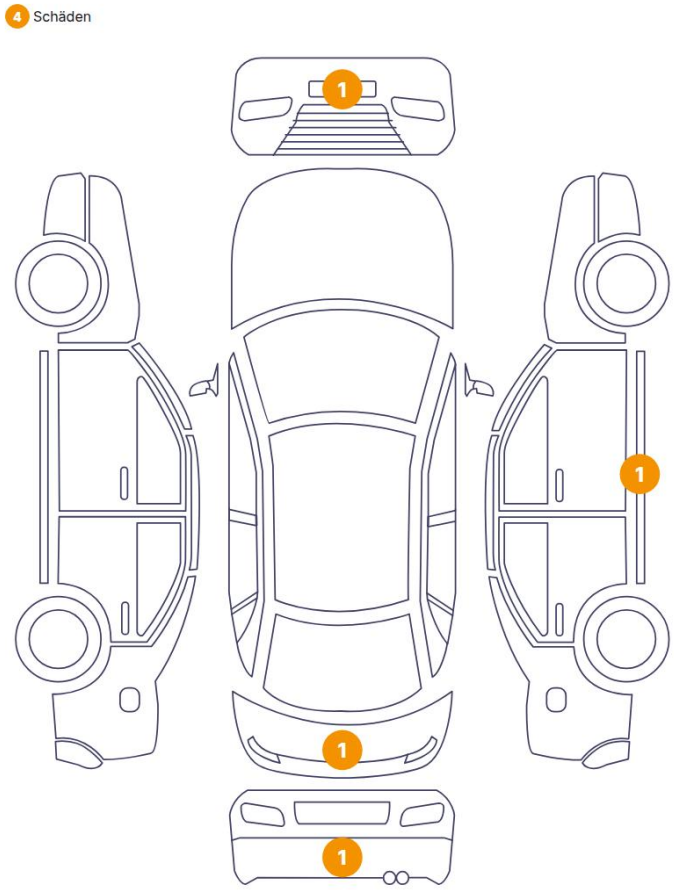
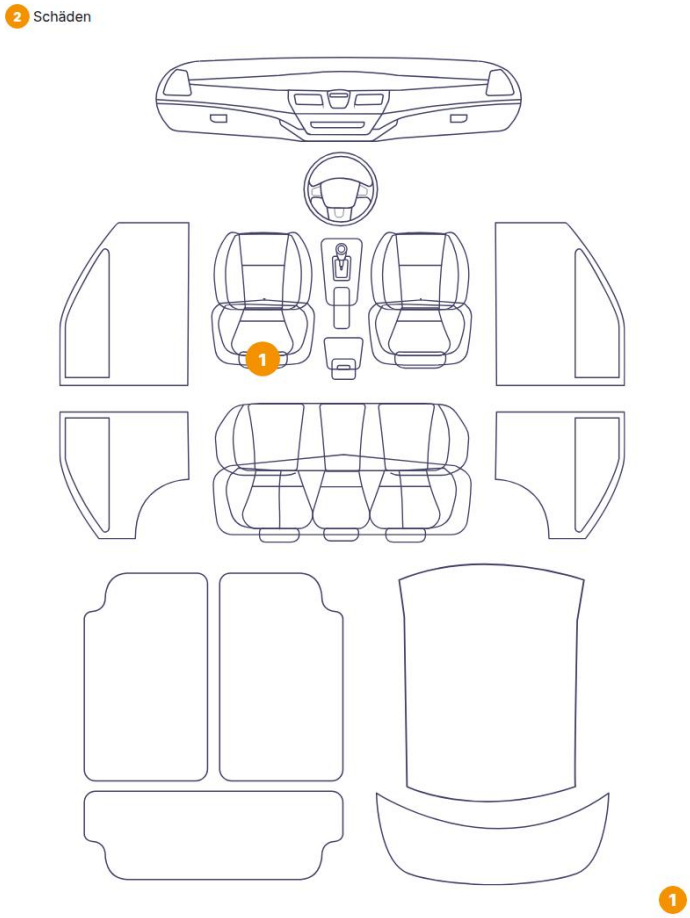
Component	Damage	Comments
1	Bumper / Front	Paint / Scratch / Scuff	
2	Backrest Cover / Front Left	Interior / Scraped	
3	Bumper / Back	Paint / Scratch / Scuff	
4	Other	Interior / Scraped	
5	Tailgate	Paint / Scratch / Scuff	
6	Rocker Panel / Center Right	Paint / Scratch / Scuff
