BMW 3er
320d Touring xDrive Aut.

VIN NO WBA31DZ010FN21971

Inspection Report Summary

Customer	BCA Online	Report Number	P20250722071558
Inspection Date / Place	2025-07-22 / BCA Heidenheim	Cosmetic Grade	2

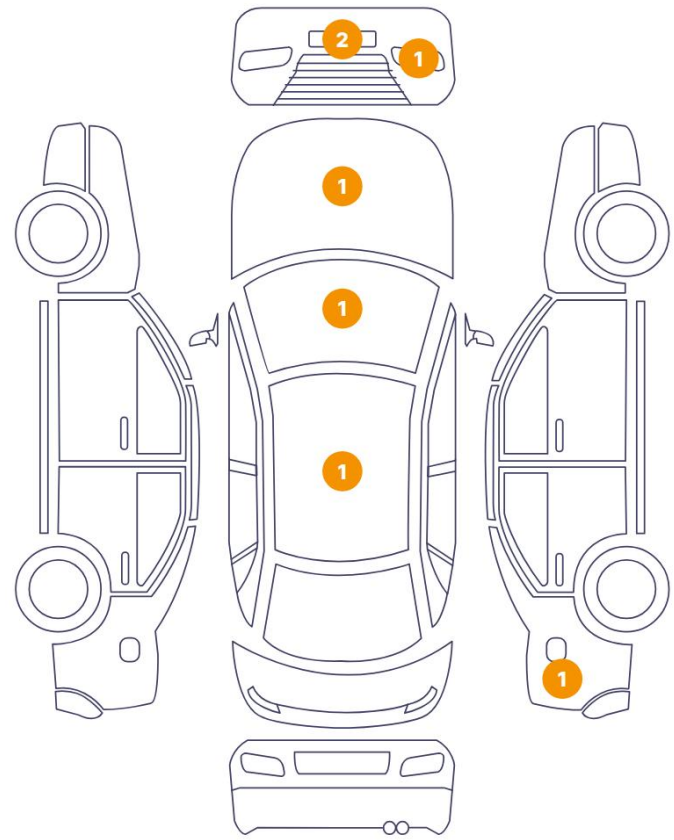
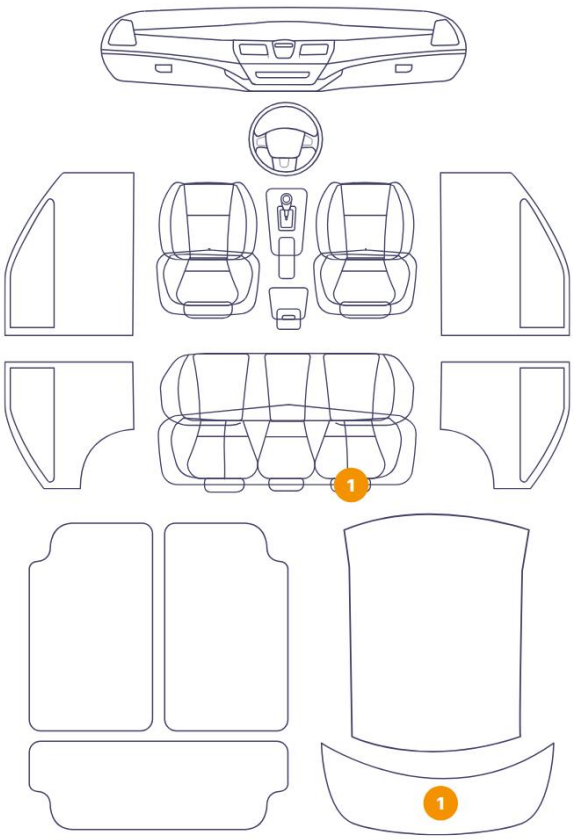
7 Schäden

2 Schäden

Component	Damage	Comments
1	Seat / Back Right	Interior / Not Working	
2	Trunk Upholstery / Back	Interior / Dirty	
3	Hood	Paint / Stone Chip	
4	LED - Xenon Headlight / Front - Right	Paint / Stone Chip	
5	Bumper / Front	Paint / Stone Chip	
6	Windshield / Front	Glass Break / Impact	
7	Side Panel / Back Right	Bodywork / Dent / Dent	
8	Roof	Bodywork / Dent / Dent	
9	Bumper / Front	Paint / Scratch / Scuff
