BMW 3er
320d Touring Aut.

VIN NO WBA6L51000FJ23353

Inspection Report Summary

Customer	BCA Online	Report Number	P20250721143151
Inspection Date / Place	2025-07-21 / BCA Heidenheim	Cosmetic Grade	3

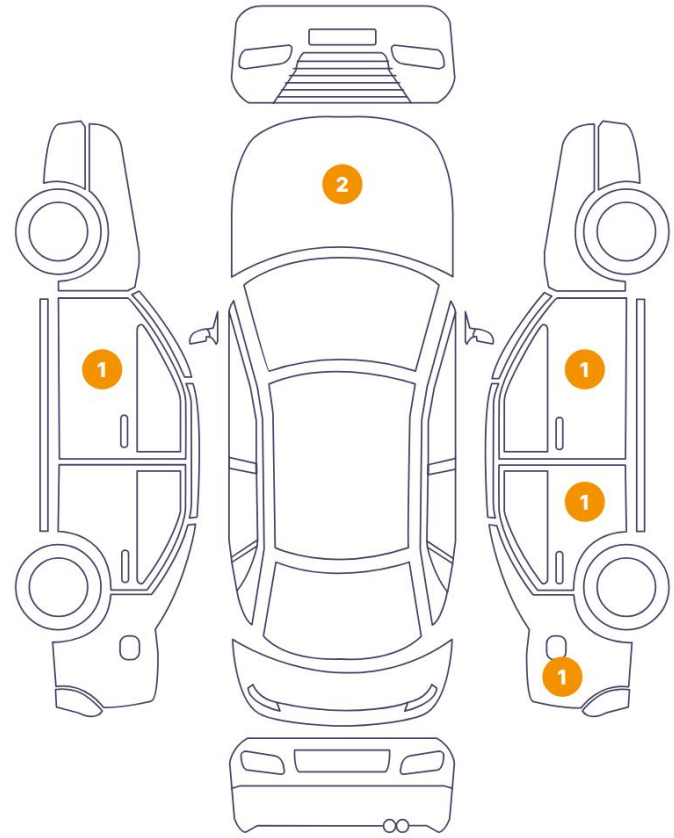
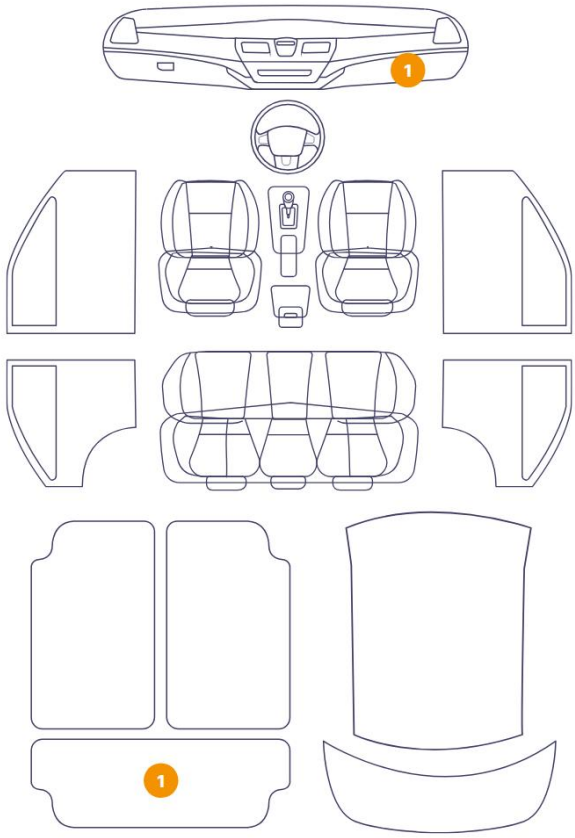
6 Schäden

2 Schäden

Component	Damage	Comments
1	Pillar / Back Right	Paint / Scratch / Scuff	
2	Side Window / Front Right	Bodywork / Assembly	
3	Center Console	Interior / Scraped	
4	Luggage Space Cover / Back	Interior / Missing	
5	Door / Front Left	Paint / Poor Previous Repair	
6	Hood	Paint / Stone Chip	
7	Hood	Bodywork / Dent / Dent	
8	Side Panel / Back Right	Bodywork / Dent / Dent

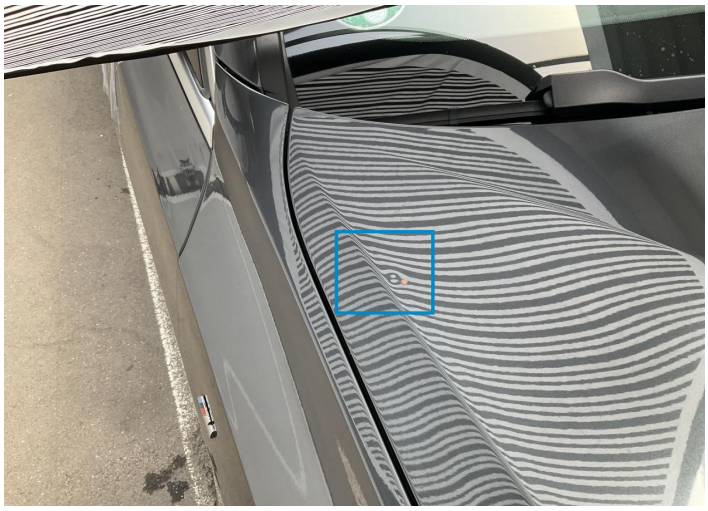
6. Hood
Paint / Stone Chip -
