MERCEDES-BENZ S-Klasse
S 560 L 4Matic 9G-TRONIC

VIN NO WDD2221861A432013

Inspection Report Summary

Customer	BCA Online	Report Number	P20250714064707
Inspection Date / Place	2025-07-14 / ARS Altmann AG Riedstadt	Cosmetic Grade	4

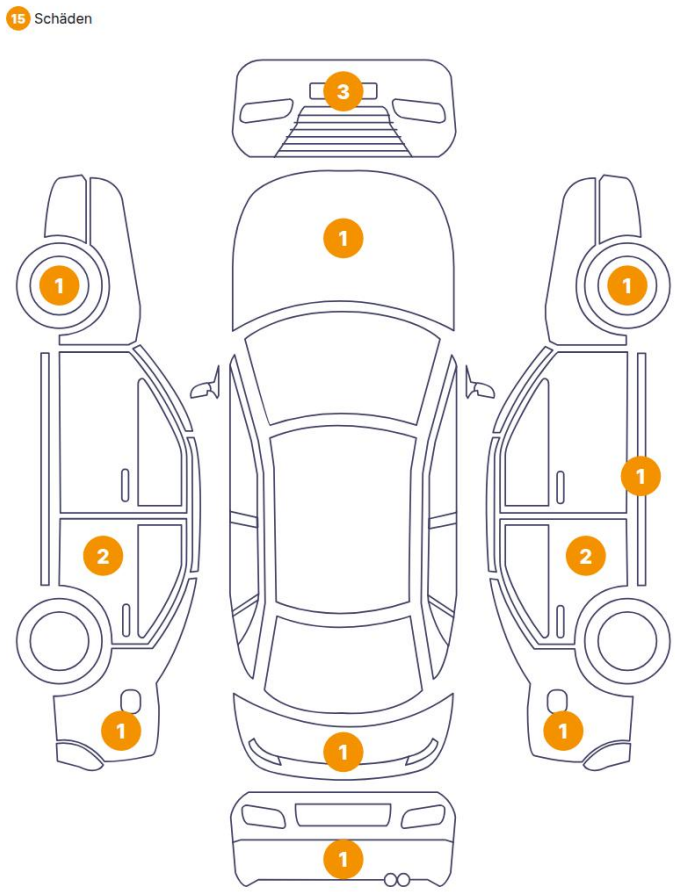
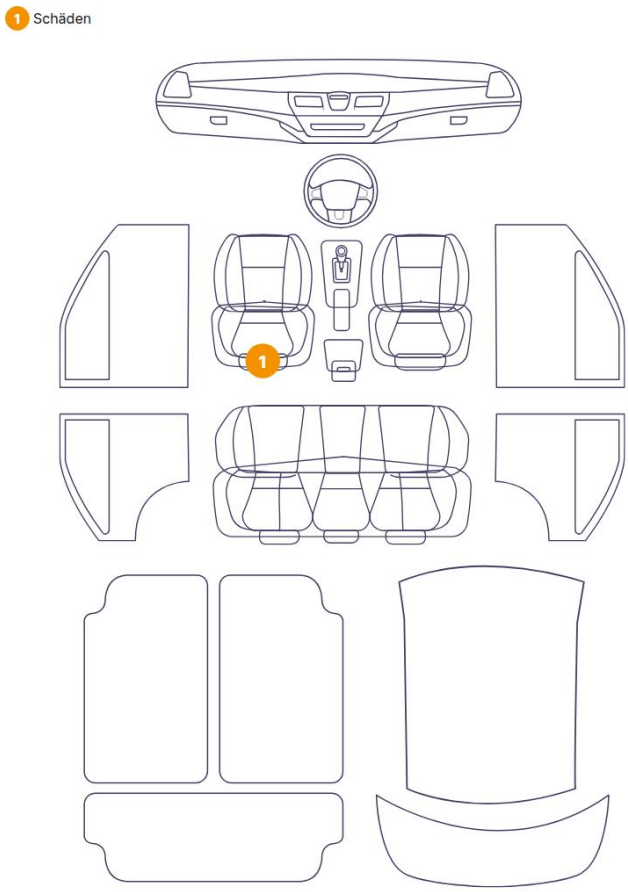
Cosmetic Damage

Component	Damage	Comments
1	Hood	Paint / Stone Chip	
2	Bumper / Front	Paint / Scratch / Scuff	
3	Bumper / Front	Bodywork / Dent / Dent	
4	Bumper / Front	Bodywork / Dent / Dent	
5	Rim / Front Left	Out of Bodywork / Scratch	
6	Seat / Front Left	Interior / Scratched	
7	Door / Back Left	Paint / Poor Previous Repair	
8	Pillar / Back Left	Paint / Scratch / Scuff	
9	Bumper / Back	Paint / Scratch / Scuff	
10	Tailgate	Paint / Scratch / Scuff	
11	Fender / Back Right	Paint / Scratch / Scuff	
12	Door / Back Right	Paint / Scratch / Scuff	
13	Rocker Panel / Center Right	Paint / Scratch / Scuff

14	Rim / Front Right	Out of Bodywork / Scratch
15	Door / Back Right	Bodywork / Dent / Dent
16	Fender / Back Left	Paint / Scratch / Scuff

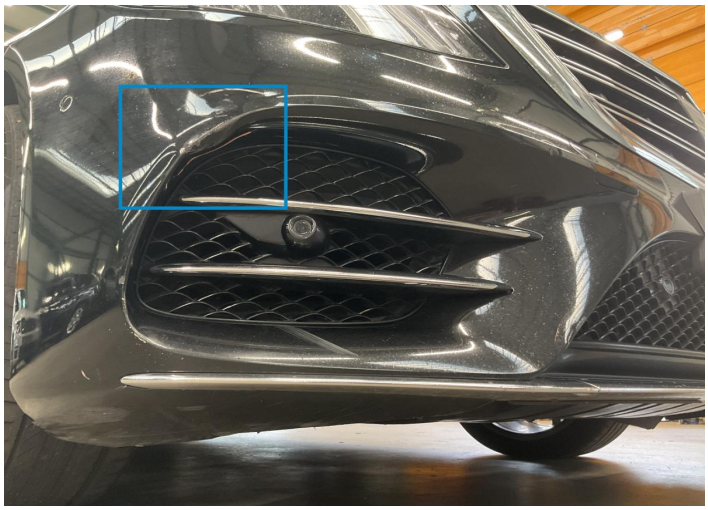
2. Bumper / Front
Paint / Scratch / Scuff -

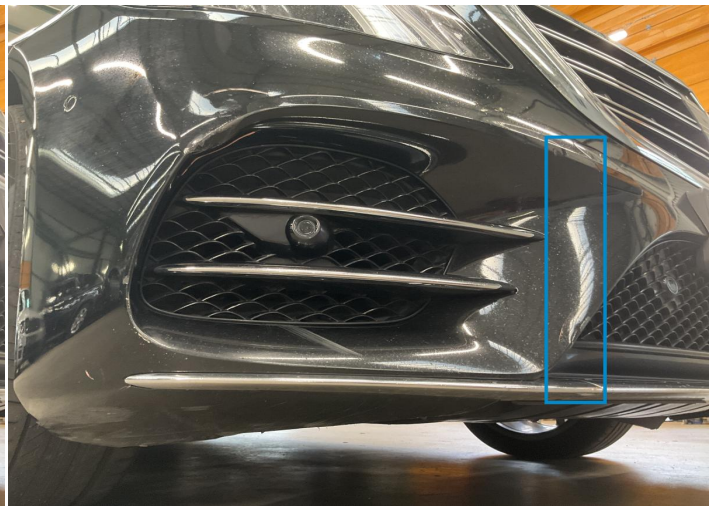
3. Bumper / Front
Bodywork / Dent / Dent -

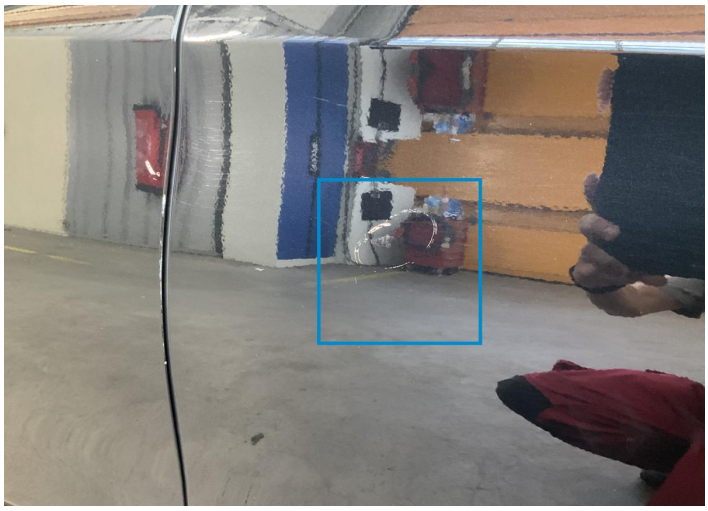
7. Door / Back Left
Paint / Poor Previous Repair -

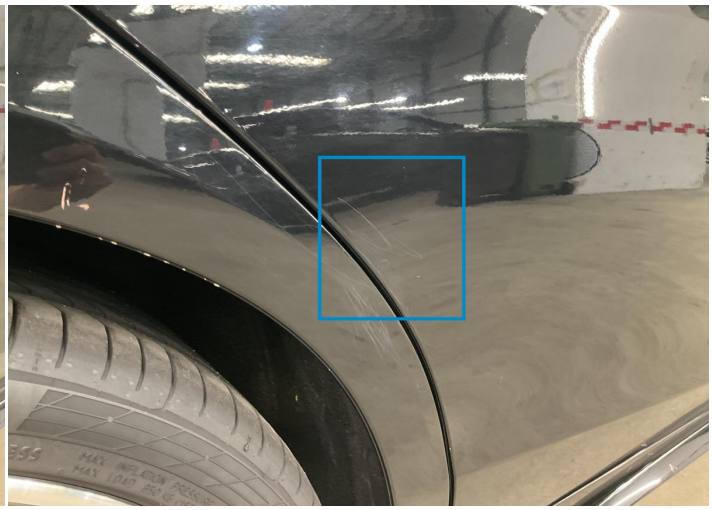
12. Door / Back Right
Paint / Scratch / Scuff -

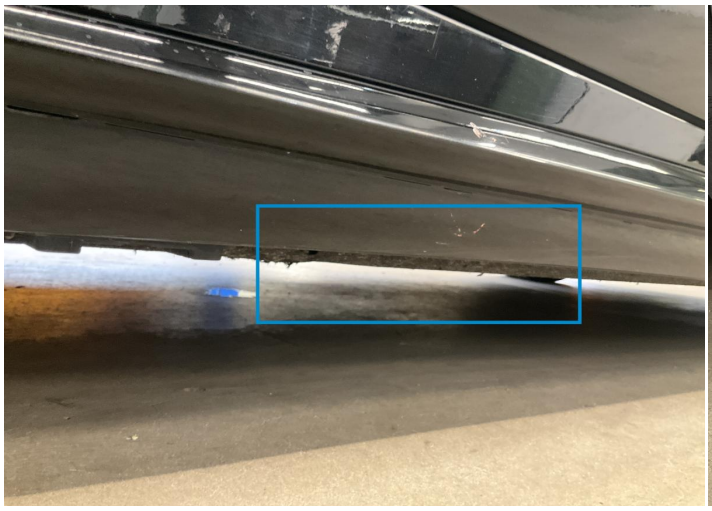
13. Rocker Panel / Center Right
Paint / Scratch / Scuff -

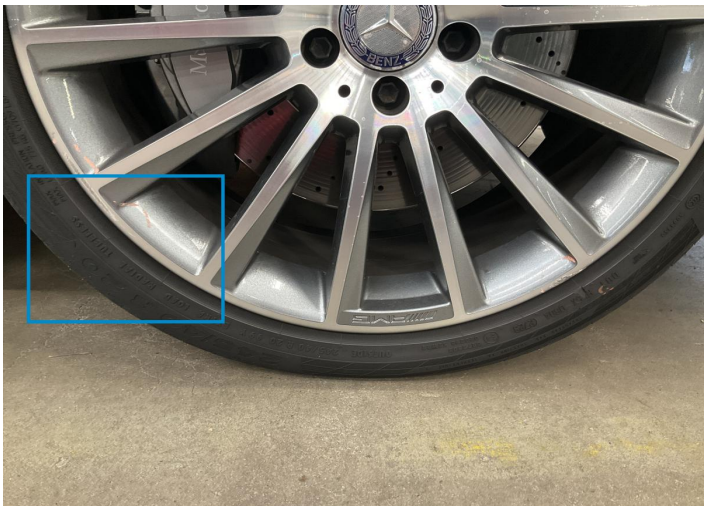
14. Rim / Front Right
Out of Bodywork / Scratch -

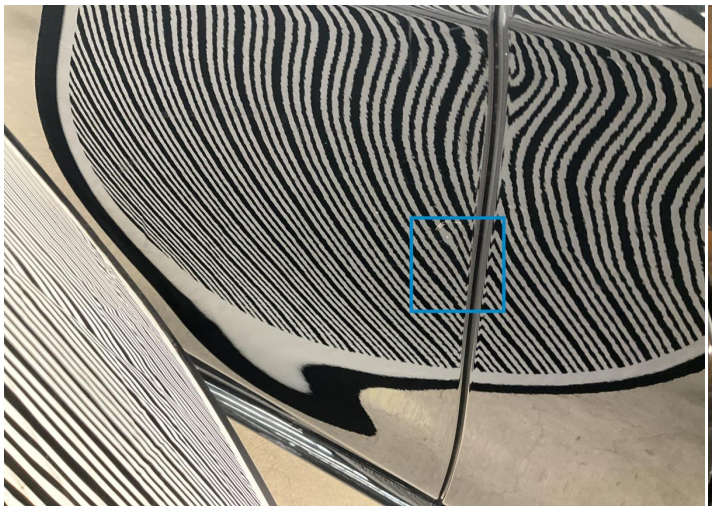
15. Door / Back Right
Bodywork / Dent / Dent -

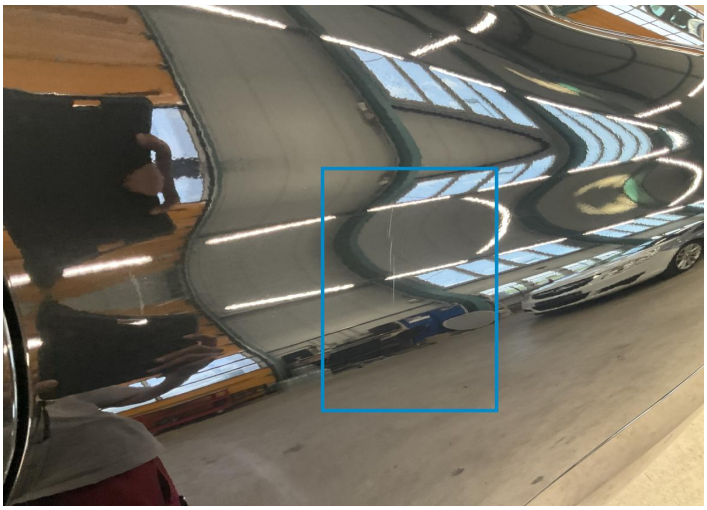
16. Fender / Back Left
Paint / Scratch / Scuff -
