FORD Focus

Focus Turnier 1.0 EcoBoost Start-Stopp-System

Inspection Report Summary

Customer	BCA Online	Report Number	P20250826141502
Inspection Date / Place	2025-08-26 / Dello Parchim	Cosmetic Grade	1

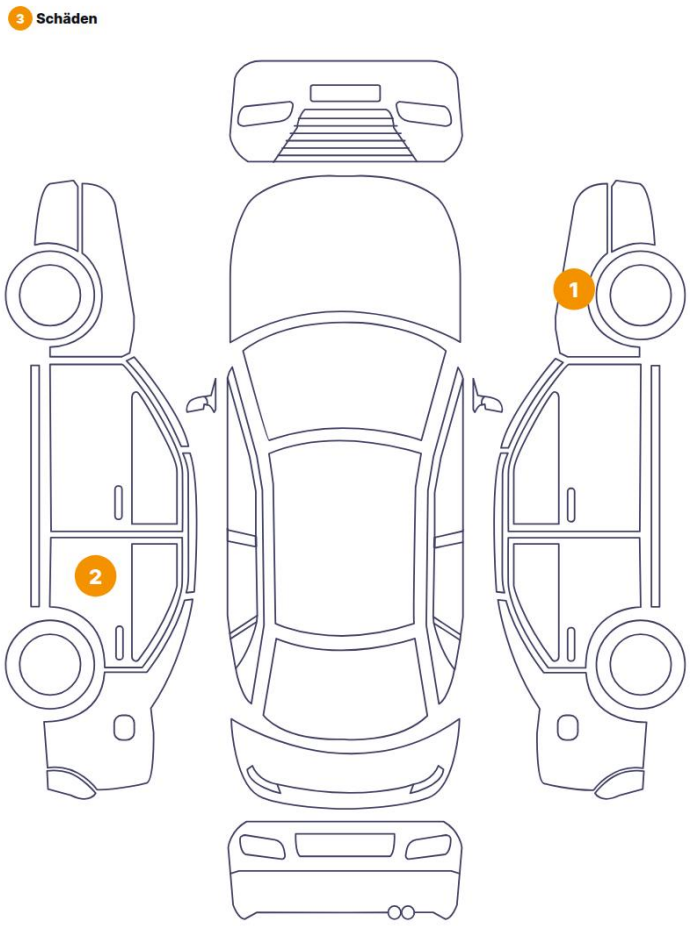
Cosmetic Damage

Component	Damage	Comments
1	Door / Back Left	Bodywork / Dent / Dent	
2	Door / Back Left	Bodywork / Dent / Dent	
3	Fender / Front Right	Bodywork / Dent / Dent

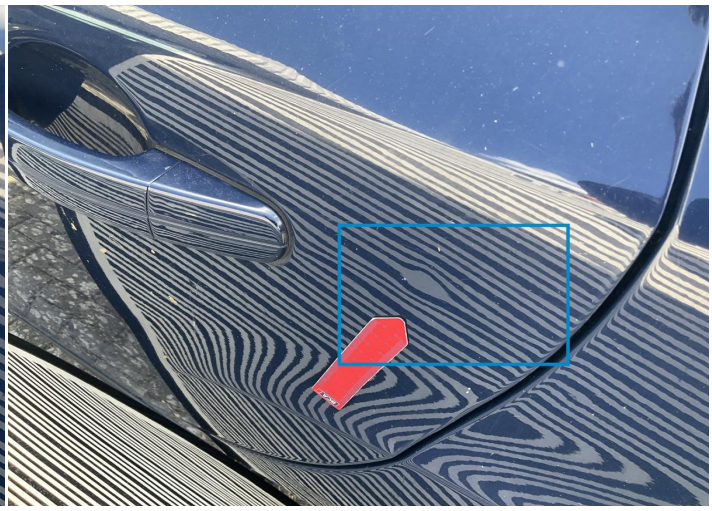
1. Door / Back Left
Bodywork / Dent / Dent -
