FORD Fiesta
Fiesta 1.0 EcoBoost S&S

VIN NO WF0FXXGAHFJS19167

Inspection Report Summary

Customer	BCA Online	Report Number	P20250910111325
Inspection Date / Place	2025-09-10 / ARS Altmann AG Wolnzach	Cosmetic Grade	3

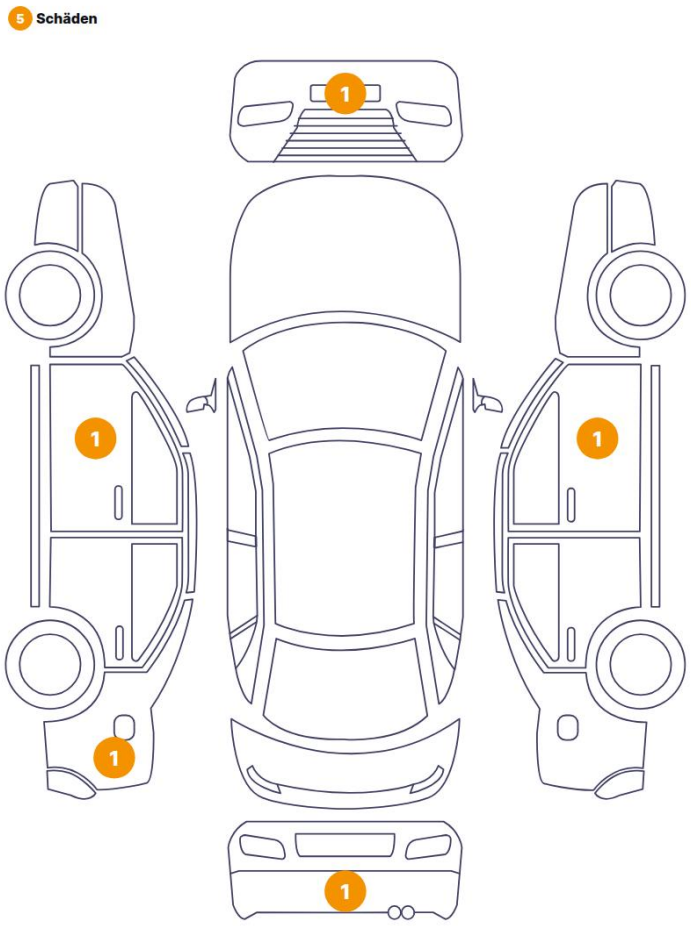
Cosmetic Damage

Component	Damage	Comments
1	Bumper / Front	Paint / Stone Chip	
2	Door / Front Left	Paint / Scratch / Scuff	
3	Side Panel / Back Left	Paint / Scratch / Scuff	
4	Bumper / Back	Paint / Scratch / Scuff	
5	Door / Front Right	Paint / Scratch / Scuff
