FORD Mondeo

Mondeo Turnier 2.0 EcoBoost Start-Stopp Autom.

Inspection Report Summary

Customer	BCA Online	Report Number	P20250814161349
Inspection Date / Place	2025-08-14 / BCA Berlin	Cosmetic Grade	4

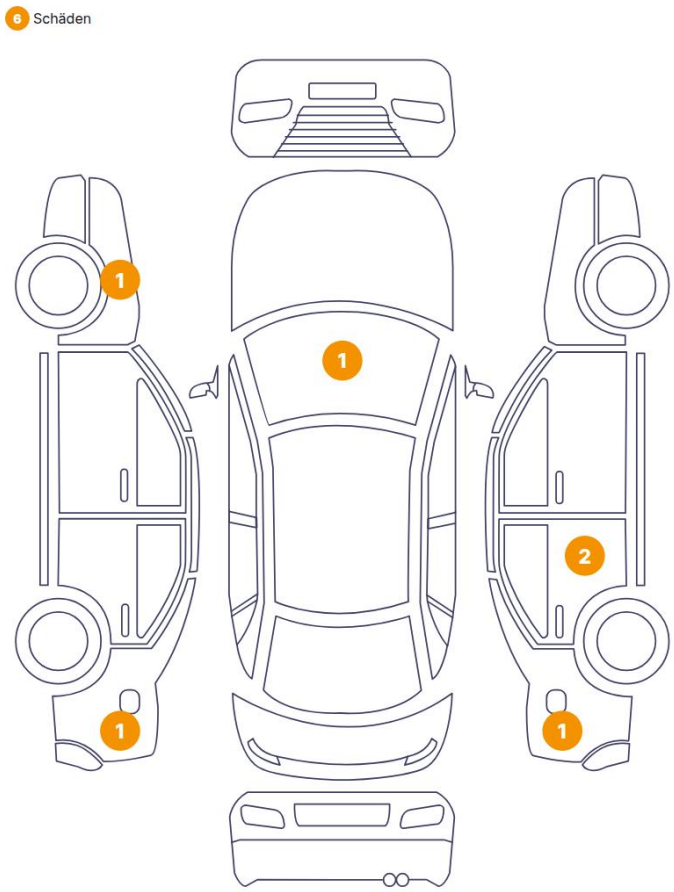
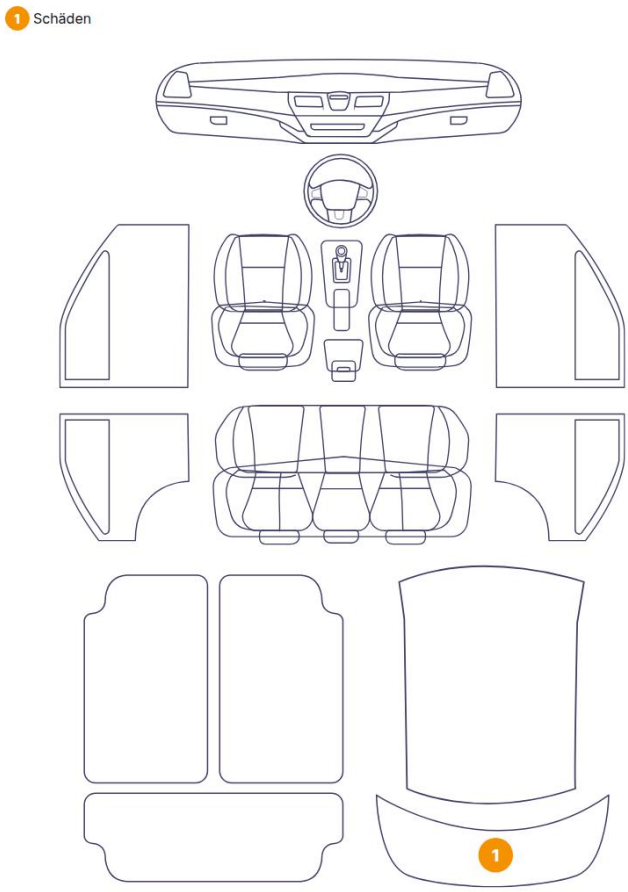
Cosmetic Damage

Component	Damage	Comments
1	Side Panel / Back Left	Paint / Scratch / Scuff	
2	Tailgate Upholstery / Back	Interior / Scratched	
3	Door / Back Right	Bodywork / Dent / Dent	
4	Windshield / Front	Paint / Chipping	
5	Fender / Front Left	Paint / Poor Previous Repair	
6	Side Panel / Back Right	Paint / Poor Previous Repair	
7	Door / Back Right	Paint / Poor Previous Repair
