# FORD Kuga
## Kuga 2.5 Duratec PHEV

VIN NO WF0FXXWPMHLE30518

## Inspection Report Summary

| Customer | BCA Online | Report Number | P20250926120413 |

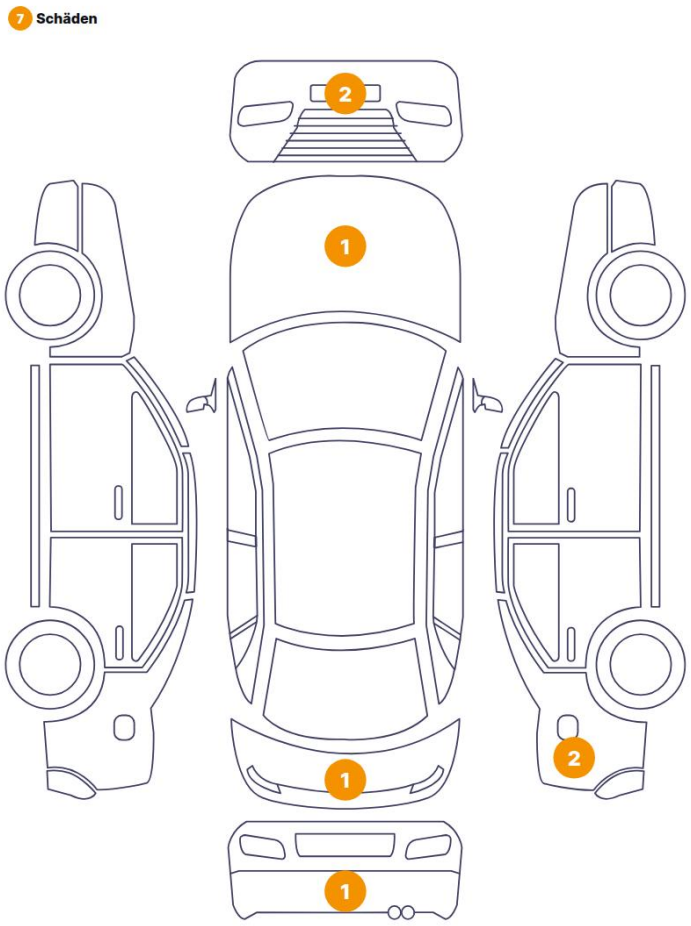
## Cosmetic Damage

| | Component | Damage | Comments |
|---|---|---|---|
| 1 | Hood | Paint / Stone Chip | |
| 2 | Bumper / Front | Paint / Scratch / Scuff | |
| 3 | Bumper / Front | Paint / Scratch / Scuff | |
| 4 | Bumper / Back | Paint / Scratch / Scuff | |
| 5 | Rear Window / Back | Glass Break / Scratch / Scratch | |
| 6 | Fender / Back Right | Bodywork / Dent / Dent | |
| 7 | Fender / Back Right | Bodywork / Dent / Dent | |

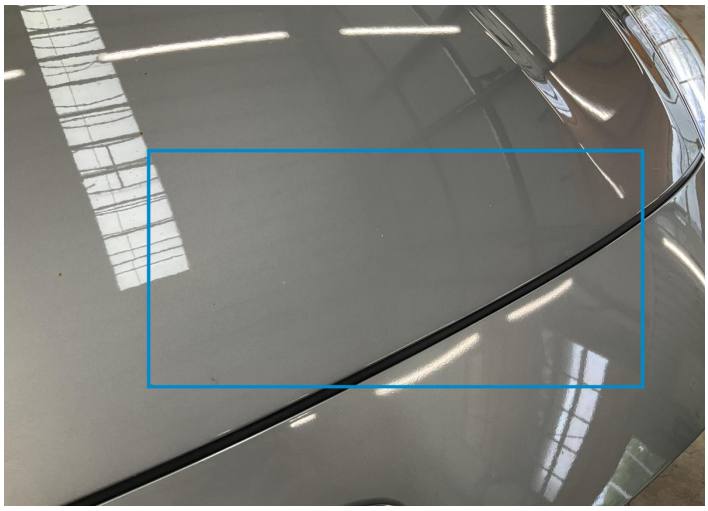
1. Hood
Paint / Stone Chip -

2. Bumper / Front
Paint / Scratch / Scuff -

3. Bumper / Front
Paint / Scratch / Scuff -

4. Bumper / Back
Paint / Scratch / Scuff -

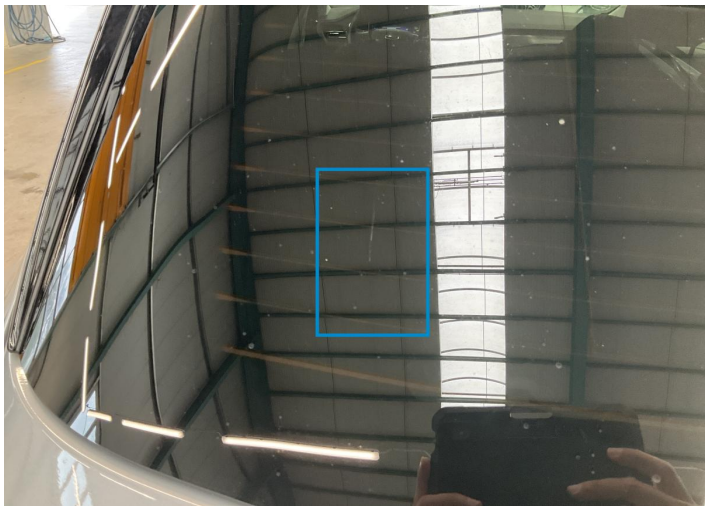
5. Rear Window / Back
Glass Break / Scratch / Scratch -

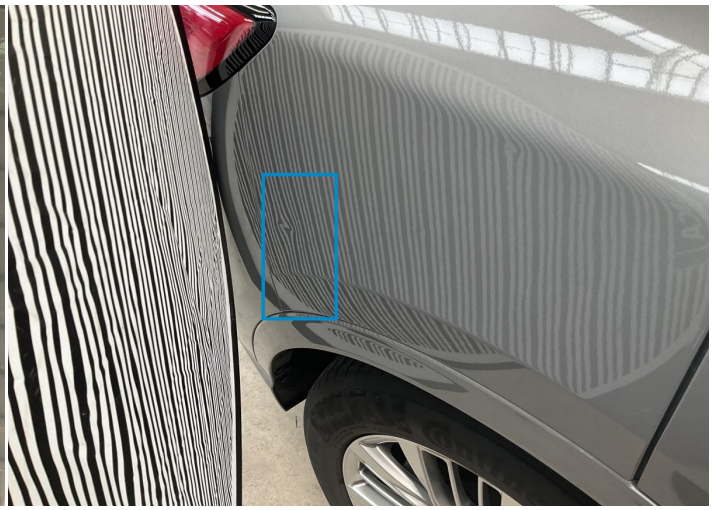
6. Fender / Back Right
Bodywork / Dent / Dent -

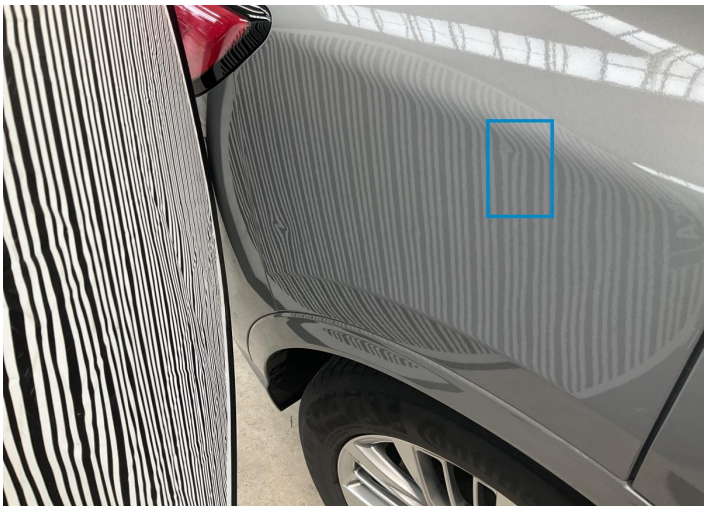
7. Fender / Back Right
Bodywork / Dent / Dent -
