FORD Mondeo
Mondeo Turnier 2.2 TDCi Aut.

VIN NO WF0GXXGBBGBT55217

Inspection Report Summary

Customer	BCA Online	Report Number	P20250925111656
Inspection Date / Place	2025-09-30 / HARTMANN Compound-Professionals GmbH Dorfmark	Cosmetic Grade	3

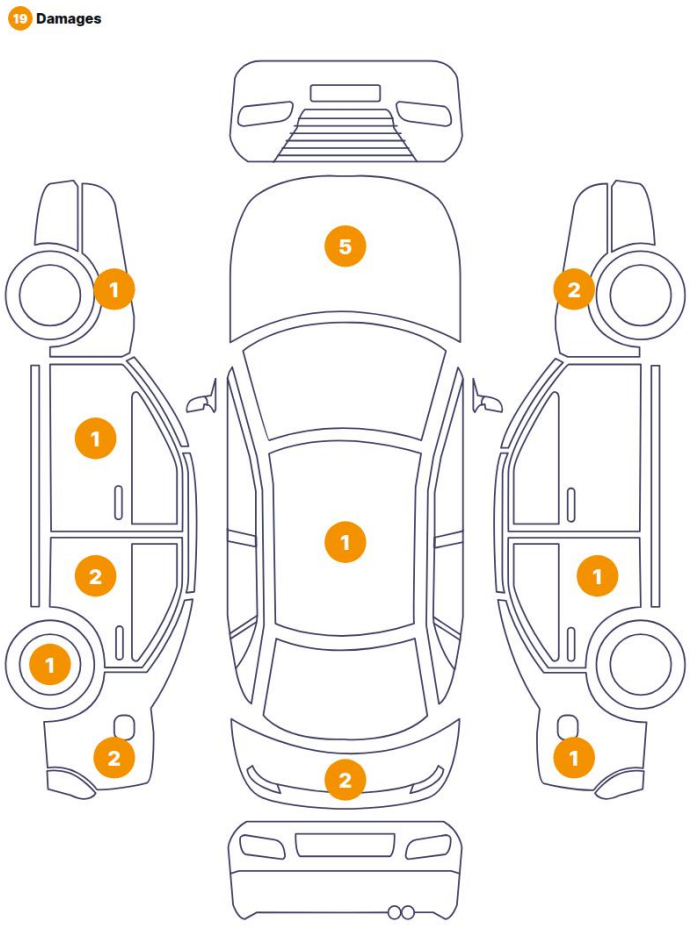
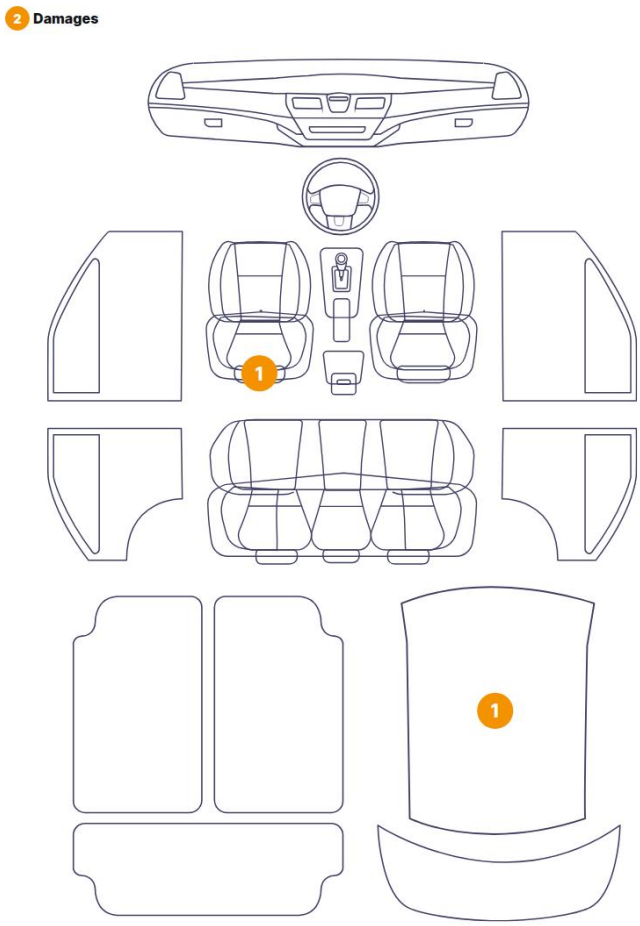
Component	Damage	Comments
1	Hood Scoop	Bodywork / Breakage / Crack	
2	Hood	Bodywork / Dent / Dent	
3	Hood	Paint / Chipping	
4	Hood	Paint / Chipping	
5	Hood	Bodywork / Dent / Dent	
6	Fender / Front Right	Bodywork / Dent / Dent	
7	Fender / Front Right	Paint / Scratch / Scuff	
8	Door / Back Right	Paint / Scratch / Scuff	
9	Fender / Back Right	Bodywork / Dent / Dent	
10	Monogram/Emblem / Back Center	Missing Part	
11	Tailgate	Paint / Scratch / Scuff	
12	Side Panel / Back Left	Bodywork / Dent / Dent

13	Fender / Back Left	Paint / Scratch / Scuff
14	Rim / Back Left	Out of Bodywork / Scratch
15	Door / Back Left	Paint / Chipping
16	Door / Back Left	Paint / Scratch / Scuff
17	Door / Front Left	Paint / Scratch / Scuff
18	Fender / Front Left	Bodywork / Dent / Dent
19	Roof	Bodywork / Dent / Deformation
20	Roof Upholstery	Interior / Broken
21	Seat / Front Left	Interior / Stained

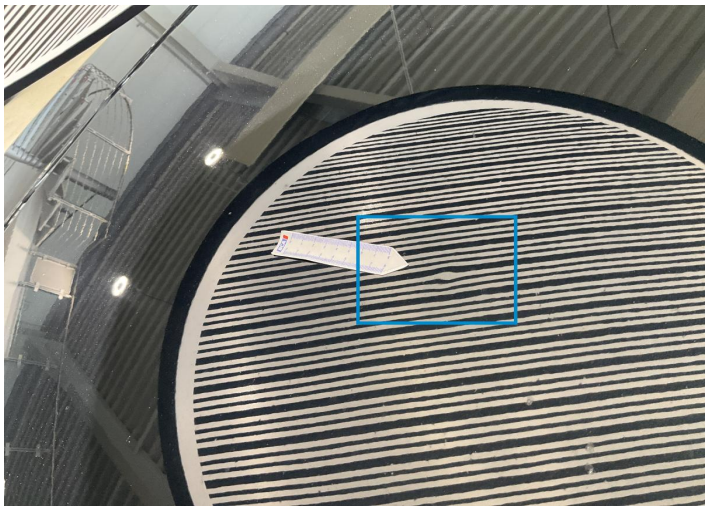
1. Hood Scoop
Bodywork / Breakage / Crack -

2. Hood
Bodywork / Dent / Dent -

3. Hood
Paint / Chipping -

4. Hood
Paint / Chipping -

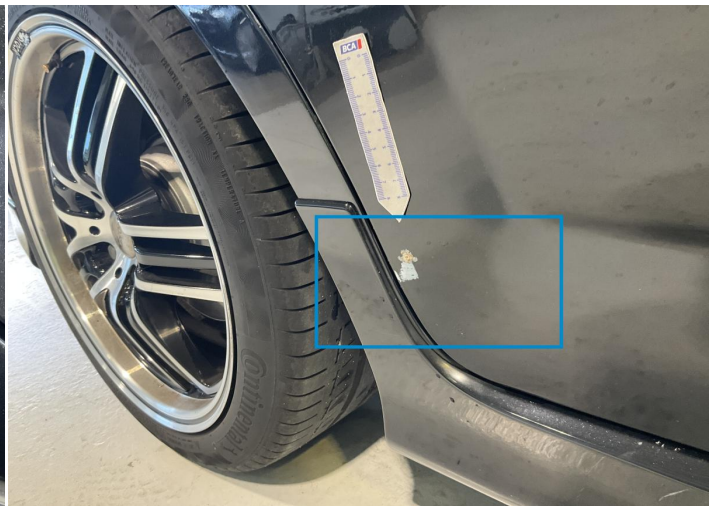
6. Fender / Front Right
Bodywork / Dent / Dent -

7. Fender / Front Right
Paint / Scratch / Scuff -

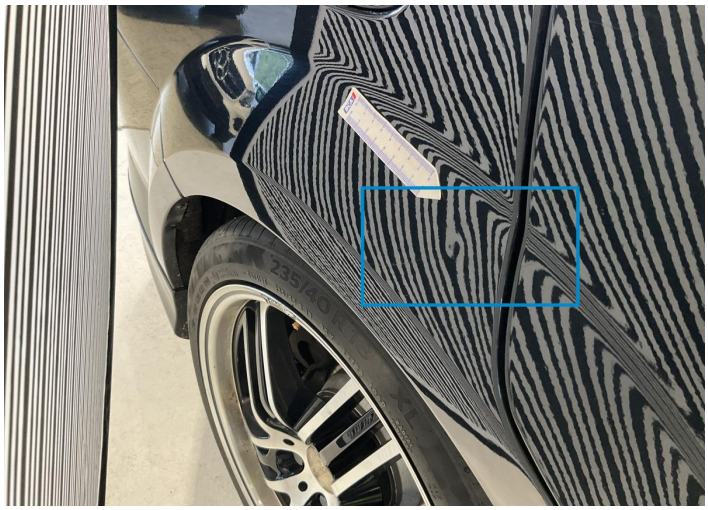
8. Door / Back Right
Paint / Scratch / Scuff -

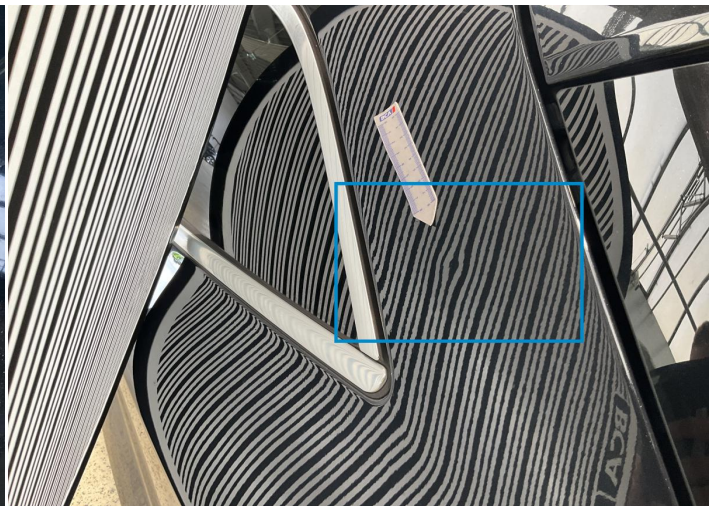
9. Fender / Back Right
Bodywork / Dent / Dent -

10. Monogram/Emblem / Back Center
Missing Part -

11. Tailgate
Paint / Scratch / Scuff -

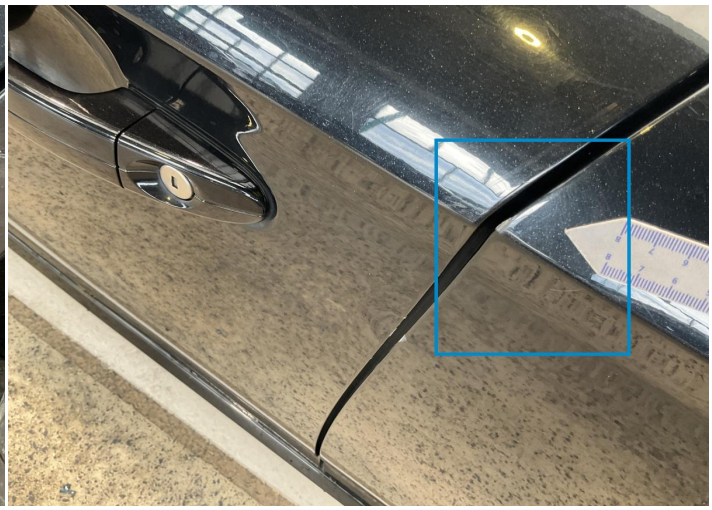
14. Rim / Back Left
Out of Bodywork / Scratch -

15. Door / Back Left
Paint / Chipping -
