FORD S-Max
S-Max 2.0 EcoBlue Aut.

VIN NO WF0JXXWPCJKM39837

Inspection Report Summary

Customer	BCA Online	Report Number	P20250820085005
Inspection Date / Place	2025-08-20 / BCA Neuss	Cosmetic Grade	5

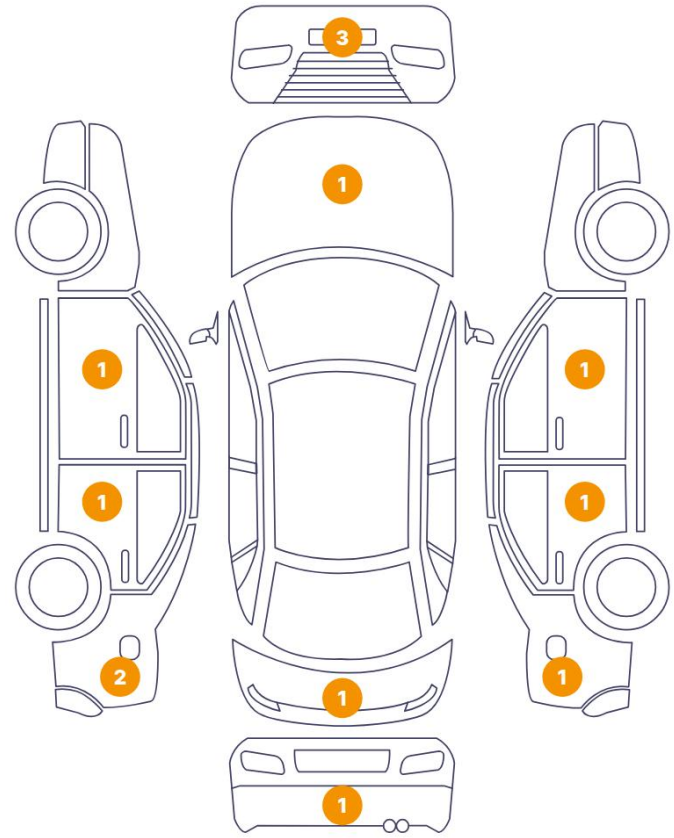
13 Schäden

Component	Damage	Comments
1	Door / Front Left	Paint / Scratch / Scuff	
2	Door / Back Left	Paint / Scratch / Scuff	
3	Side Panel / Back Left	Bodywork / Dent / Dent	
4	Side Panel / Back Left	Bodywork / Dent / Dent	
5	Tailgate	Paint / Scratch / Scuff	
6	Bumper / Back	Paint / Scratch / Scuff	
7	Side Panel / Back Right	Bodywork / Dent / Dent	
8	Door / Back Right	Paint / Scratch / Scuff	
9	Door / Front Right	Bodywork / Dent / Dent	
10	Bumper / Front	Bodywork / Breakage / Crack	
11	Bumper / Front	Paint / Scratch / Scuff	
12	Bumper / Front	Paint / Scratch / Scuff	
13	Hood	Paint / Stone Chip

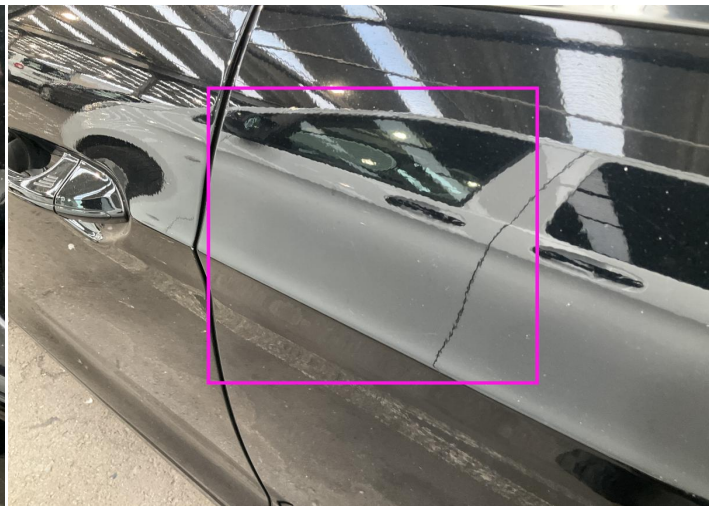
1. Door / Front Left
Paint / Scratch / Scuff -

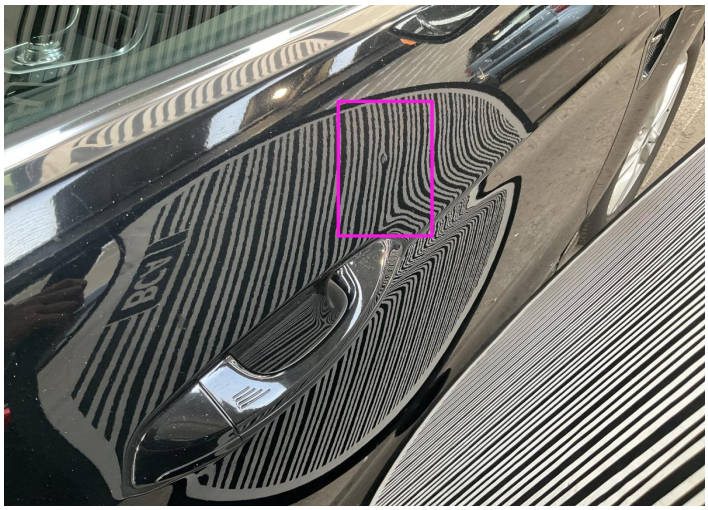
8. Door / Back Right
Paint / Scratch / Scuff -
