MINI COUNTRYMAN
Mini Cooper D Countryman All4

VIN NO WMWYU110603E28293

Inspection Report Summary

Customer	BCA Online	Report Number	P20250731111425
Inspection Date / Place	2025-07-31 / BCA Oberndorf	Cosmetic Grade	2

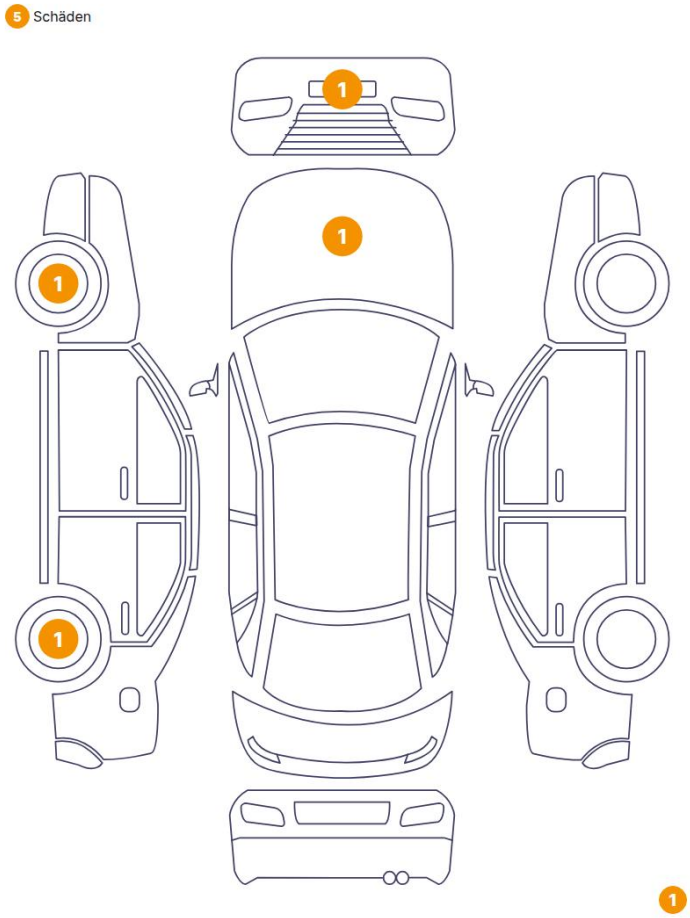
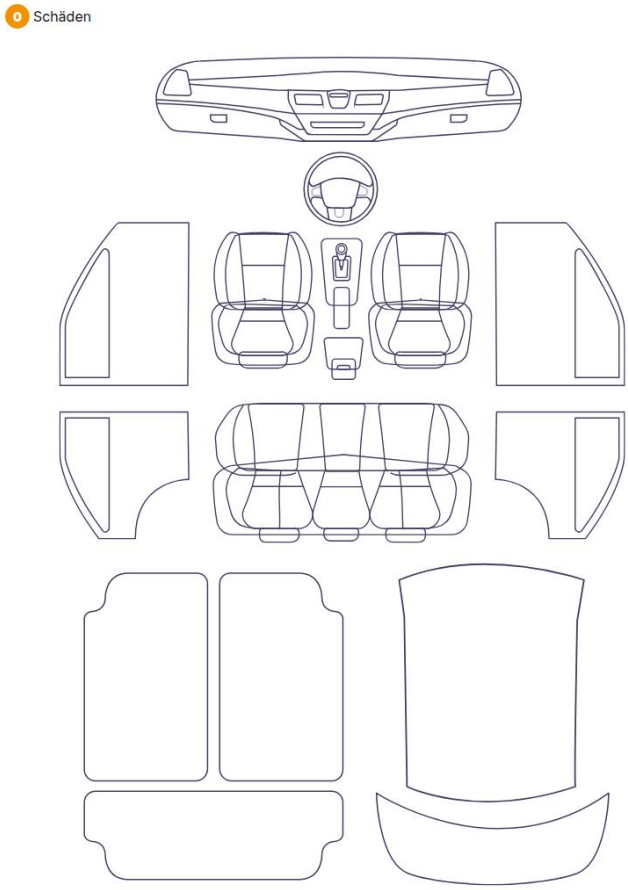
Cosmetic Damage

Component	Damage	Comments
1	Other	Anomalyon Element	
2	Corner Bumper / Front Left	Paint / Scratch / Line	
3	Hood	Bodywork / Dent / Dent	
4	Rim / Front Left	Paint / Stone Chip	
5	Rim / Back Left	Out of Bodywork / Scratch

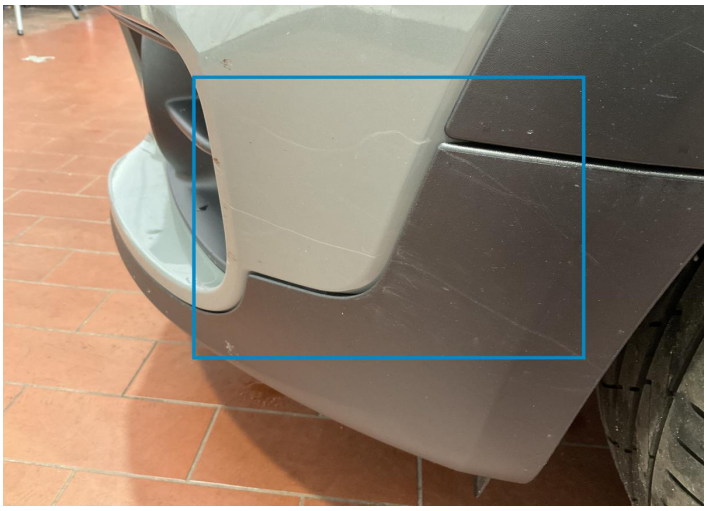
1.
Anomalyon Element -
