MINI COUNTRYMAN

Mini Cooper D Countryman All4

VIN NO WMWYU110603E28293

Inspection Report Summary

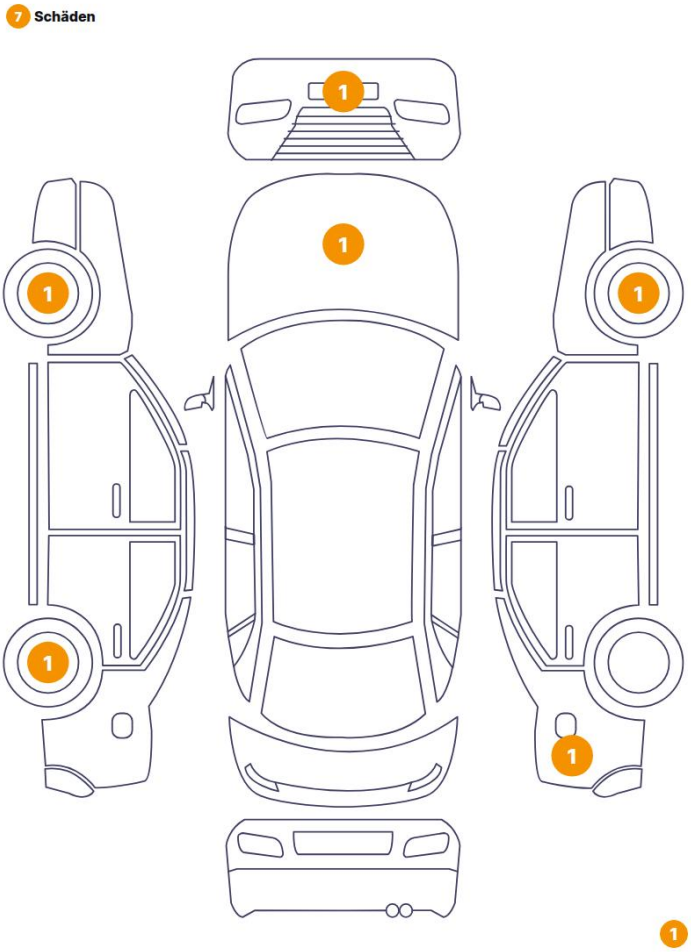
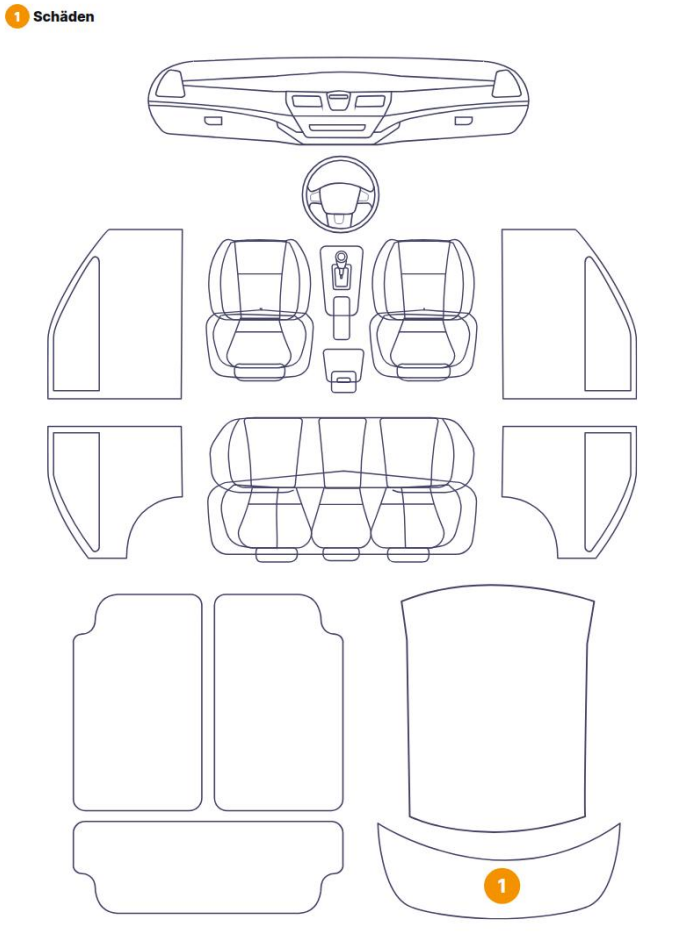
Cosmetic Damage

Component	Damage	Comments
1	Other	Anomalyon Element	
2	Bumper / Front	Paint / Scratch / Line	
3	Hood	Bodywork / Dent / Dent	
4	Rim / Front Left	Paint / Stone Chip	
5	Rim / Back Left	Out of Bodywork / Scratch	
6	Trunk Upholstery / Back	Interior / Scratched	
7	Wing Stick / Back Right	Paint / Scratch / Line	
8	Rim / Front Right	Paint / Stone Chip

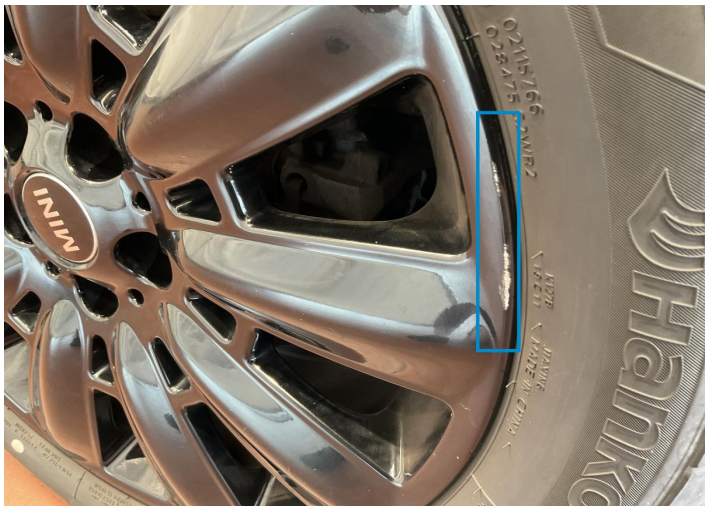
1.
Anomalyon Element -

2. Bumper / Front
Paint / Scratch / Line -

3. Hood
Bodywork / Dent / Dent -

4. Rim / Front Left
Paint / Stone Chip -

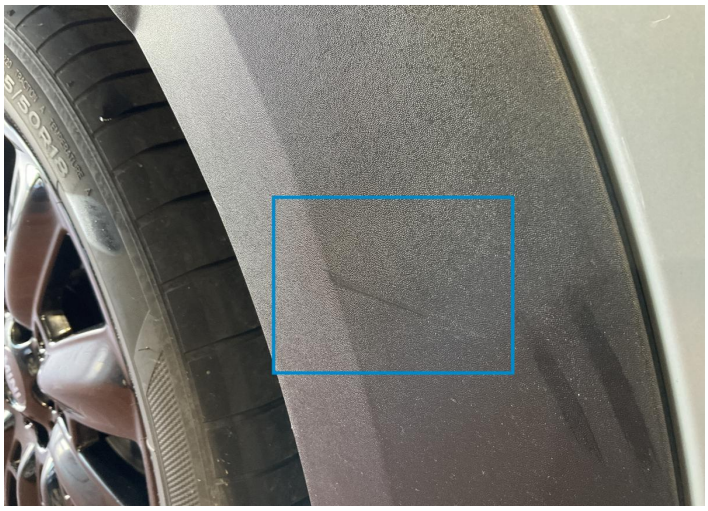
5. Rim / Back Left
Out of Bodywork / Scratch -

6. Trunk Upholstery / Back
Interior / Scratched -
