VOLKSWAGEN Touareg
Touareg 3.6 V6 FSI Automatik

VIN NO WVGEF9BP6GD004684

Inspection Report Summary

Customer	BCA Online	Report Number	P20250408100936
Inspection Date / Place	2025-04-08 / Dürkop Goslar	Cosmetic Grade	2

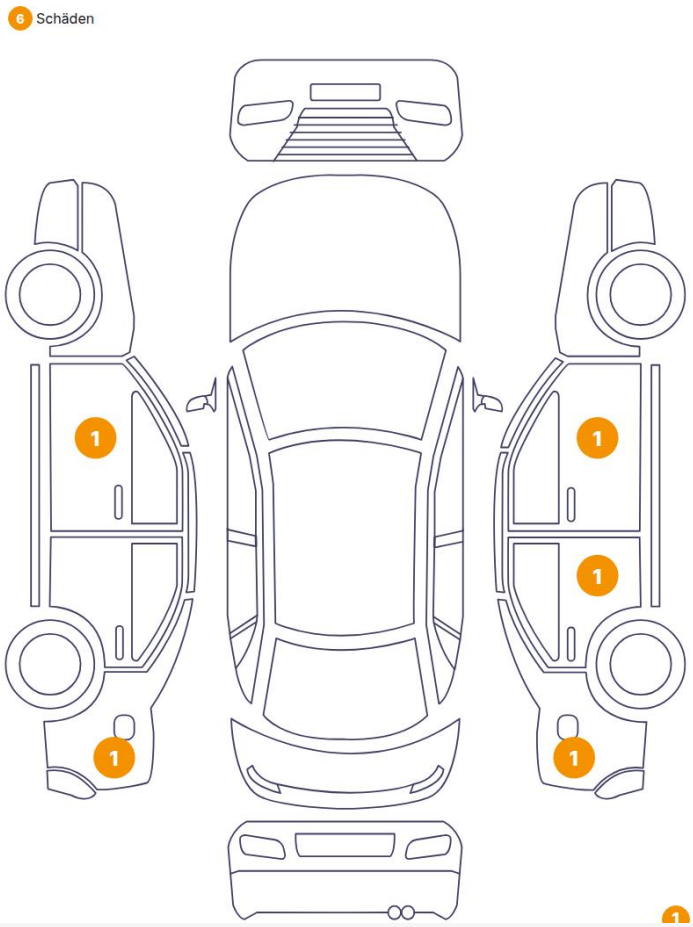
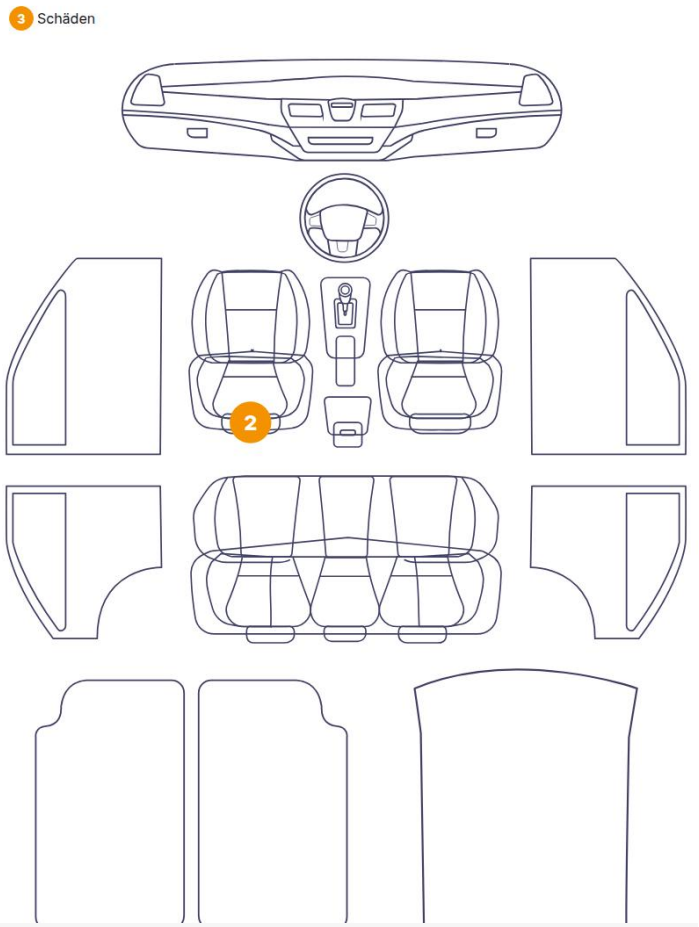
Cosmetic Damage

Component	Damage	Comments
1	Other	Anomalyon Element	
2	Seat / Front Left	Interior / Scratched	
3	Seat / Front Left	Interior / Scraped	
4	Other	Interior / Loose	
5	Door / Front Left	Bodywork / Dent / Dent	
6	Side Panel / Back Left	Bodywork / Dent / Dent	
7	Side Panel / Back Right	Paint / Scratch / Line	
8	Door / Back Right	Paint / Scratch / Scuff	
9	Door / Front Right	Bodywork / Dent / Dent

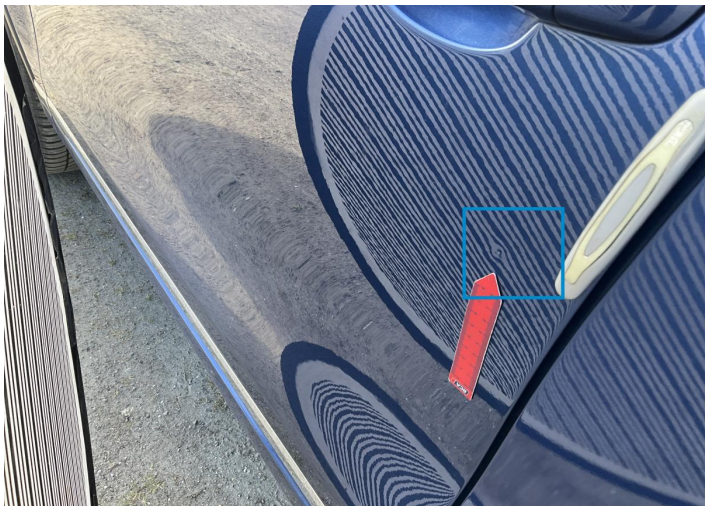
1.
Anomalyon Element -

2. Seat / Front Left
Interior / Scratched -

3. Seat / Front Left
Interior / Scraped -

4.
Interior / Loose -

5. Door / Front Left
Bodywork / Dent / Dent -

6. Side Panel / Back Left
Bodywork / Dent / Dent -

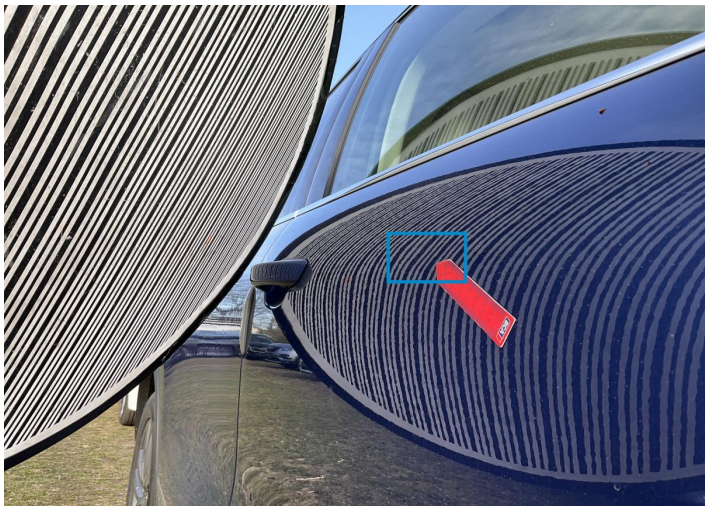
7. Side Panel / Back Right
Paint / Scratch / Line -

8. Door / Back Right
Paint / Scratch / Scuff -

9. Door / Front Right
Bodywork / Dent / Dent -
