VOLKSWAGEN T-Cross

T-Cross 1.0 TSI OPF

Inspection Report Summary

Customer	BCA Online	Report Number	P20250926121640
Inspection Date / Place	2025-09-26 / BCA Neuss	Cosmetic Grade	1

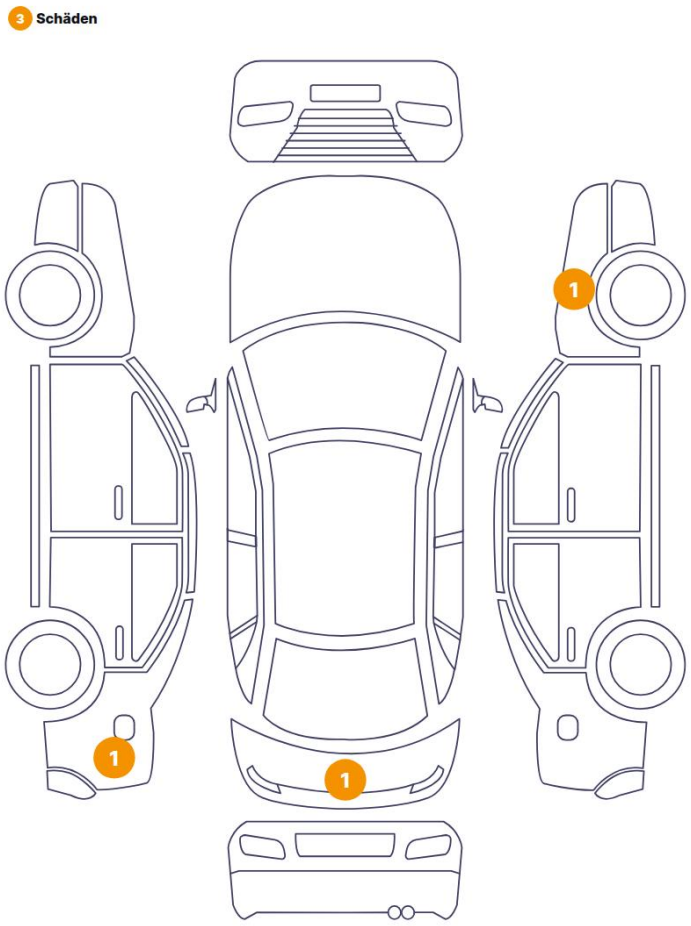
Cosmetic Damage

Component	Damage	Comments
1	Fender / Back Left	Bodywork / Dent / Dent	
2	Tailgate	Bodywork / Dent / Dent	
3	Fender / Front Right	Paint / Scratch / Scuff

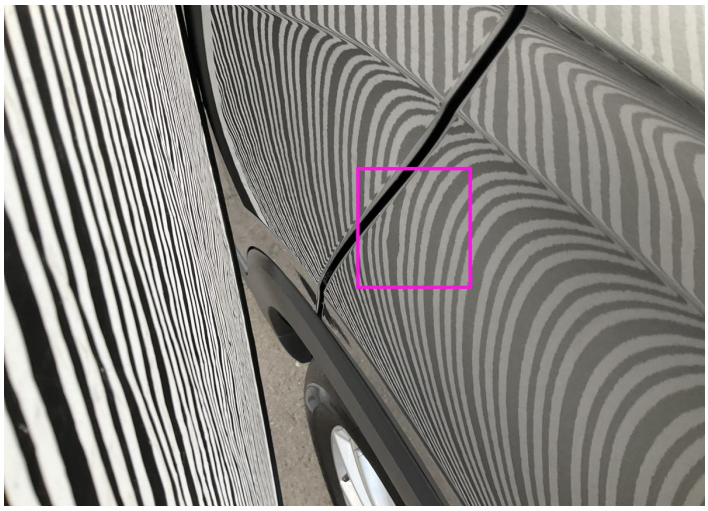
1. Fender / Back Left
Bodywork / Dent / Dent -

2. Tailgate
Bodywork / Dent / Dent -

3. Fender / Front Right
Paint / Scratch / Scuff -
