VOLKSWAGEN Passat
Passat Variant 2.0 TDI SCR DSG

VIN NO WVWZZZ3CZKE088193

Inspection Report Summary

Customer	BCA Online	Report Number	P20250925125928
Inspection Date / Place	2025-09-25 / BCA Berlin	Cosmetic Grade	2

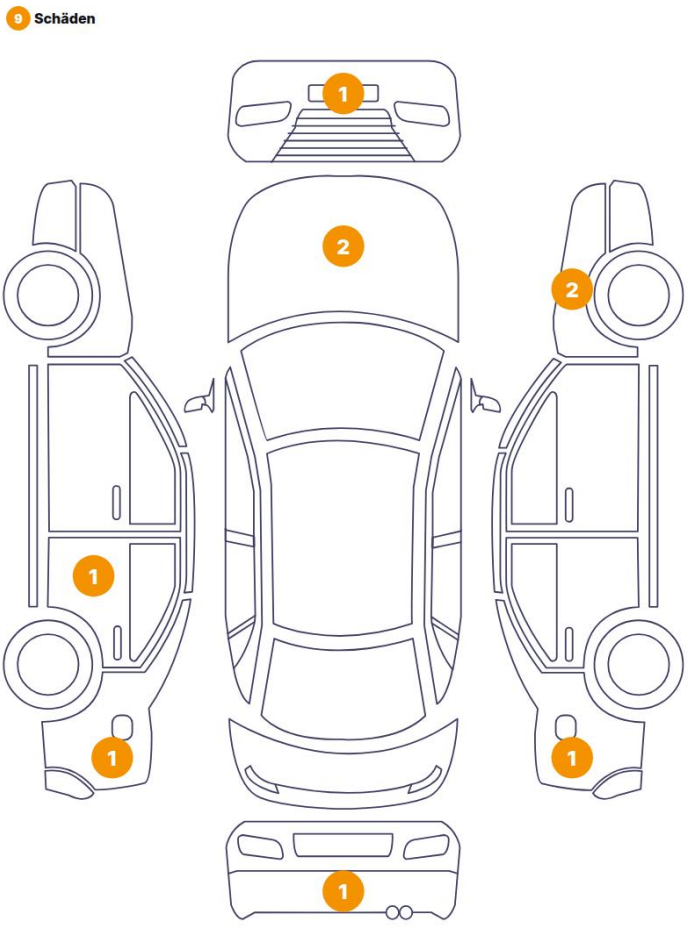
Cosmetic Damage

Component	Damage	Comments
1	Door / Back Left	Paint / Poor Previous Repair	
2	Bumper / Back	Paint / Scratch / Scuff	
3	Fender / Back Left	Bodywork / Dent / Dent	
4	Fender / Back Right	Paint / Scratch / Scuff	
5	Fender / Front Right	Bodywork / Dent / Dent	
6	Fender / Front Right	Paint / Poor Previous Repair	
7	Hood	Paint / Poor Previous Repair	
8	Bumper / Front	Paint / Stone Chip	
9	Hood	Paint / Stone Chip

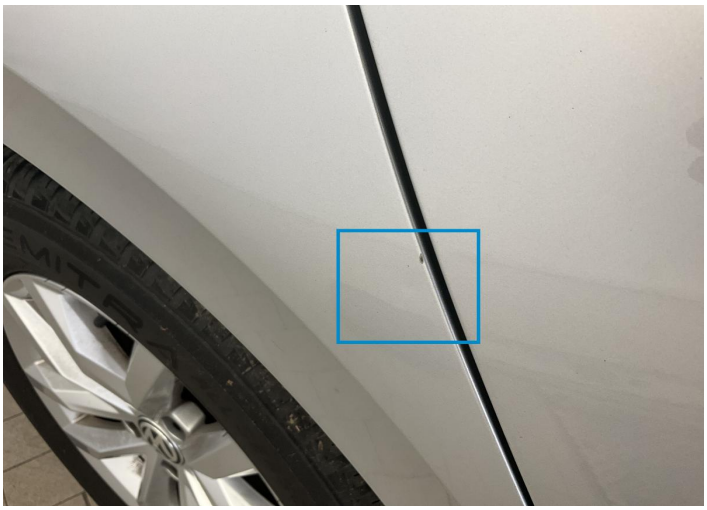
3. Fender / Back Left
Bodywork / Dent / Dent -

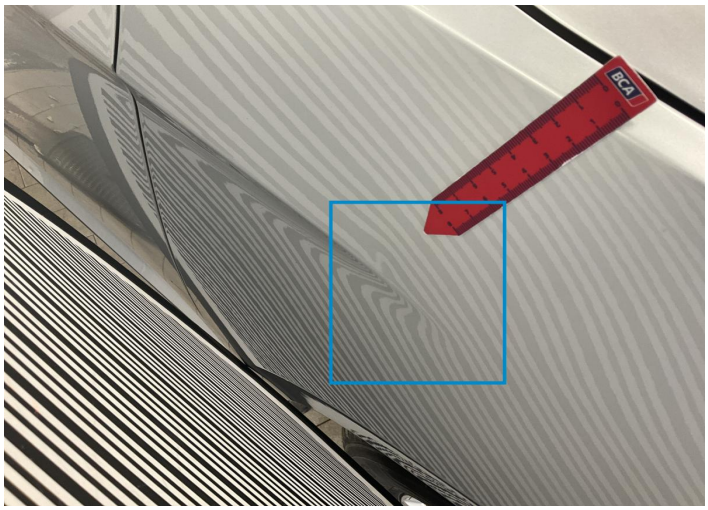
4. Fender / Back Right
Paint / Scratch / Scuff -
