VOLKSWAGEN Polo V Polo 1.2 TSI

VIN NO WVWZZZ6RZCY189242

Inspection Report Summary

Customer	BCA Online	Report Number	P20250930105429
Inspection Date / Place	2025-09-30 / SULOJA Mönchengladbach	Cosmetic Grade	4

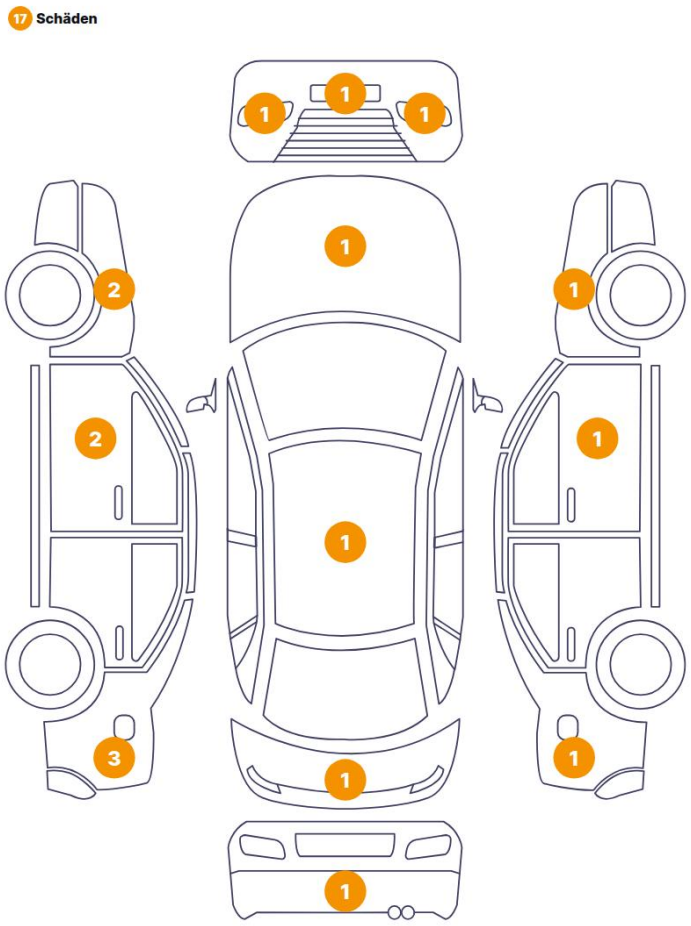
Cosmetic Damage

Component	Damage	Comments
1	Bumper / Front	Paint / Stone Chip	
2	Hood	Paint / Poor Previous Repair	
3	Front Light / Front Left	Glass Break	
4	Front Light / Front Right	Paint / Burn	
5	Fender / Front Left	Bodywork / Dent / Dent	
6	Fender / Front Left	Paint / Poor Previous Repair	
7	Door / Front Left	Paint / Scratch / Scuff	
8	Door / Front Left	Paint / Poor Previous Repair	
9	Side Panel / Back Left	Bodywork / Dent / Dent	
10	Side Panel / Back Left	Paint / Poor Previous Repair	
11	Side Panel / Back Left	Paint / Scratch / Scuff	
12	Tailgate	Bodywork / Dent / Dent

13	Bumper / Back	Paint / Scratch / Scuff
14	Fender / Front Right	Paint / Poor Previous Repair
15	Door / Front Right	Bodywork / Dent / Dent
16	Side Panel / Back Right	Bodywork / Dent / Dent
17	Roof	Bodywork / Dent / Hail Area
