VOLVO V60 Cross Country
V60 Cross Country B4 D AWD

VIN NO YV1ZZK5VXP2107093

Inspection Report Summary

Customer	BCA Online	Report Number	P20251002142941
Inspection Date / Place	2025-10-02 / BCA Neuss	Cosmetic Grade	1

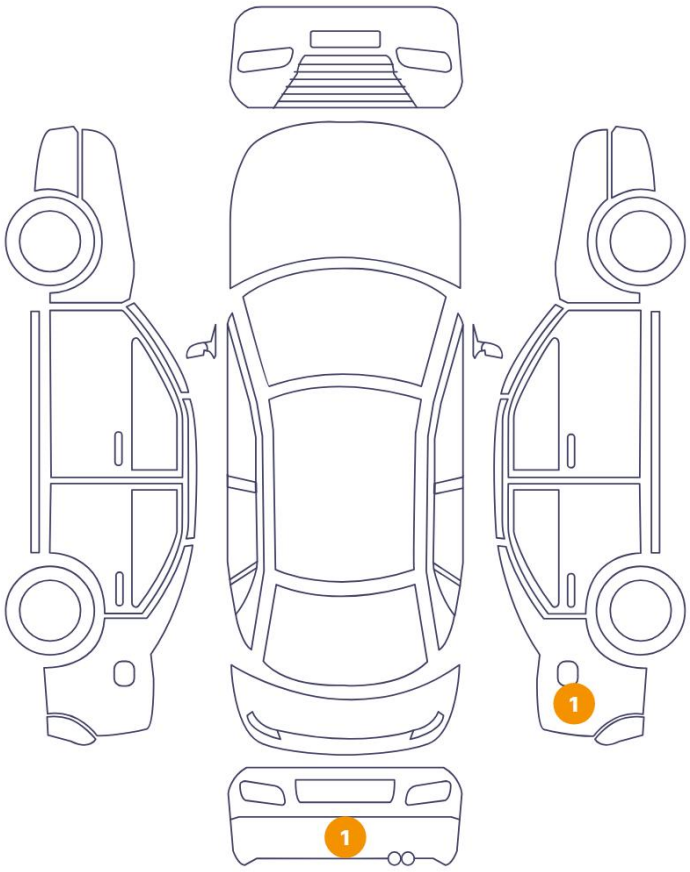
2 Schäden

Component	Damage	Comments
1	Fender / Back Right	Paint / Scratch / Scuff	
2	Bumper / Back	Paint / Scratch / Scuff
