MASERATI Ghibli Ghibli

VIN NO ZAMZS57B001373056

Inspection Report Summary

Customer	BCA Online	Report Number	P20250814115152
Inspection Date / Place	2025-08-14 / BCA Heidenheim	Cosmetic Grade	3

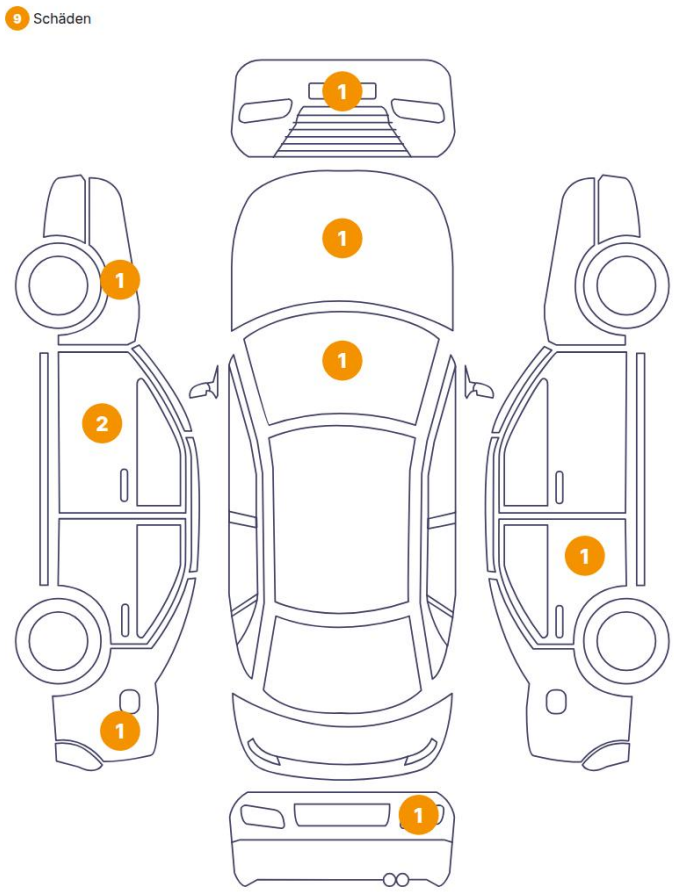
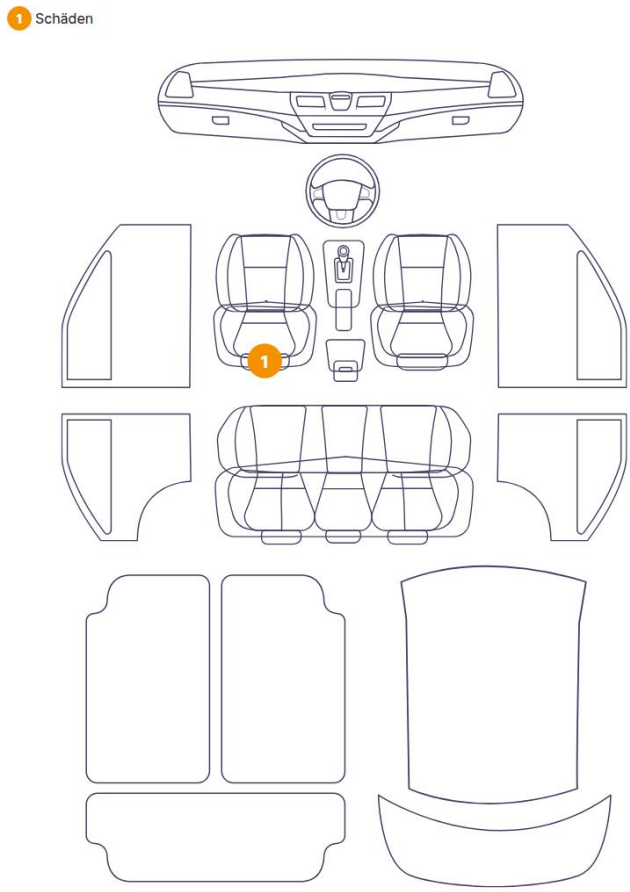
Cosmetic Damage

Component	Damage	Comments
1	Seat / Front Left	Interior / Worn - out	
2	Fender / Front Left	Paint / Poor Previous Repair	
3	Bumper / Front	Paint / Scratch / Scuff	
4	Hood	Paint / Poor Previous Repair	
5	Back Light / Right	Glass Break	
6	Pillar / Back Right	Bodywork / Dent / Dent	
7	Side Panel / Back Left	Paint / Poor Previous Repair	
8	Door / Front Left	Bodywork / Dent / Dent	
9	Mirror Shell / Front Left	Paint / Scratch / Scuff	
10	Windshield / Front	Glass Break / Impact

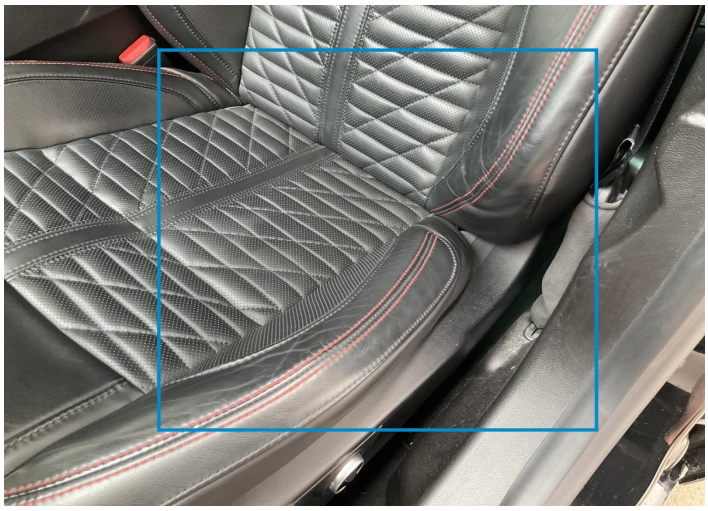
1. Seat / Front Left
Interior / Worn - out -

2. Fender / Front Left
Paint / Poor Previous Repair -

3. Bumper / Front
Paint / Scratch / Scuff -

4. Hood
Paint / Poor Previous Repair -

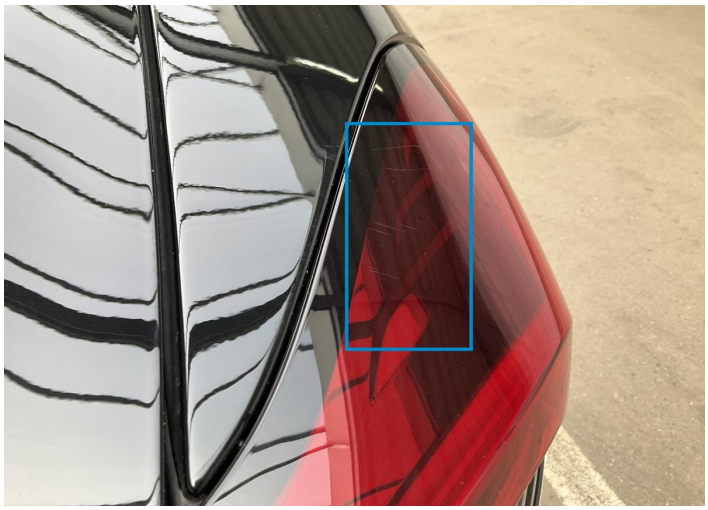
5. Back Light / Right
Glass Break -

6. Pillar / Back Right
Bodywork / Dent / Dent -

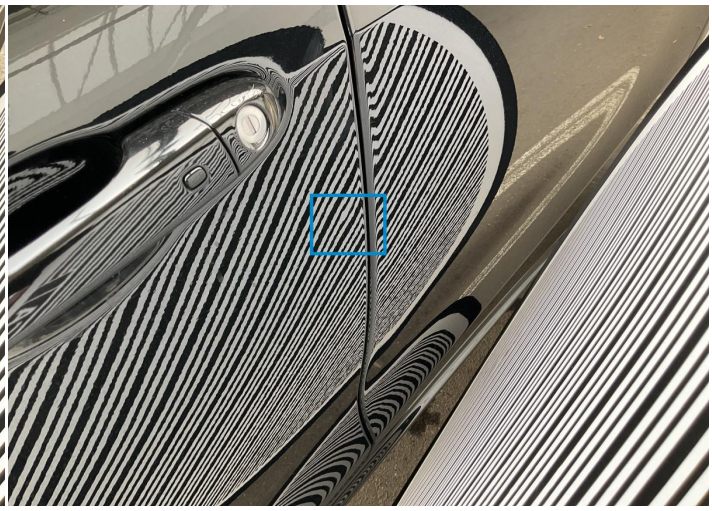
7. Side Panel / Back Left
Paint / Poor Previous Repair -

8. Door / Front Left
Bodywork / Dent / Dent -

9. Mirror Shell / Front Left
Paint / Scratch / Scuff -

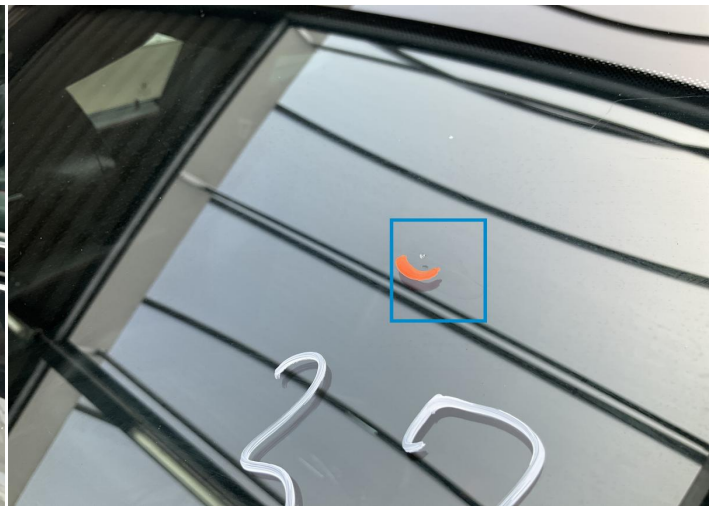
10. Windshield / Front
Glass Break / Impact -
