status report

Jeep Renegade S Plug-In-Hybrid 4xe

Vehicle identification number	1C4BU0000LP006342	mileage read:	39252 km
..			
First Registration / construction year:	16.06.2021 / 2020	Visit Date / place of birth:	12.09.2025 Dahlwitz- Hoppegarten
Bodywork:	SUV	Re - import:	no
Body type:	Road /	KBA no. :	1726//ACP
Fuel / emission class:	Petrol / hybrid / € 6	transmission type:	automatic
Displacement / power:	1332 ccm / 132 kW (179 PS)	Engine:	four-wheel
paint:	COLORADO RED CLEAR COAT	Number of previous owners:	Unbekannt
Doors / seats:	5 / 5	number keys:	2
Next HU / AU:	- / -	cushion type:	substance
Service book available:	yes	Interior Color:	black
smoking vehicle:	no	Last service km / on the:	37790 / 23.09.2024
Vehicle roadworthy:	yes	Vehicle roadworthy:	yes
Submitted vehicle documents:	For example, I (Fzg.Schein)	state outside:	2 - Good
visit condition:	-	condition inside:	2 - Good
state general:	2 - Good

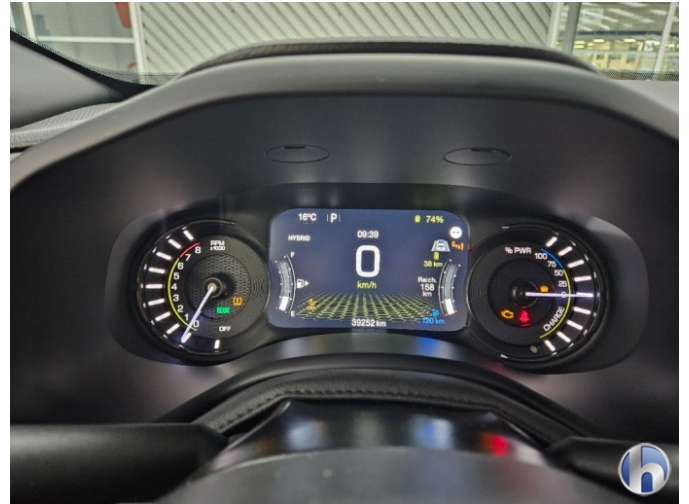
instrument cluster

component	Damage	Rep kind
1. maintenance	Due	Replace
2. motor	Error message	Carry out a fault diagnosis
3. Reifendrucküberwachung	Error message	Carry out a fault diagnosis
4. tailgate	Deformed (slightly)	Smart repair
5. Rear bumper	Scratch(es)	Smart repair
6.	Scratch(es)	Paint
7. tire front - right	Damaged	Replace
8.	Scratch(es)	Paint
9. exterior body	Sticker	
10. battery	Empty battery	Replace
