## status report

**customer:** Bank 11, Neuss  
**contract number:** 903930931  
**reference:**

#### Dodge Ram 1500

| Vehicle identification number | <b>1C6RR7LG3MS589304</b> | mileage read: | <b>50389 km</b> |

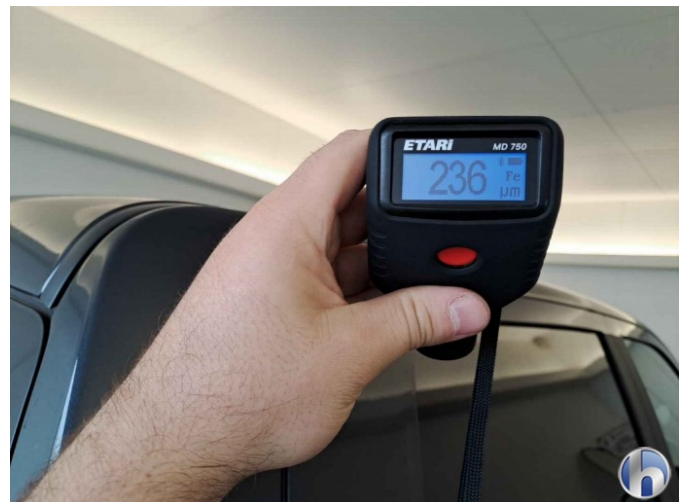
6. Roof frame - right

| component | Damage | Rep kind |
|---|---|---|
| 37. Roof frame - right | Execution defect | Refurbish and paint |

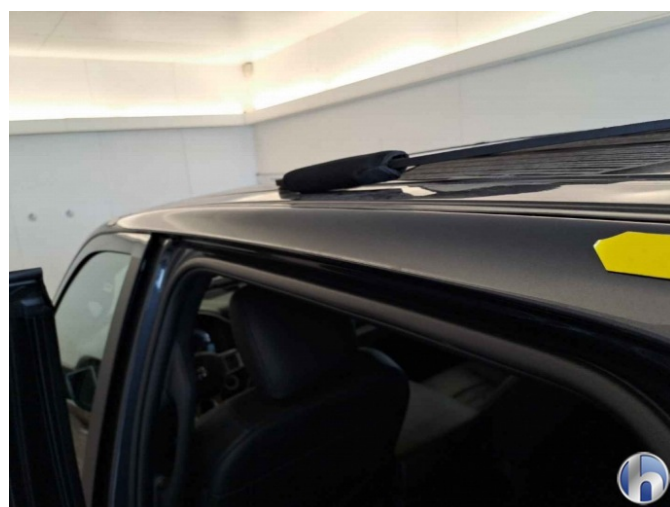
| component | Damage | Rep kind |
|---|---|---|
| 26. Türeinstieg Hinten - Links | Execution defect | Paint |

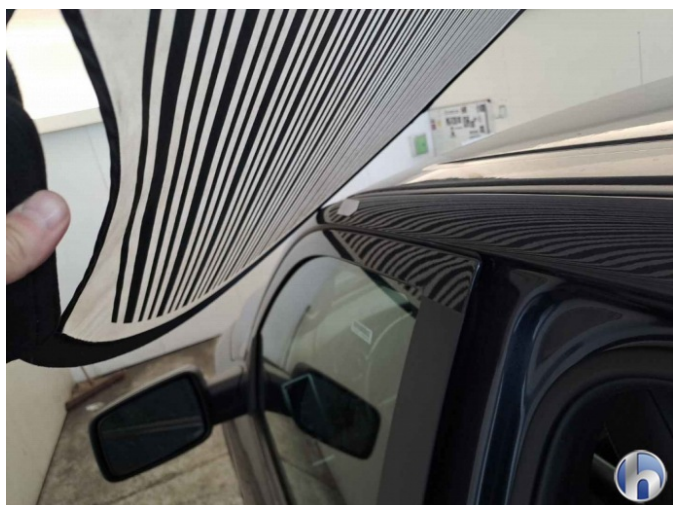
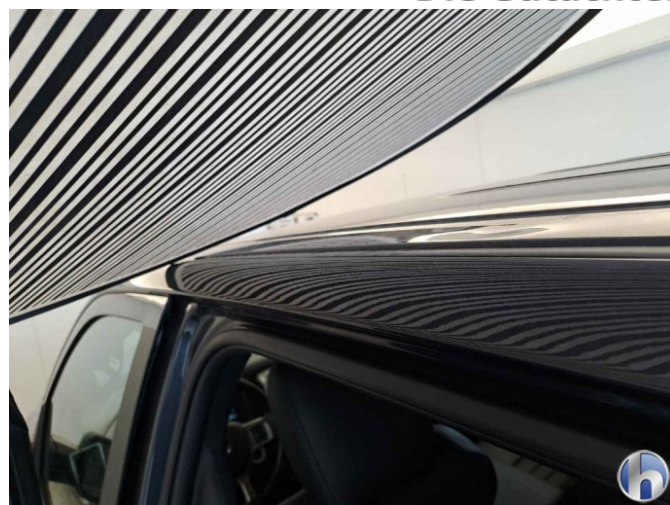
| component | Damage | Rep kind |
|---|---|---|
| 27. Roof frame - left | Execution defect | Refurbish and paint |

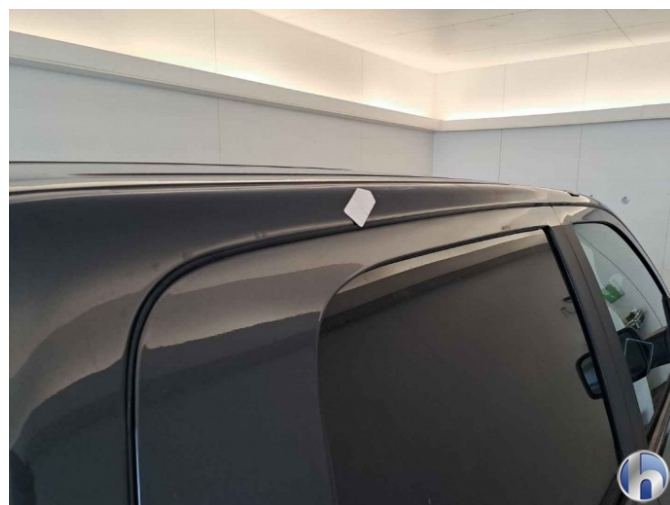
| component | Damage | Rep kind |
|---|---|---|
| 36. roof | Execution defect | Refurbish and paint |
