## status report

**customer:** BCA Autoauktionen GmbH  
**contract number:**  
**reference:**

#### DODGE RAM1500

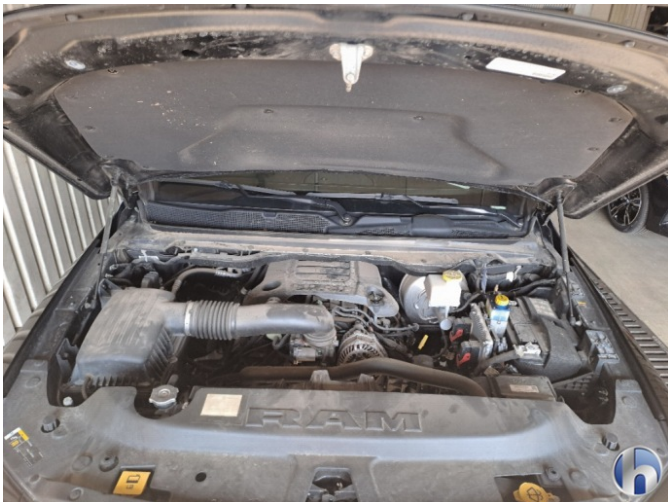
engine compartment

| Performed testing technology | |
|---|---|
| <b>oil loss:</b> | The vehicle could be checked only limited to oil leaks . |
| <b>engine running:</b> | Checking the engine running was limited. Here no audible or visual abnormalities were noted . |

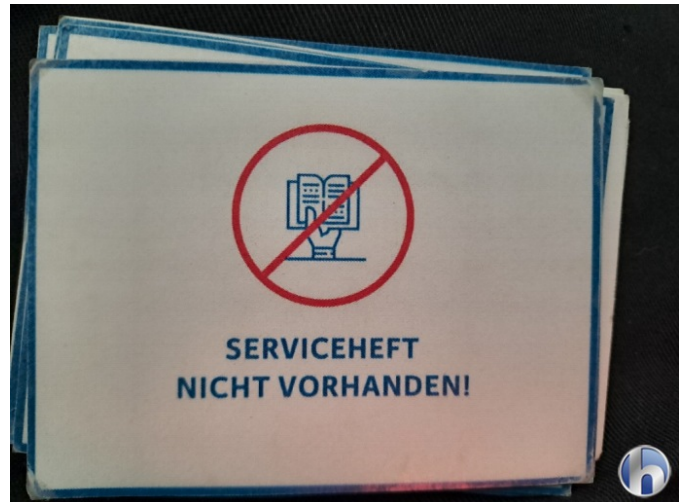
service book

| component | Damage | Rep kind |
|---|---|---|
| 14. proof of maintenance | Missing | Replace |
