Expertise

Protocol number: 41830977
Order number / reference: 25277617
Inspection date: 6 Oct 2025

Manufacturer: Ford

Model: Ranger 2,0 I EcoBlue Autm. XLT

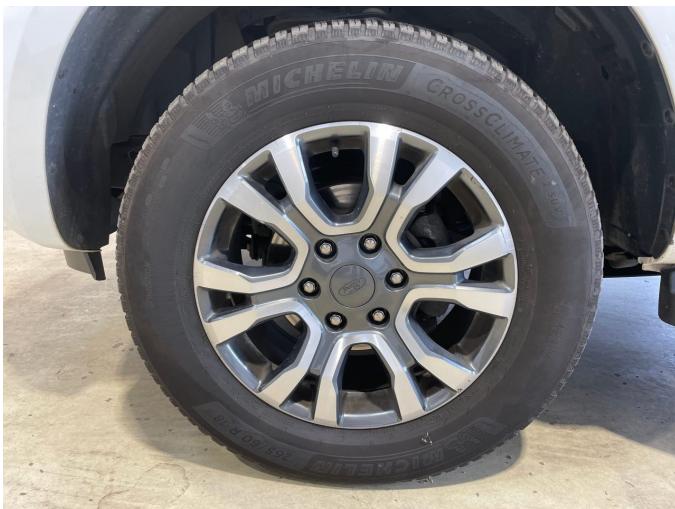
Figure 11: Mounted tyres

#	Tyre size	Type of tyre	Manufacturer	Tread depth
1)	265/60 R18 110H	All-season tyres on Light alloy	Michelin	5mm / 5mm
2)	265/60 R18 110H	All-season tyres on Light alloy	Michelin	6mm / 6mm
