MITSUBISHI Outlander Outlander 2.0 DI-D 4WD

Inspection Report Summary

Customer	BCA Online	Report Number	P20250924140823
Inspection Date / Place	2025-09-24 / BCA Oberndorf	Cosmetic Grade	5

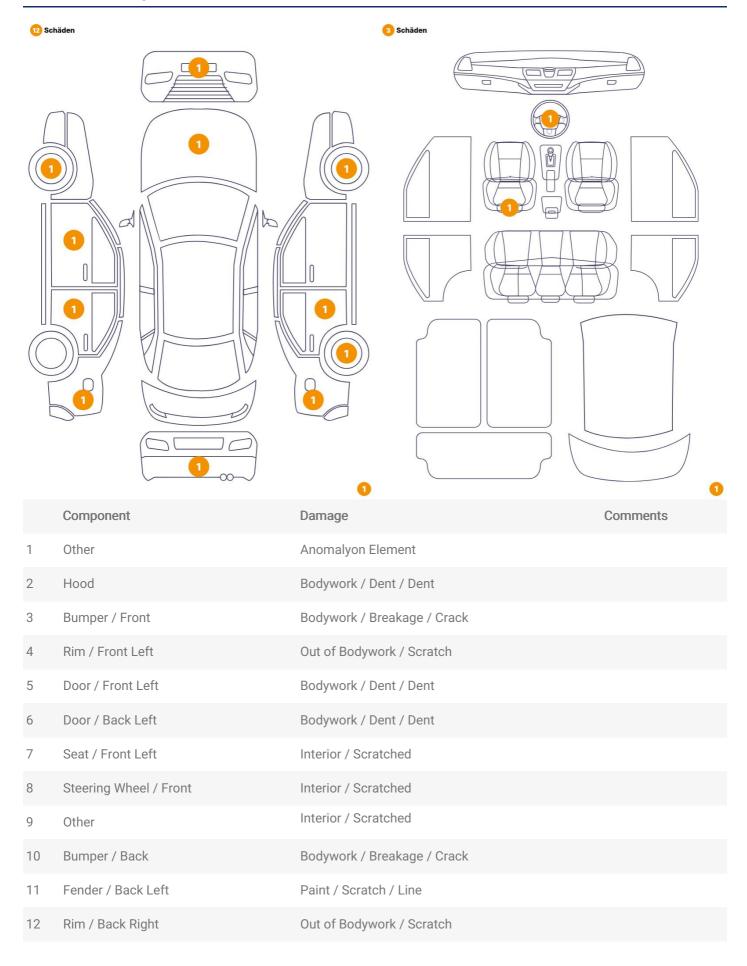
13	Fender / Back Right	Bodywork / Dent / Dent
14	Door / Back Right	Bodywork / Dent / Dent
15	Rim / Front Right	Out of Bodywork / Scratch
