MAZDA CX-3 CX-3 SKYACTIV-G 120 FWD

Inspection Report Summary

Customer	BCA Online	Report Number	P20250917133205
Inspection Date / Place	2025-09-17 / ARS Altmann AG Riedstadt	Cosmetic Grade	3

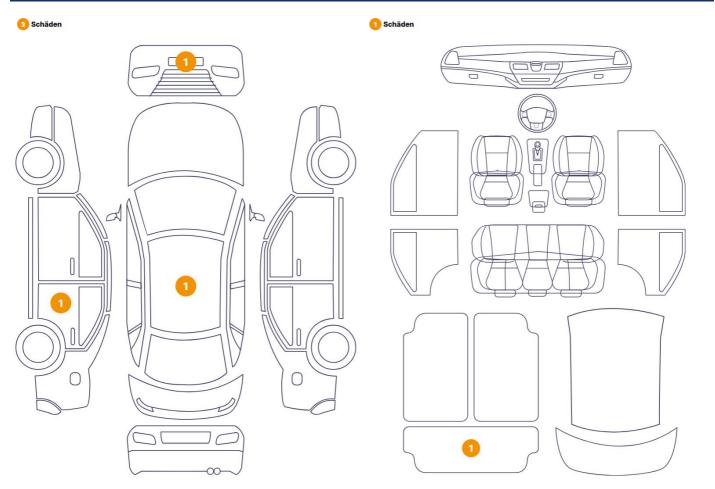
Cosmetic Damage

Component	Damage	Comments
1 Bumper / Front	Paint / Scratch / Scuff	
2 Door / Back Left	Bodywork / Dent / Dent	
3 Luggage Space Cover / Back	Interior / Dysfunctional	
4 Roof	Bodywork / Dent / Hail Area
