# HYUNDAI BAYON

## Bayon 1.0 T-GDi 100 Hybrid 48V Creative

VIN NO NLHBR81G0SZ559854

### Inspection Report Summary

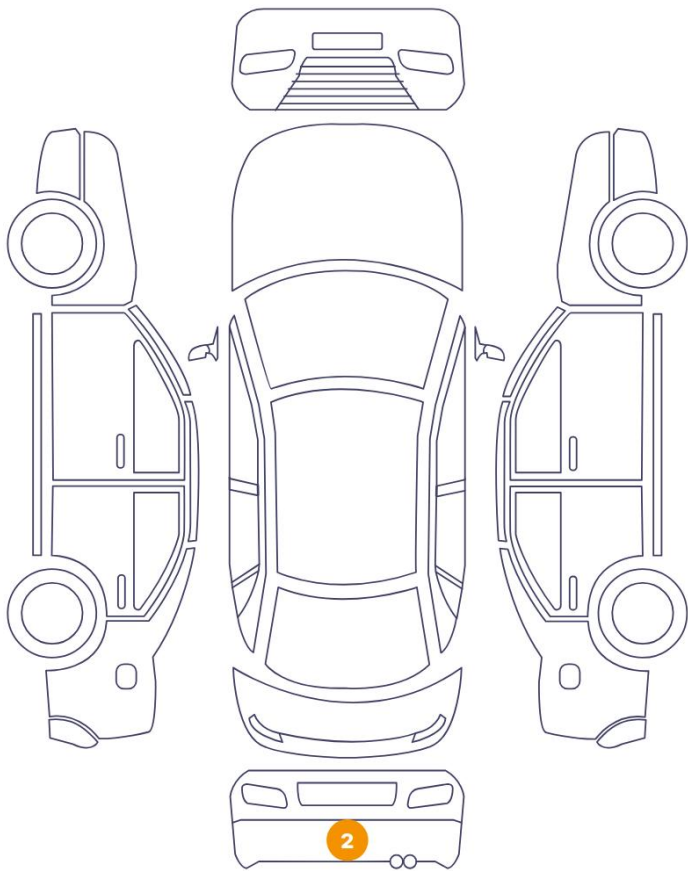
2 Dommages
