Expertise

Protocol number: 41196429
Order No. / Reference: 25104261
Inspection date: 21 Aug 2025

Manufacturer: Land Rover

Model: Discovery Sport D200 R-Dynamic SE

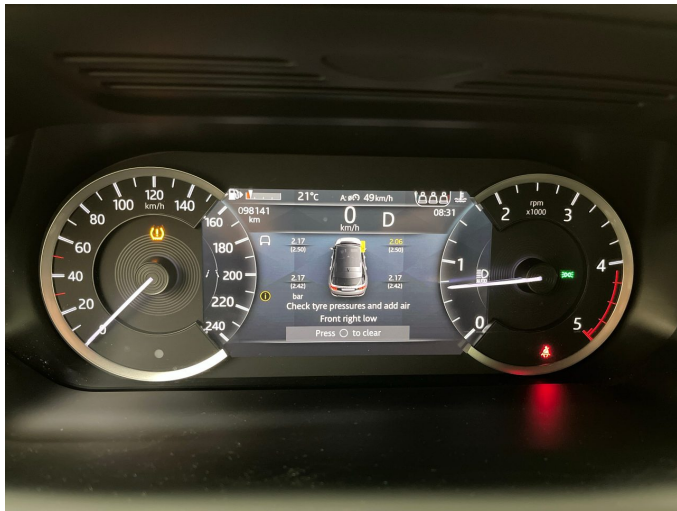
Figure 7: Instrument cluster

Damage 3: Instrument panel: Indicator light (Reifendruckkontrollleuchte) - on - Diagnosed and repair if necessary

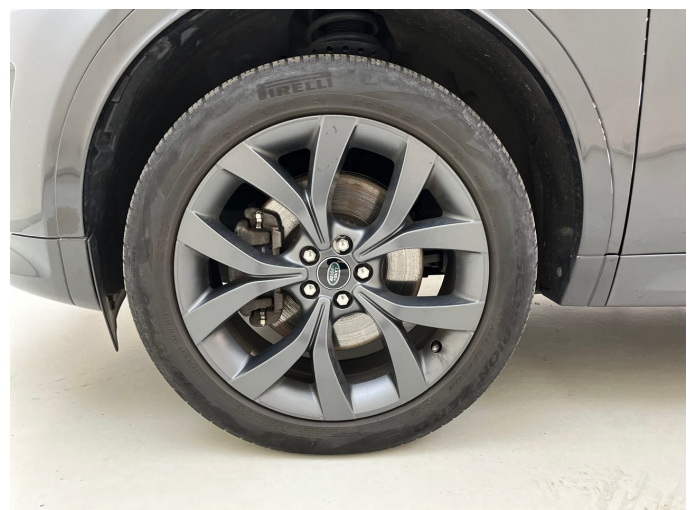
Figure 12: Mounted tyres

#	Tyre size	Type of tyre	Manufacturer	Tread depth
1)	235/50 R20 104W	All-season tyres on Light alloy	Pirelli	4mm / 4mm
2)	235/50 R20 104W	All-season tyres on Light alloy	Pirelli	5mm / 5mm

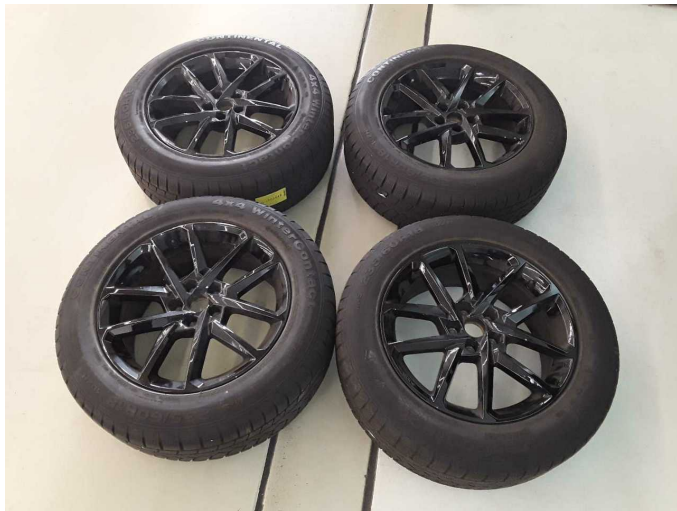
Figure 15: Additional tyres

#	Tyre size	Type of tyre	Manufacturer	Tread depth
1)	235/60 R18 107H	Winter tyres on Light alloy	Continental	3mm / 3mm
2)	235/60 R18 107H	Winter tyres on Light alloy	Continental	6mm / 6mm
