LAND ROVER Range Rover Sport II 2018 Die.

Range Rover Sport 3.0d i6 mhev HSE Dynamic 249cv a

Inspection Report Summary

Customer	BCA Lodi	Report Number	P20251002102442
Inspection Date / Place	2025-10-02 / BCA Lodi	Cosmetic Grade	2

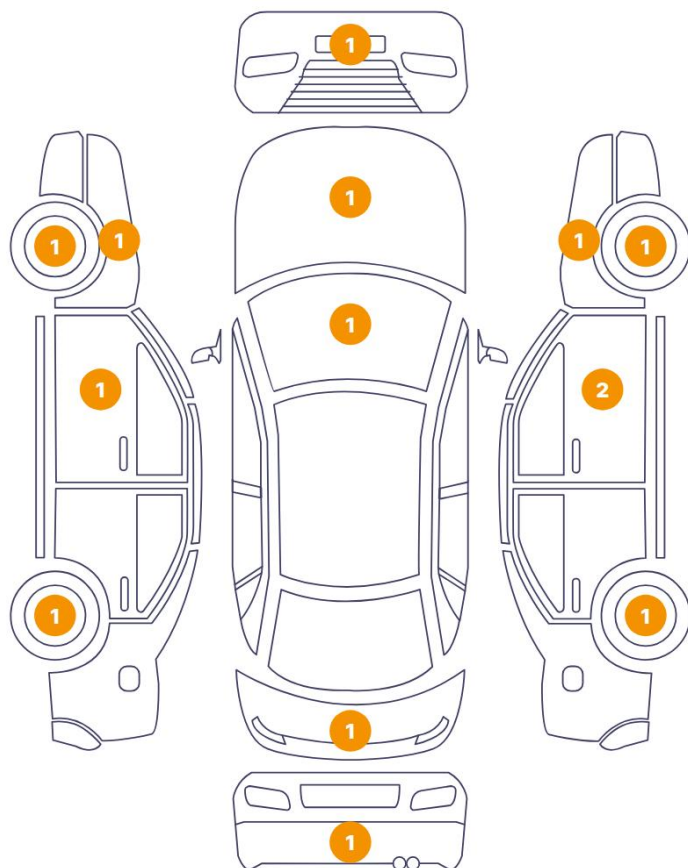
14 Danni

13	Fender / Front Left	Paint / Scratch / Line
14	Door / Front Left	Paint / Scratch / Line
15	Rim / Back Left	Out of Bodywork / Scratch
16	Bumper / Back	Bodywork / Dent
17	Tailgate	Paint / Chipping
18	Rim / Back Right	Out of Bodywork / Scratch
19	Door / Front Right	Paint / Chipping
20	Panel Filling / Back Right	Interior / Scratched
21	Panel Filling / Front Right	Interior / Scratched
