## status report

| vehicle data | | | |
|---|---|---|---|
| <b>Land Rover Range Rover Evoque R-Dynamic SE</b> | | | |
| Vehicle identification number | <b>SALZA2BX4PH225570</b> | mileage read: | <b>17174 km</b> |
| First Registration / construction year: | <b>14.11.2023 / 2022</b> | Visit Date / place of birth: | <b>21.03.2025 Riedstadt-Goddelau</b> |

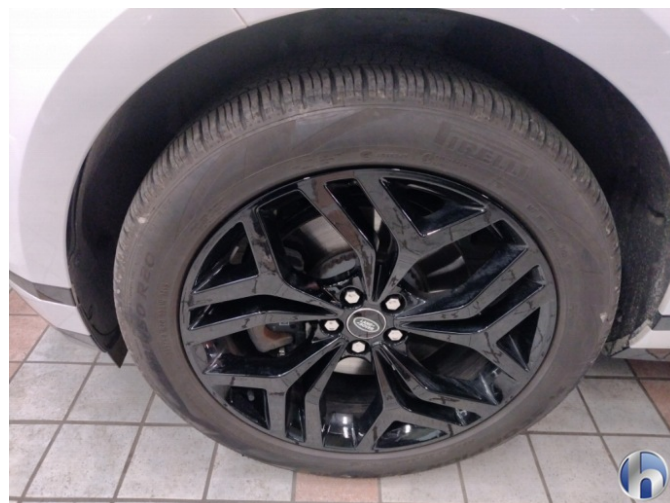
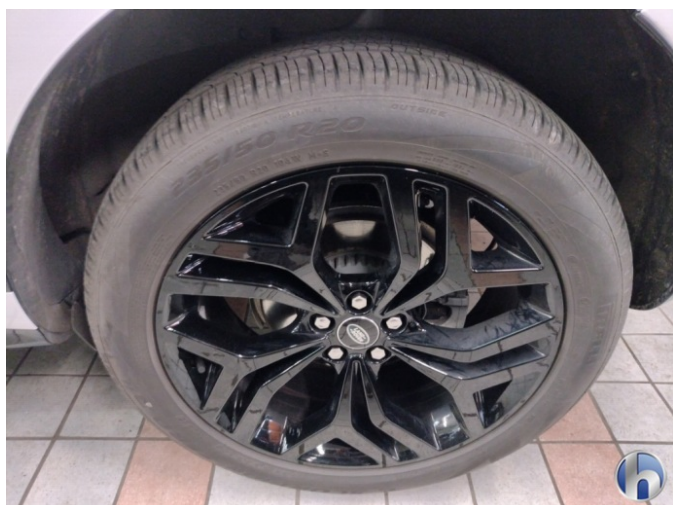
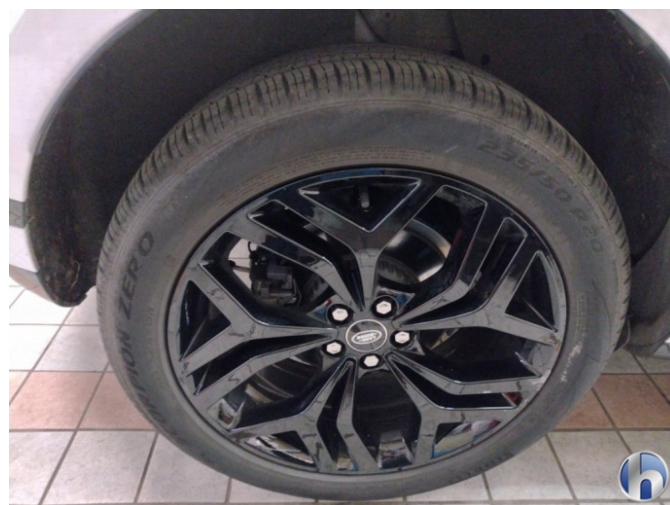
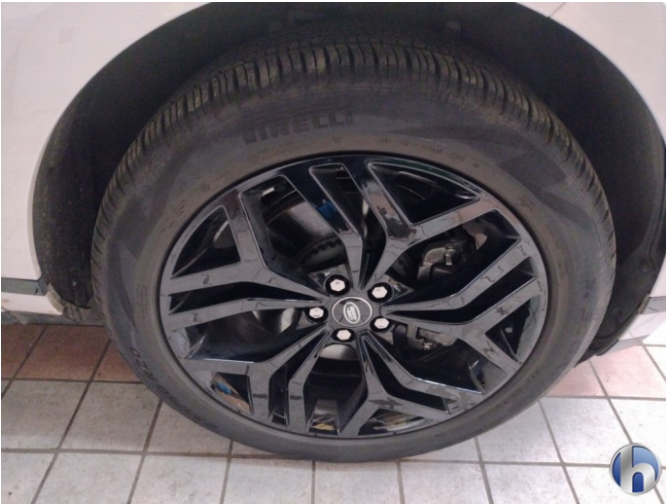
rims

| component | Damage | Rep kind |
|---|---|---|
| 3. Rim rear - right | Scratch(es) | Replace |
| 4. tire rear - right | Wear and tear | acceptable |
| 5. Allwetterreifen ohne Alpine Symbol | Not okay | Replace |

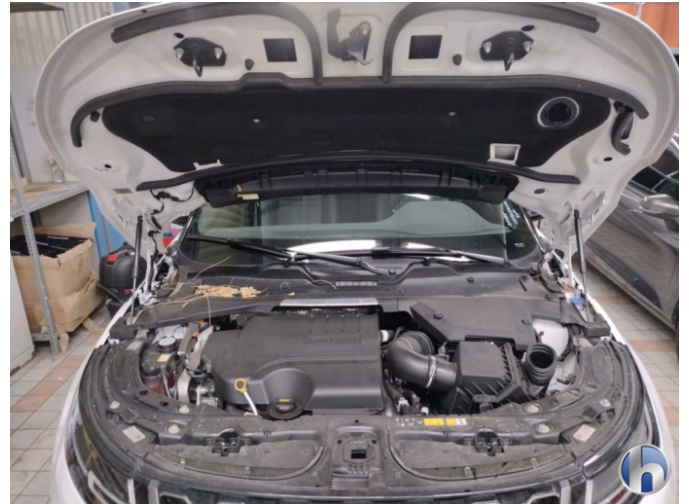
engine compartment

| Performed testing technology | |
|---|---|
| <b>engine running:</b> | Checking the engine running was limited. Here no audible or visual abnormalities were noted . |
