## status report

| <b>customer:</b> | <b>Bank 11, Neuss</b> |

| vehicle data | | | |
|---|---|---|---|
| <b>Hyundai i30 N Performance</b> | | | |
| Vehicle identification number | <b>TMAHC51AALJ018670</b> | mileage read: | <b>120005 km</b> |

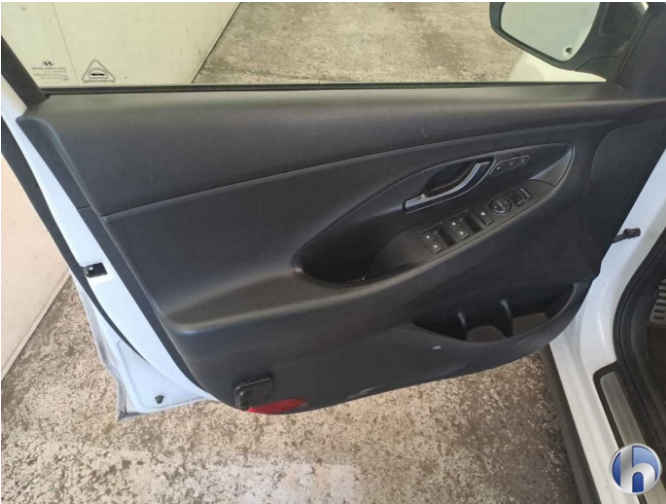
| component | Damage | Rep kind |
|---|---|---|
| 27. Front door trim - left | Scrape | Replace |
