status report

Customer:	Allane SE HCBE	Off. Mark :	B-MK 6010E
Report number:	0000000805901-EN968		
reference number:	30834465

Hyundai Kona (OS)(2017->) Select Elektro 2WD

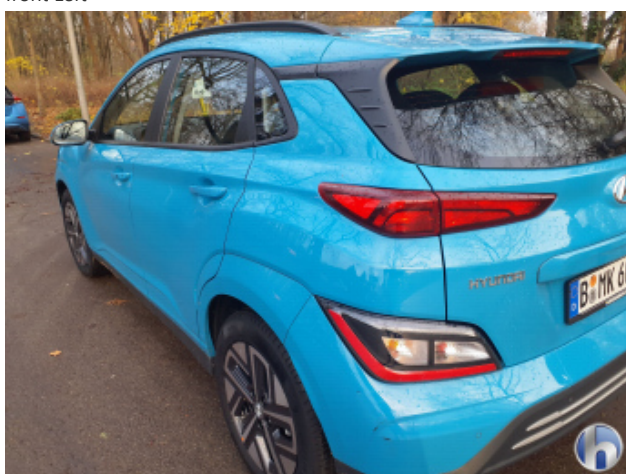
rear Left

Component	Damage	Rep kind
1.	Rear Bumper	Light scratch	Paint

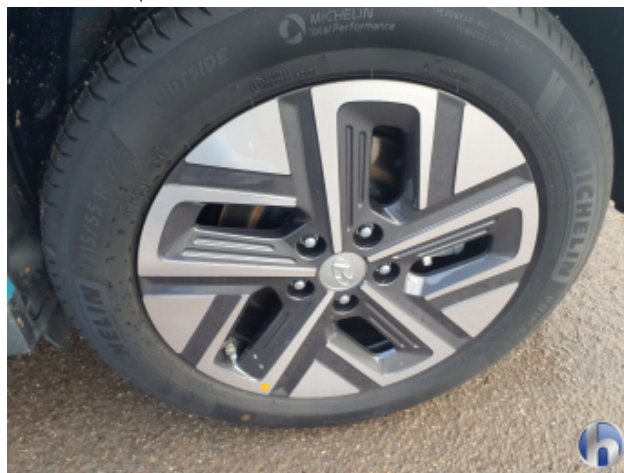
Tyre / wheel type:	Summer tires	Aluminium original
1st axis - Left / states .	Michelin	215/-/R17/-- 5 mm
1st axis - right / states .	Michelin	215/-/R17/-- 5 mm
2nd axis - Left / states .	Michelin	215/-/R17/-- 5 mm
2nd axis - right / states .	Michelin	215/-/R17/-- 5 mm
Traffic Safety:	Roadworthy
