## status report

Customer:	Allane SE HCBE	Off. Mark :	MB-MR 604E
Report number:	0000000806347-EN968		
reference number:	30829568

#### Hyundai Kona (OS)(2017->) Trend Elektro 2WD

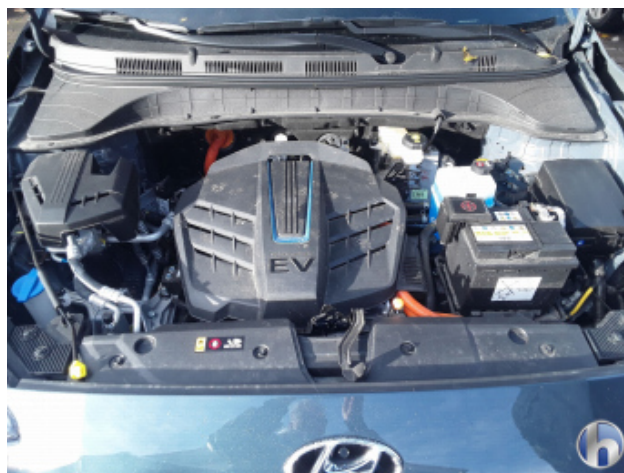
engine compartment

**engine running:** Checking the engine running was limited. Here no audible or visual abnormalities were noted .  
**reference:** \*

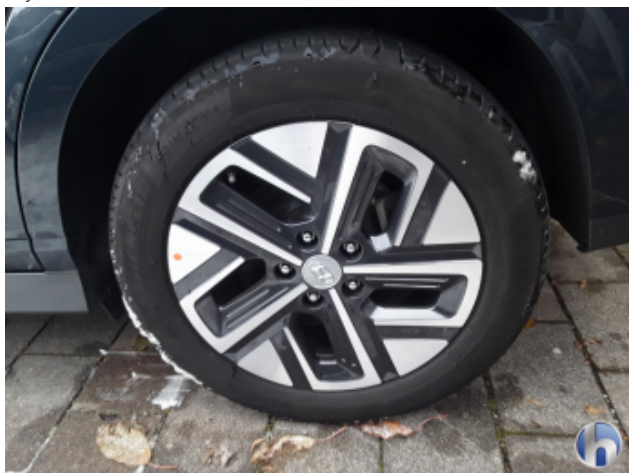
Summer tires	Aluminium original
Tyre / wheel type:	<b>Marangoni</b>	<b>215/-R17/-- 5.5 mm</b>
1st axis - Left / states .	<b>Marangoni</b>	<b>215/-R17/-- 5.5 mm</b>
1st axis - right / states .	<b>Marangoni</b>	<b>215/-R17/-- 4 mm</b>
2nd axis - Left / states .	<b>Marangoni</b>	<b>215/-R17/-- 4 mm</b>
2nd axis - right / states .	<b>Marangoni</b>	<b>215/-R17/-- 4 mm</b>
Traffic Safety:	<b>Roadworthy</b>
