## status report

**customer:** Bank 11, Neuss  
**contract number:** 718773430  
**reference:**

#### Skoda Superb Lim. Style

| Vehicle identification number | <b>TMBAJ9NP7G7092477</b> | mileage read: | <b>259827 km</b> |

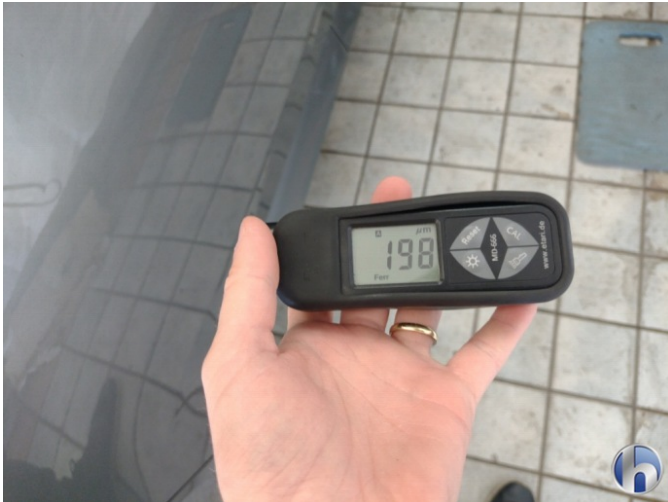
| component | Damage | Rep kind |
|---|---|---|
| 31. Door Rear - right | Damaged | Refurbish and paint |

2. Door Rear - right

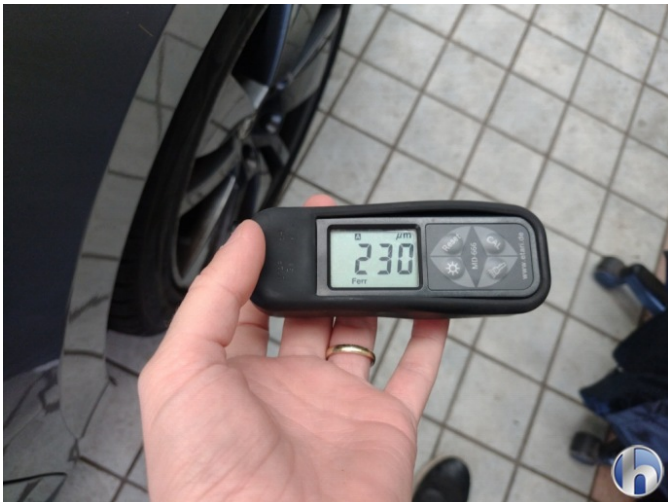
4. Front fender - right

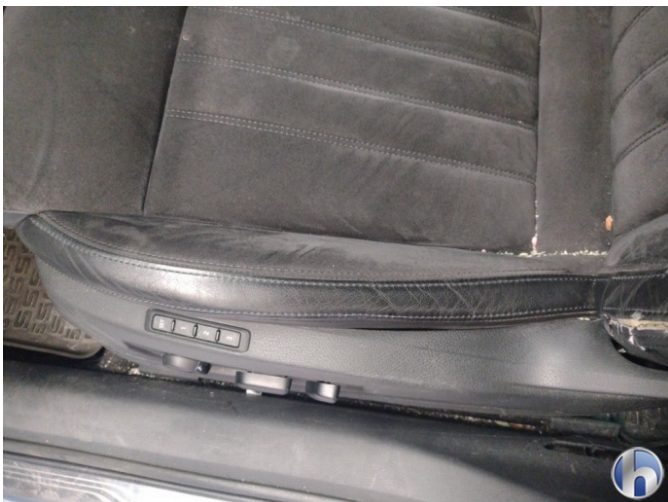
| component | Damage | Rep kind |
|---|---|---|
| 6. Sitz Vorne Links Kissen | Damaged | Smart repair |

6. Sitz Vorne Links Kissen

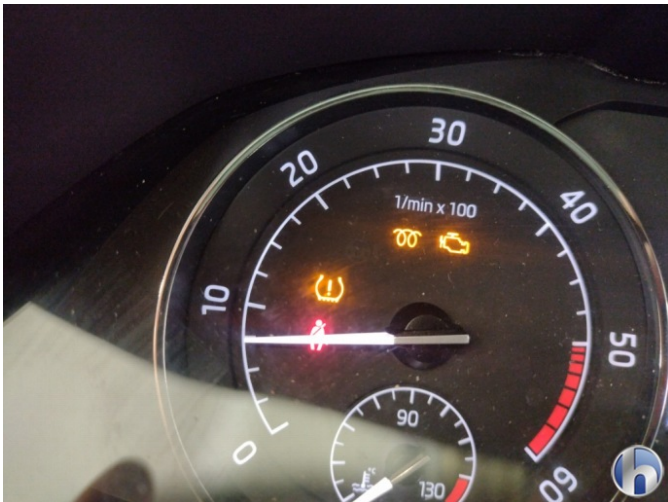
12. Reifendruckkontrollleuchte

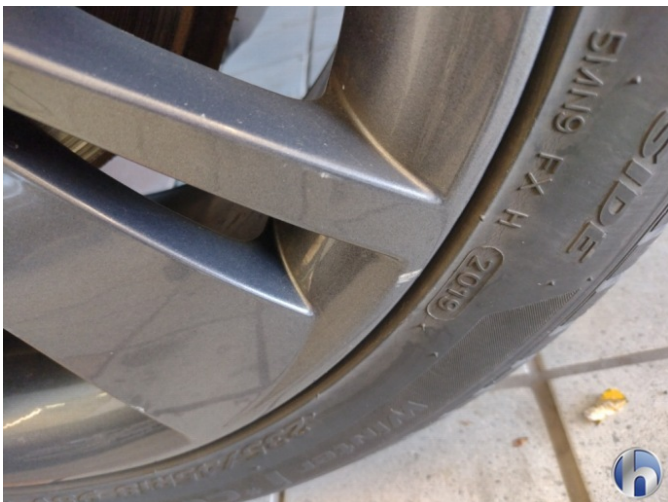
| component | Damage | Rep kind |
|---|---|---|
| 14. Rim rear - left | Scratch(es) | Smart repair |

14. Rim rear - left

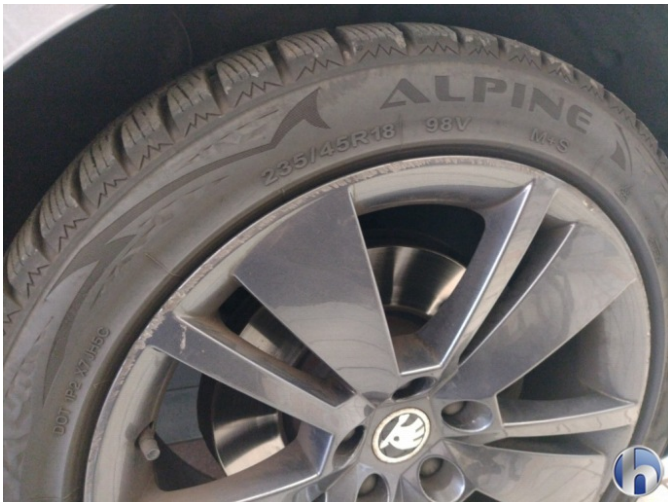
| component | Damage | Rep kind |
|---|---|---|
| 16. Rim front - right | Scratch(es) | Smart repair |

16. Rim front - right

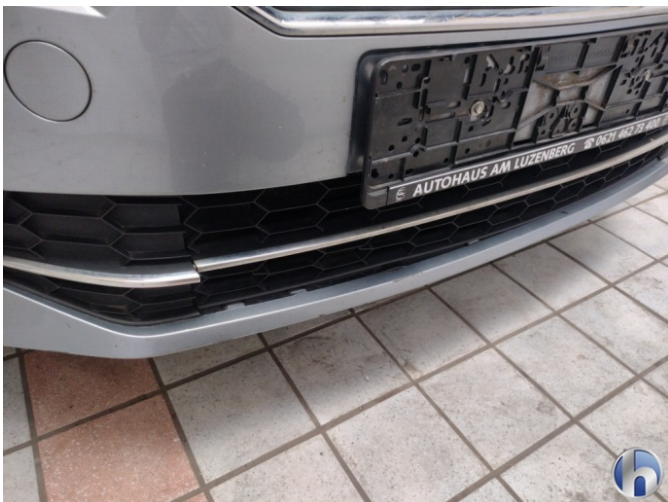
| component | Damage | Rep kind |
|---|---|---|
| 17. Front grill bumper Below | Damaged | Replace |

17. Front grill bumper Below

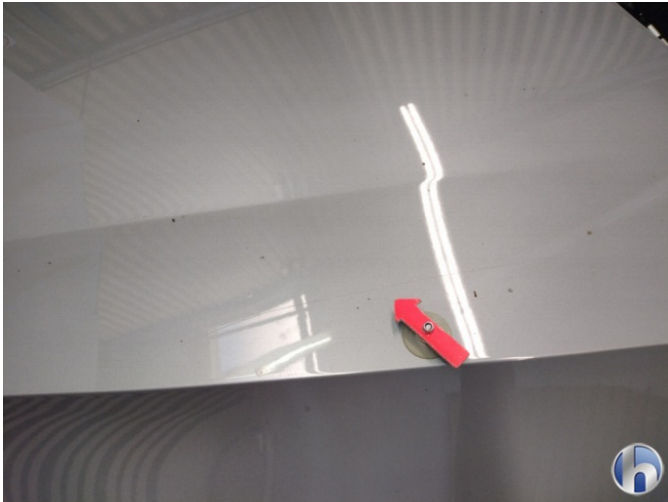
18. hood

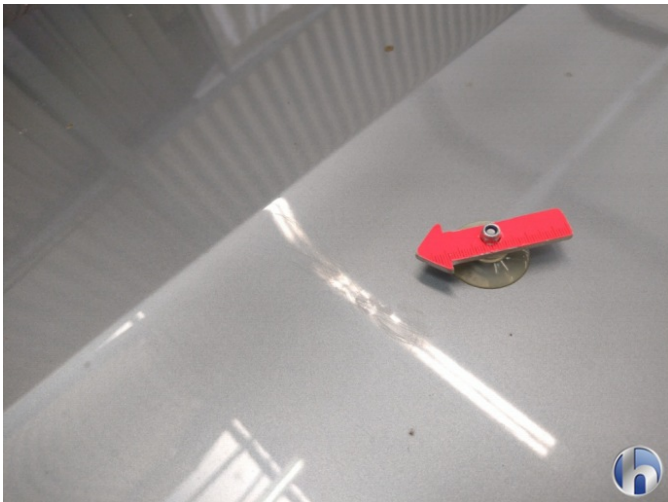
18. hood

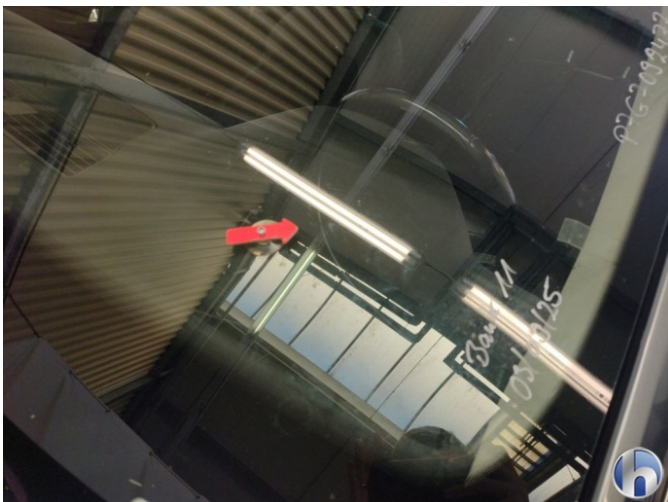
| component | Damage | Rep kind |
|---|---|---|
| 19. Windshield | Scratch(es) | Replace |

19. Windshield
