## status report

**customer:** Bank 11, Neuss  
**contract number:** 868551730-INSO  
**reference:**

#### Skoda Kamiq Ambition

| Vehicle identification number | <b>TMBGP9NW8M3126090</b> | mileage read: | <b>90200 km</b> |

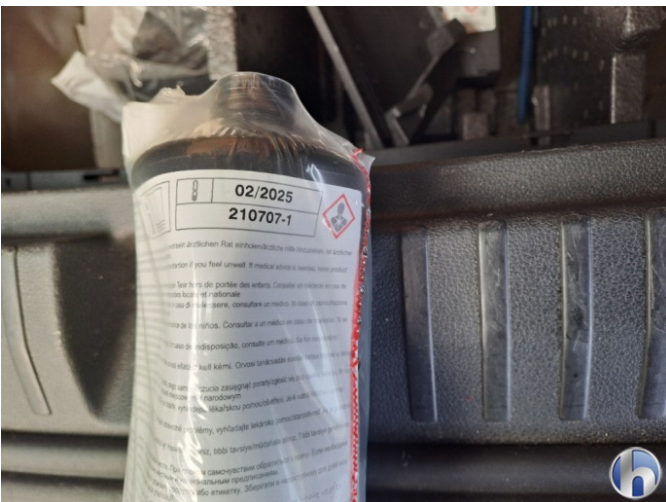
24. reifendichtmittel

| | component | Damage | Rep kind |
|---|---|---|---|
| 24. | reifendichtmittel | Due | Replace |
