Expertise

Protocol number: 41186826  
Order No. / Reference: 25036588  
Inspection date: 20 Aug 2025

Manufacturer: Skoda  
VIN: TMBJH7NP8N7029322

Model: Superb Combi 2.0 TDI DSG Ambition

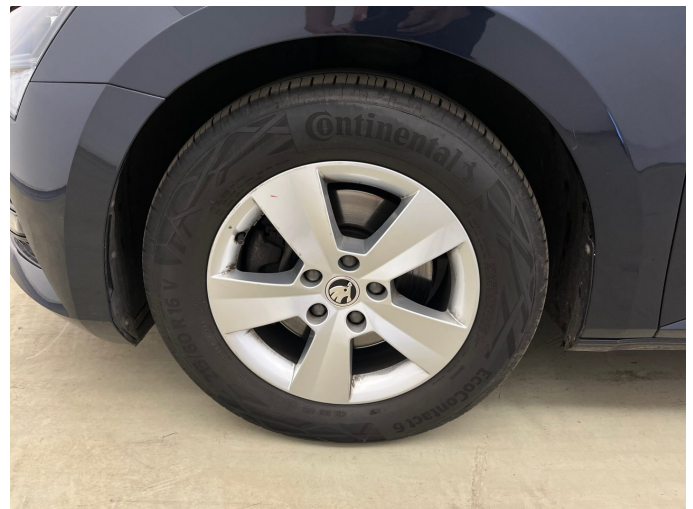
Figure 12: Mounted tyres

#	Tyre size	Type of tyre	Manufacturer	Tread depth
1)	215/60 R16 95V	Summer tyres on Light alloy	Continental	4mm / 4mm
2)	215/60 R16 95V	Summer tyres on Light alloy	Continental	4mm / 4mm

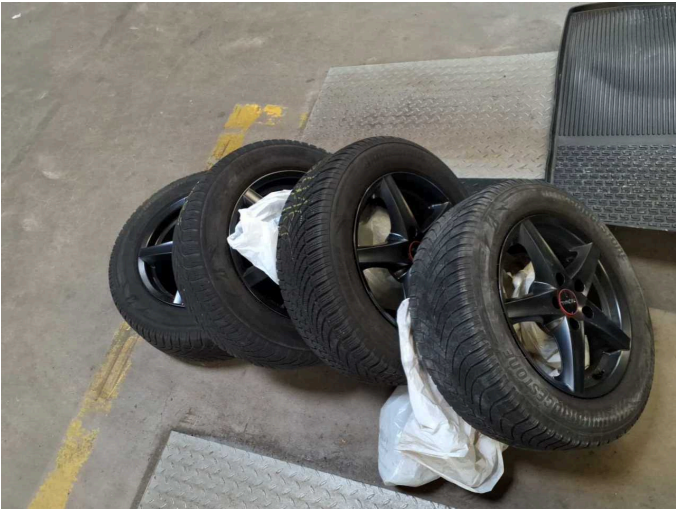
Figure 15: Additional tyres

#	Tyre size	Type of tyre	Manufacturer	Tread depth
1)	215/60 R16 99H	Winter tyres on Light alloy	Bridgestone	3mm / 3mm
2)	215/60 R16 99H	Winter tyres on Light alloy	Bridgestone	6mm / 6mm
