Expertise

Protocol number: 39967748
Order No. / Reference: 24798987
Inspection date: 30 May 2025

Manufacturer: Skoda	Model: Octavia Combi 2.0 TDI DSG Style
VIN: TMBJJ7NX0MY141190

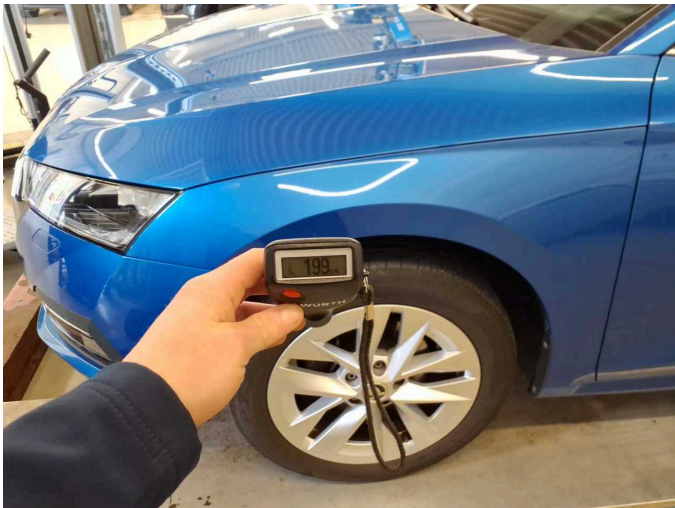
Repainting 1: Roof rail - left side, Roof rail - right side, Mudguard - left side, Mudguard - right side, Bonnet, Side panel - rear left side, Door - front left side

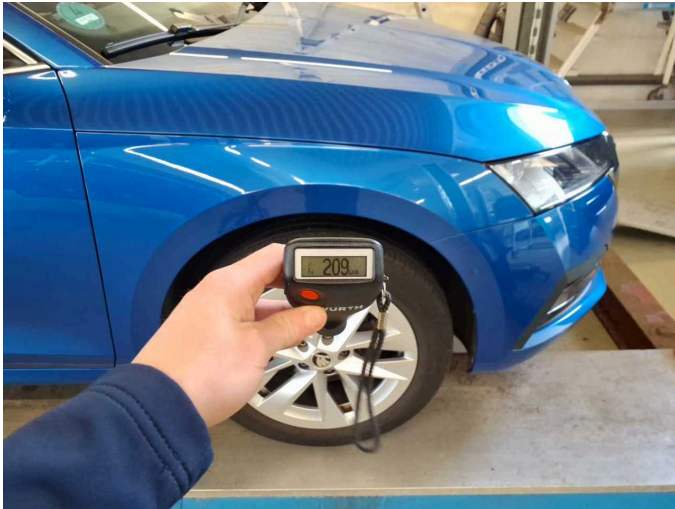
Repainting 1: Roof rail - left side, Roof rail - right side, Mudguard - left side, Mudguard - right side, Bonnet, Side panel - rear left side, Door - front left side

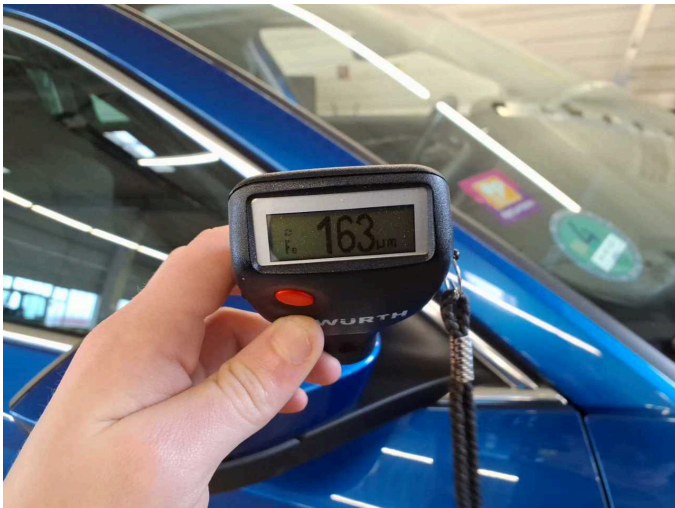
Repainting 1: Roof rail - left side, Roof rail - right side, Mudguard - left side, Mudguard - right side, Bonnet, Side panel - rear left side, Door - front left side

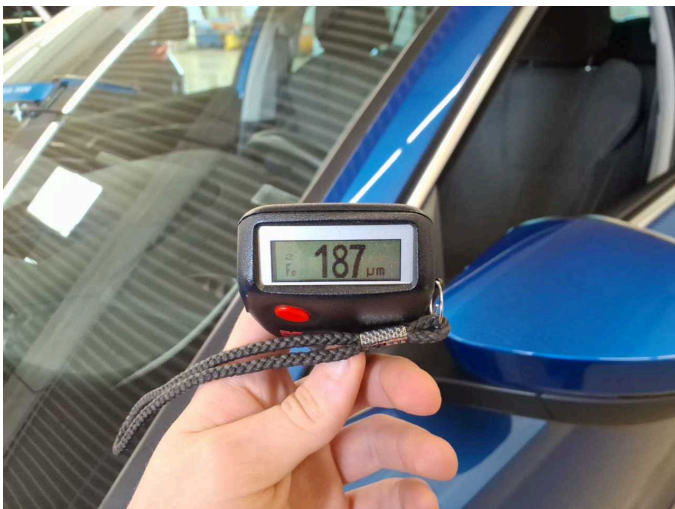
Repainting 1: Roof rail - left side, Roof rail - right side, Mudguard - left side, Mudguard - right side, Bonnet, Side panel - rear left side, Door - front left side

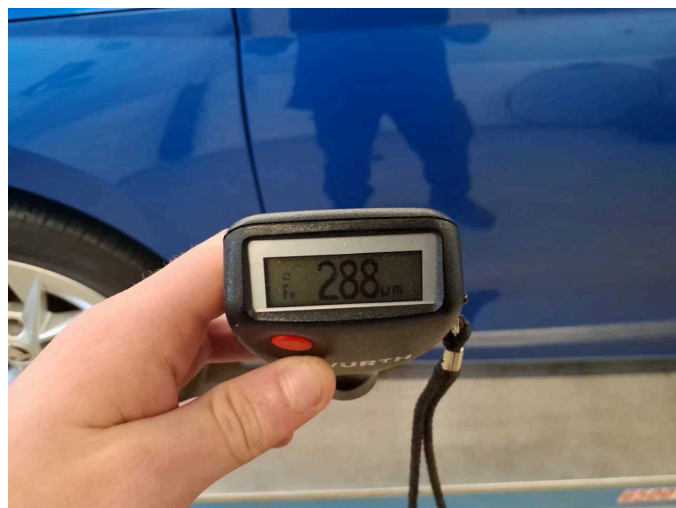
Door - front left side: 288 μm
