Expertise

Protocol number: 41662199
Order No. / Reference: 25188050
Inspection date: 18 Sept 2025

Manufacturer: Skoda
VIN: TMBJJ7NX9MY184099

Model: Octavia Combi 2.0 TDI DSG Ambition

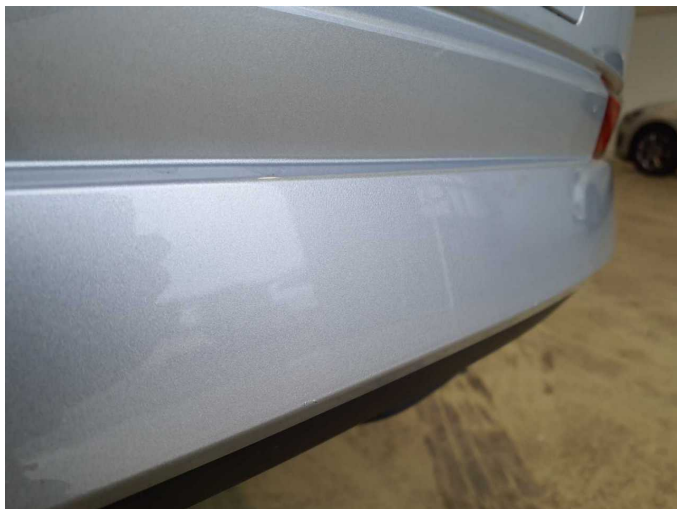
1 Bonnet, Bumper rear, Bumper front, Unprofessionally carried out, Invoice of repair done Non-existent

Repainting 1: Bonnet, Bumper rear, Bumper front

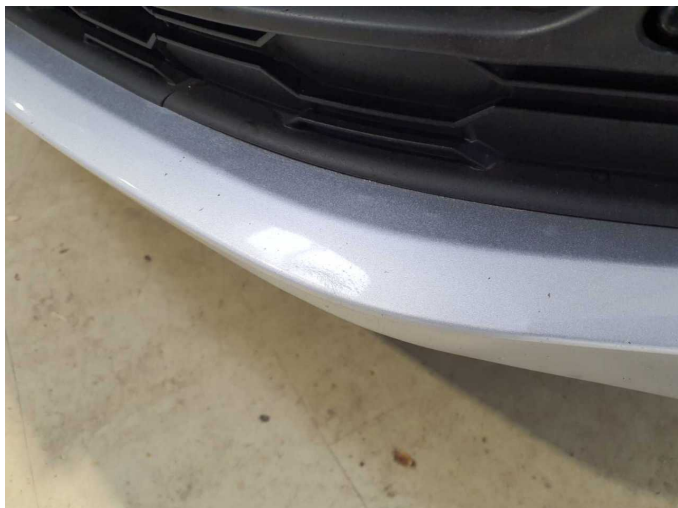
Repainting 1: Bonnet, Bumper rear, Bumper front
