Expertise

Protocol number: 39556940
Order No. / Reference: 24652184
Inspection date: 23 Apr 2025

Manufacturer: Skoda
VIN: TMBJR7NP7M7035835

Model: Superb Combi 2.0 TDI DSG Ambition

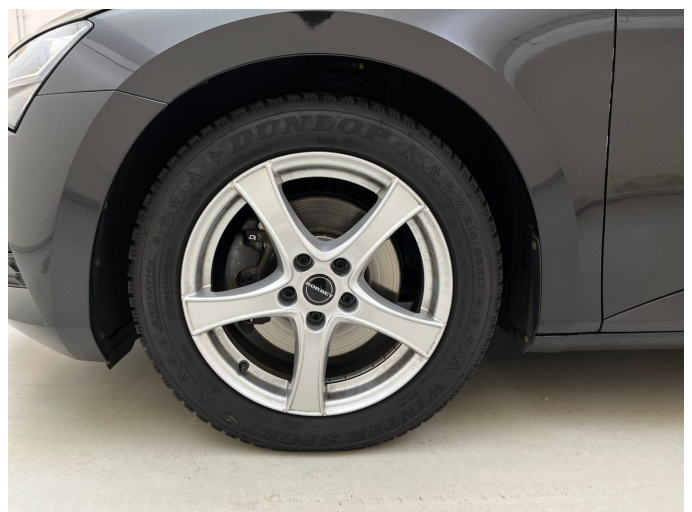
Figure 12: Mounted tyres

#	Tyre size	Type of tyre	Manufacturer	Tread depth
1)	215/55 R17 98V	Winter tyres on Light alloy	Dunlop	3mm / 4mm
2)	215/55 R17 98V	Winter tyres on Light alloy	Dunlop	7mm / 7mm

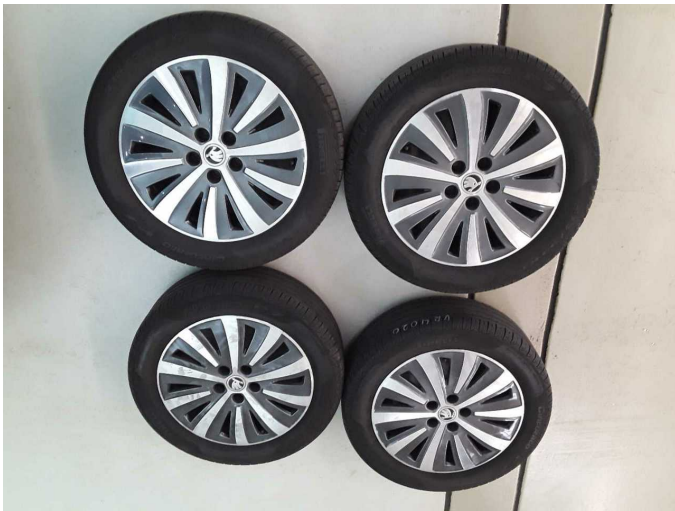
Figure 15: Additional tyres

#	Tyre size	Type of tyre	Manufacturer	Tread depth
1)	215/55 R17 94W	Summer tyres on Light alloy	Pirelli	2mm / 3mm
2)	215/55 R17 94W	Summer tyres on Light alloy	Pirelli	5mm / 5mm
