Expertise

Protocol number: 39455293
Order No. / Reference: 24633938
Inspection date: 4 Apr 2025

Manufacturer: Skoda
VIN: TMBJR7NXXMY112028

Model: Octavia Combi 1.5 TSI First Edition

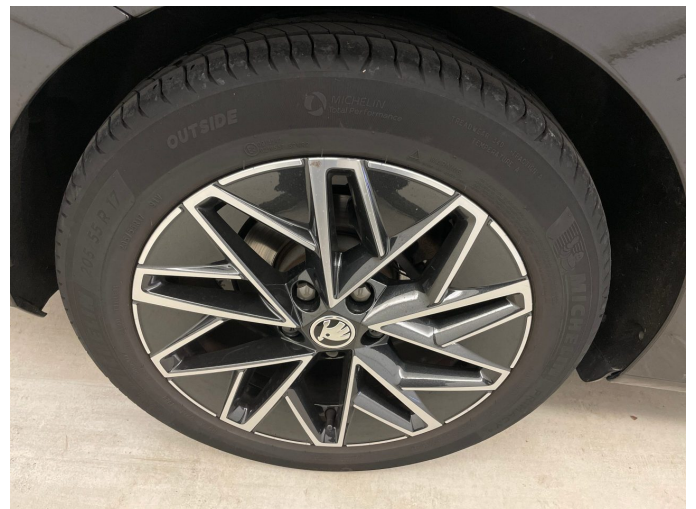
Figure 12: Mounted tyres

#	Tyre size	Type of tyre	Manufacturer	Tread depth
1)	205/55 R17 91V	Summer tyres on Light alloy	Michelin	6mm / 6mm
2)	205/55 R17 91V	Summer tyres on Light alloy	Michelin	6mm / 6mm
