Expertise

Protocol number: 39570670  
Order No. / Reference: 24660994  
Inspection date: 28 Apr 2025

Manufacturer: Skoda  
VIN: TMBLJ7NU1M5057590

Model: Karoq 2.0 TDI SCR 4x4 DSG Ambition

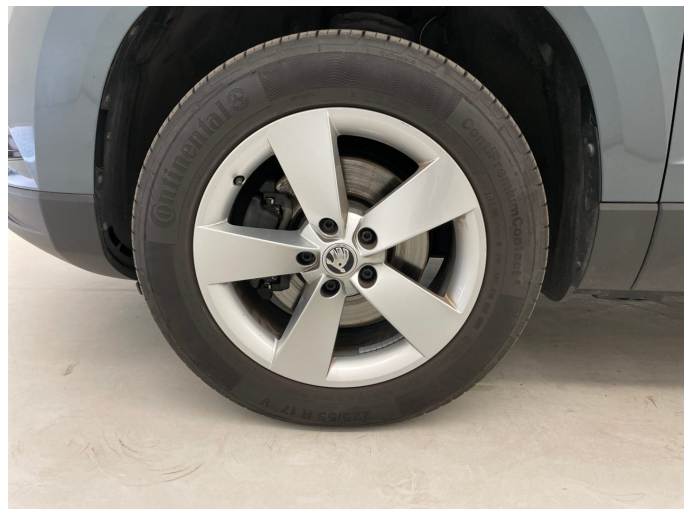
Figure 12: Mounted tyres

#	Tyre size	Type of tyre	Manufacturer	Tread depth
1)	225/55 R17 97V	Summer tyres on Light alloy	Continental	6mm / 6mm
2)	225/55 R17 97V	Summer tyres on Light alloy	Continental	6mm / 6mm

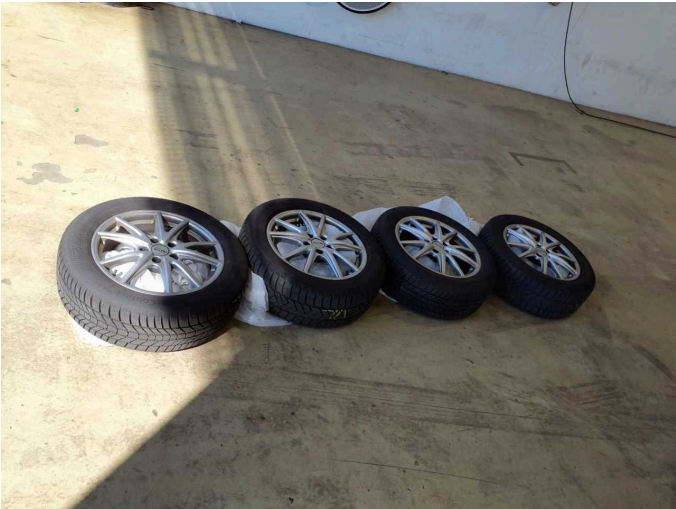
Figure 15: Additional tyres

#	Tyre size	Type of tyre	Manufacturer	Tread depth
1)	225/55 R17 101V	Winter tyres on Light alloy	Pirelli	6mm / 6mm
2)	225/55 R17 101V	Winter tyres on Light alloy	Continental	8mm / 8mm
