Expertise

Protocol number: 41032244
Order No. / Reference: 25069892
Inspection date: 7 Aug 2025

Manufacturer: Skoda
VIN: TMBLJ7NUXM5037628

Model: Karoq 2.0 TDI SCR 4x4 DSG Clever

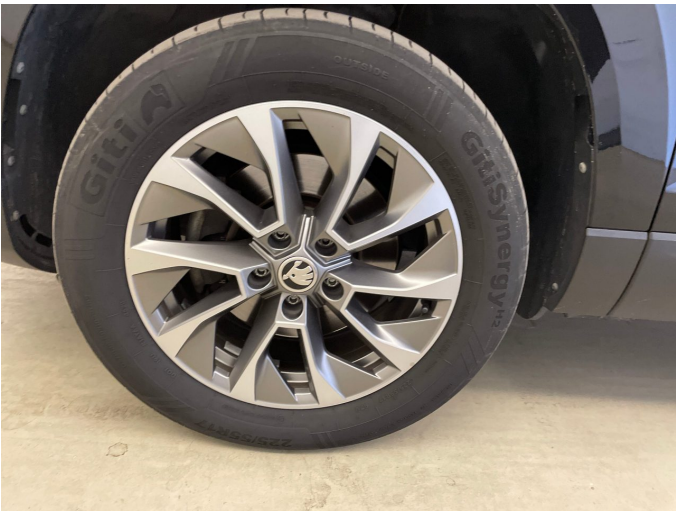
Figure 13: Mounted tyres

#	Tyre size	Type of tyre	Manufacturer	Tread depth
1)	225/55 R17 97V	Summer tyres on Light alloy	Sonstige	3mm / 3mm
2)	225/55 R17 97V	Summer tyres on Light alloy	Sonstige	4mm / 4mm
