status report

vehicle data			
Å koda Kodiaq			
Vehicle identification number	TMBLK9NSXK8016216	mileage read:	107996 km
First Registration / construction year:	19.11.2018 / 0	Visit Date / place of birth:	16.05.2025 Hoppegarten
Bodywork:	cars	Re - import:	no
Body type:	station wagon	KBA no. :	8004//ARX
Fuel / emission class:	diesel / € 6	transmission type:	automatic
Displacement / power:	1968 ccm / 140 kW (190 PS)	Engine:	four-wheel
paint:	blue	Number of previous owners:	3
Doors / seats:	5 / 5	number keys:	3
Next HU / AU:	01.2027 / 01.2027	cushion type:	Leather / Alcantara
Service book available:	-	Interior Color:	black
smoking vehicle:	no	Last service km / on the:	- / -
Vehicle roadworthy:	yes	Vehicle roadworthy:	yes
Submitted vehicle documents:	For example, I \u0026 II For example,	state outside:	3 - Average
visit condition:	-	condition inside:	3 - Average
state general:	3 - Average

Hüsges GmbH
Gießerallee 23
47877 Willich
Tel.: 02154 / 9534 0
E-Mail: gutachten@huesges-group.eu

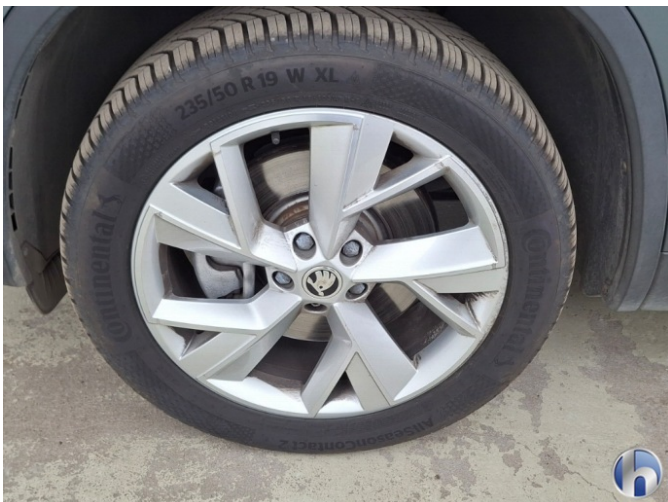
rims

component	Damage	Rep kind
1. Rear door - left	Subsequently painted	acceptable
2. Front door - left	Subsequently painted	acceptable
3. Felge vorne links	Scratch(es)	Refurbish and paint
4. Felge vorne rechts	Scratch(es)	Refurbish and paint
5. Tür hinten links Kantenschutz abgebrochen	Breakage	Replace
6. maintenance	Missing	Replace
7. proof of maintenance	Missing	Replace
