## status report

| <b>customer:</b> | <b>Bank 11, Neuss</b> |

| vehicle data | | | |
|---|---|---|---|
| <b>Skoda Kodiaq Style 4x4</b> | | | |
| Vehicle identification number | <b>TMBLN7NS9P8524020</b> | mileage read: | <b>76904 km</b> |

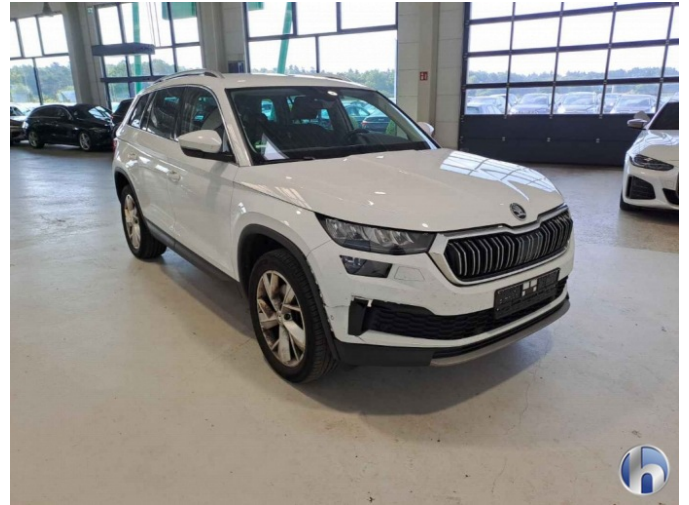
front Right

| component | Damage | Rep kind |
|---|---|---|
| 7. Front bumper | Accident damage | Replace |

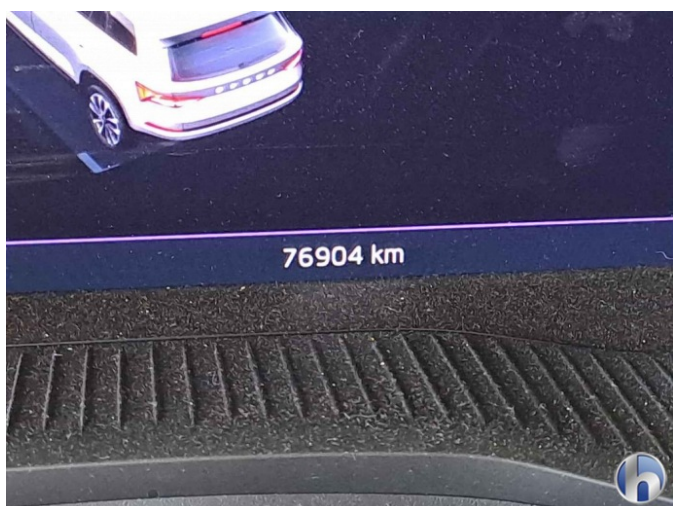
instrument cluster

| Performed testing technology | |
|---|---|
| <b>reference:</b> | *Fahrzeug hat Alter und Laufleistungs bedingte Gebrauchsspuren innen und außen<br>Kombiinstrument Fehlermeldung Fehlerdiagnose durchführen lassen Unfallschaden Stoßfänger<br>vorne rechts Schaden und Kosten Erweiterung möglich |
