## status report

#### Skoda Octavia Combi RS

| Vehicle identification number | <b>TMBUF61Z4B2054683</b> | mileage read: | <b>185933 km</b> |
| First Registration /<br>construction year: | <b>04.11.2010 / 2010</b> | Visit Date / place of birth: | <b>25.09.2025 Riedstadt-<br/>Goddelau</b> |

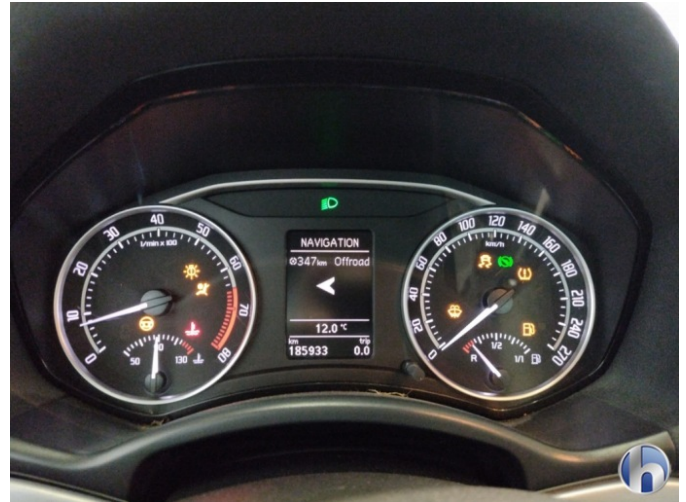
instrument cluster

| Performed testing technology | |
|---|---|
| <b>lighting system:</b> | For sightseeing timing defects in the lighting system were noted .<br>*Fehlermeldung |

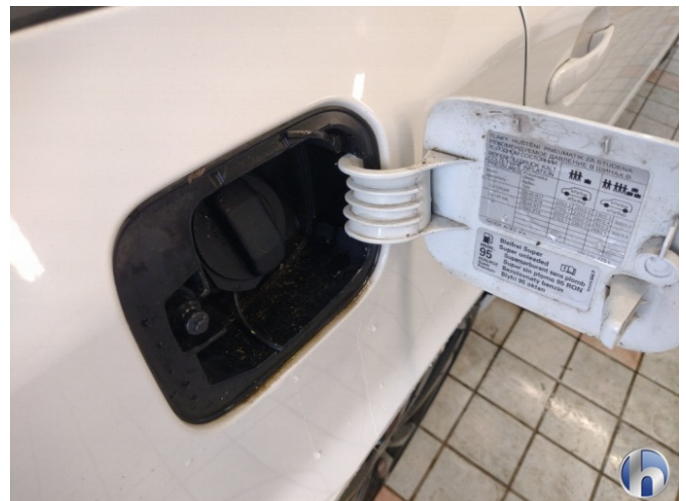
filler cap

| component | Damage | Rep kind |
|---|---|---|
| 34. Tankdeckel Fangband | Damaged | Replace |

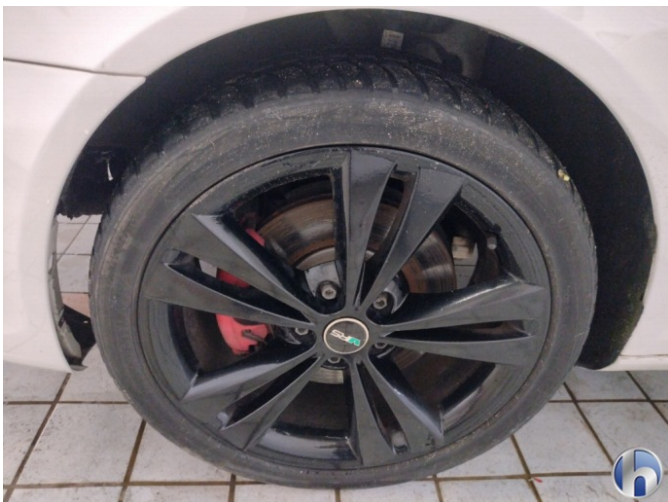
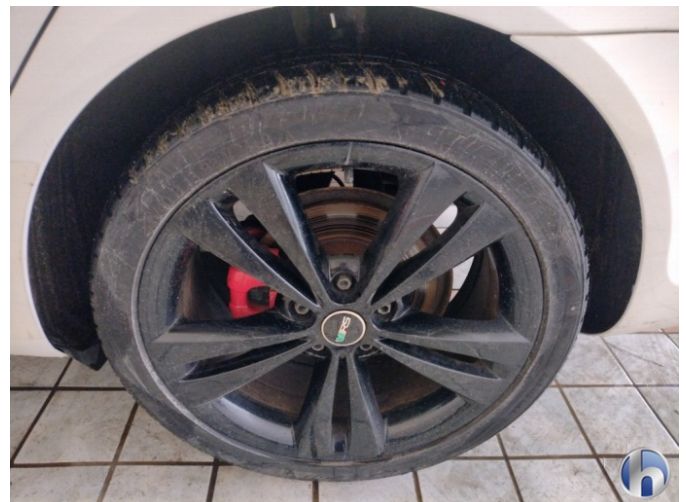
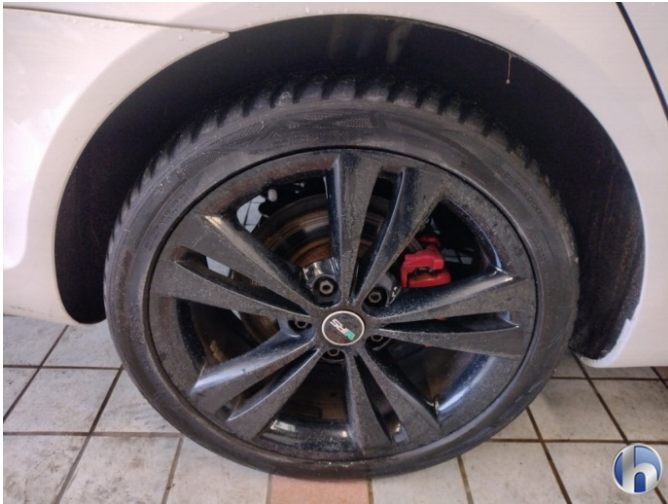
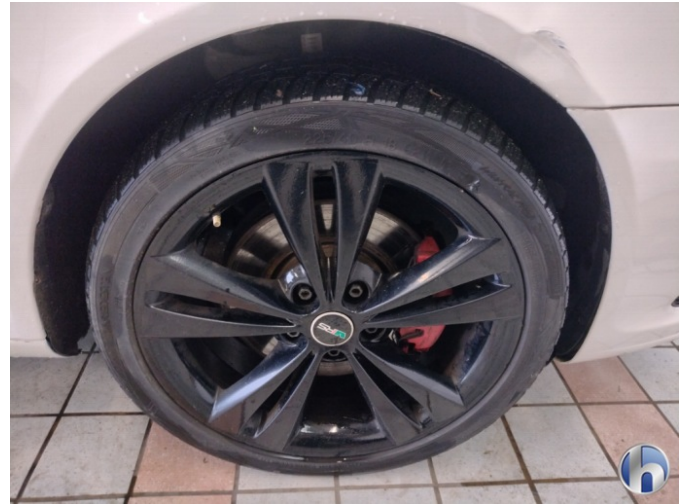
rims

| component | Damage | Rep kind |
|---|---|---|
| 2. Rim front - left | Scratch(es) | Smart repair |
| 3. tire front - right | Damaged | Replace |
| 4. Rim front - right | Scratch(es) | Smart repair |
| 5. 3x Reifen | Worn | Replace |

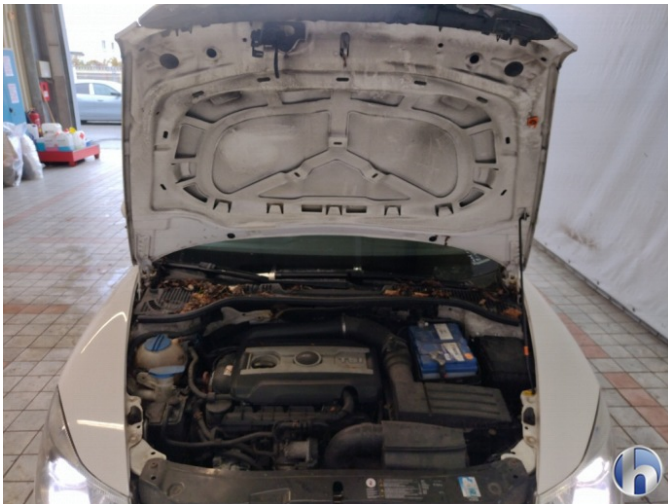
engine compartment

| component | Damage | Rep kind |
|---|---|---|
| 6. Ausgleichsbehälter Kühlwasser | Missing | Carry out a fault diagnosis |
| 32. battery | Defective | Replace |
