## status report

#### Kia Venga Spirit

| Vehicle identification number | <b>U5YEH812BHL157931</b> | mileage read: | <b>33868 km</b> |

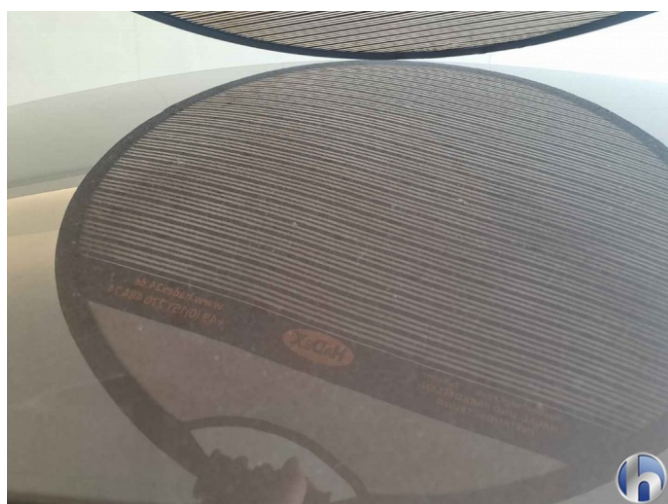
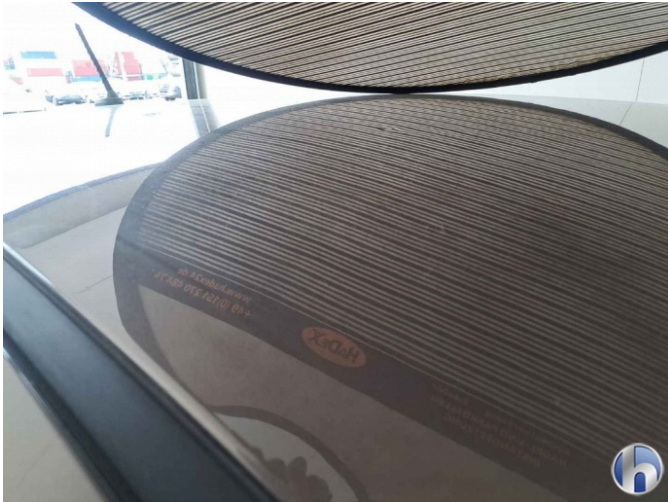
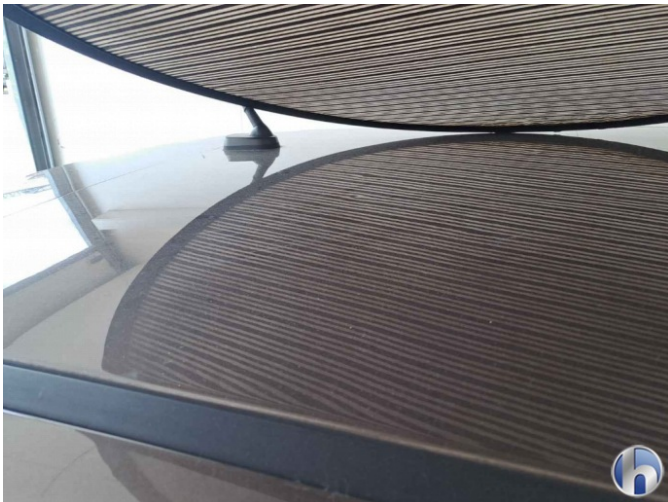
| component | Damage | Rep kind |
|---|---|---|
| 29. Dach mit 60 Dellen à 20-25mm | Hail damage | Refurbish and paint |
