DACIA Duster I 2014 Diesel

Duster 1.5 dci Laureate 4x2 110cv

Inspection Report Summary

Customer	BCA Lodi	Report Number	P20250917152745
Inspection Date / Place	2025-09-17 / BCA Lodi	Cosmetic Grade	5

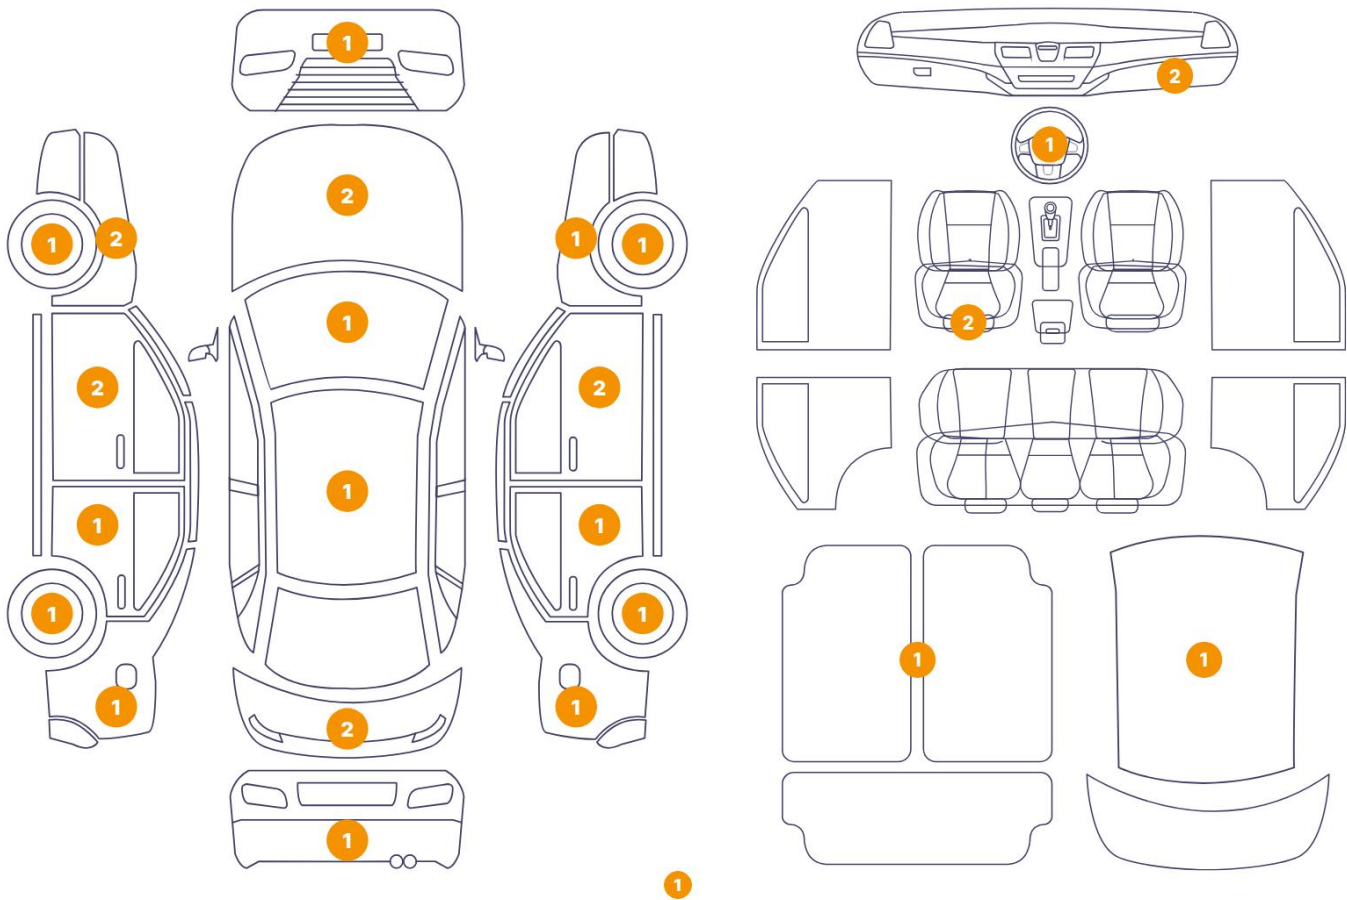
Component		Damage	Comments
1	Steering Wheel / Front	Interior / Worn - out	
2	Dashboard / Front	Interior / Broken	
3	Center Console	Interior / Broken	
4	Seat Cushion / Front Left	Interior / Ripped	
5	Seat Cushion / Front Left	Interior / Ripped	
6	Floor Carpet	Interior / Ripped	
7	Windshield / Front	Glass Break / Impact	
8	Hood	Bodywork / Dent	
9	Hood	Bodywork / Dent	
10	Bumper / Front	Bodywork / Dent	
11	Rim / Front Left	Out of Bodywork / Scratch	
12	Fender / Front Left	Paint / Chipping

13	Fender / Front Left	Bodywork / Poor Previous Repair
14	Mirror Shell / Front Left	Paint / Scratch / Line
15	Door / Front Left	Bodywork / Dent
16	Door / Back Left	Bodywork / Dent
17	Fender / Back Left	Bodywork / Dent
18	Rim / Back Left	Out of Bodywork / Scratch
19	Bumper / Back	Bodywork / Dent
20	Tailgate	Bodywork / Dent
21	Rear Window / Back	Glass Break / Scratch
22	Fender / Back Right	Bodywork / Dent
23	Rim / Back Right	Out of Bodywork / Scratch
24	Door / Back Right	Bodywork / Dent
25	Door / Front Right	Bodywork / Dent
26	Mirror Shell / Front Right	Paint / Scratch / Line
27	Fender / Front Right	Bodywork / Dent
28	Roof	Bodywork / Dent / Hail Area
29	Roof Upholstery	Interior / Ripped
30	Other	Bodywork / Poor Previous Repair
31	Rim / Front Right	Out of Bodywork / Scratch
