DACIA DUSTER  
Duster 1.5 dCi 110 4x4 Ambiance

VIN NO UU1HSDADG52012089

Inspection Report Summary

Customer	BCAuto Encheres	Report Number	P20251001163205
Inspection Date / Place	2025-10-01 / BCA SOLOGNE	Cosmetic Grade	4

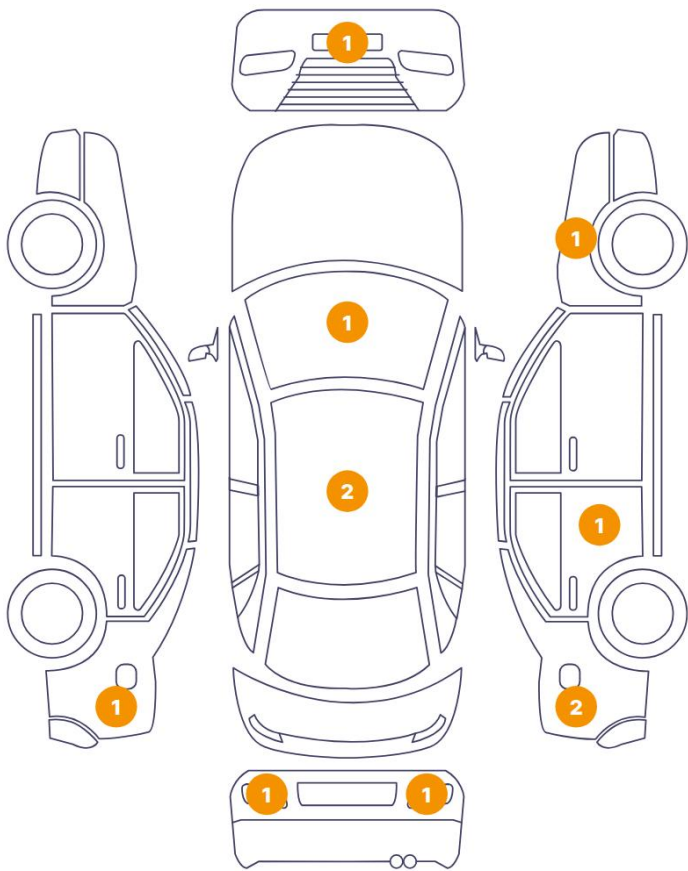
11 Dommages

Component		Damage	Comments
1	Seat / Front Left	Interior / Ripped	
2	Floor Carpet	Interior / Dirty	
3	Panel Filling / Front Left	Interior / Dirty	
4	Dashboard / Front	Interior / Dirty	
5	Seat / Back Center	Interior / Dirty	
6	Trunk Carpet	Interior / Dirty	
7	Seat / Front Right	Interior / Dirty	
8	Roof	Paint / Scratch / Line	
9	Roof	Bodywork / Dent / Dent	
10	Fender / Back Right	Bodywork / Dent / Deformation	
11	Fender / Back Right	Bodywork / Dent / Dent	
12	Fender / Front Right	Bodywork / Dent / Deformation
