## status report

#### Dacia Dokker Stepway

| Vehicle identification number | <b>UU1K6720164200706</b> | mileage read: | <b>75797 km</b> |

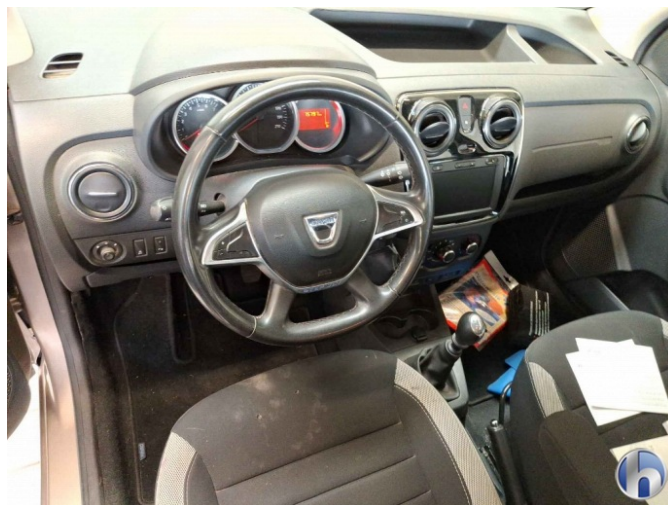
instrument cluster

| component | Damage | Rep kind |
|---|---|---|
| 1. Fehlermeldungen, Schaden erweiterung möglich | Error message | Carry out a fault diagnosis |
