RENAULT Megane

Megane ENERGY TCe 115 Start & Stop

Inspection Report Summary

Customer	BCA Online	Report Number	P20251002085538
Inspection Date / Place	2025-10-02 / BCA Berlin	Cosmetic Grade	5

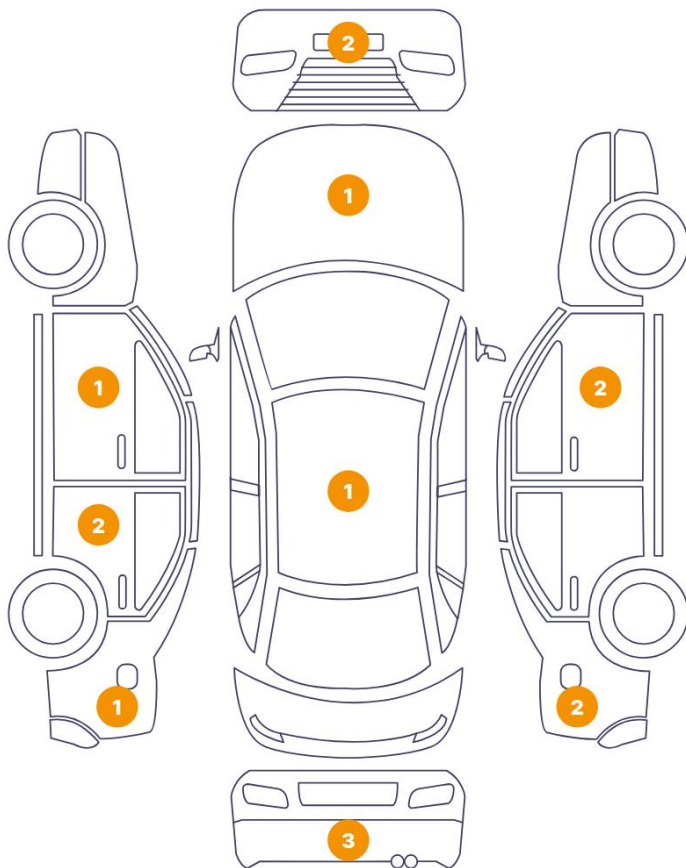
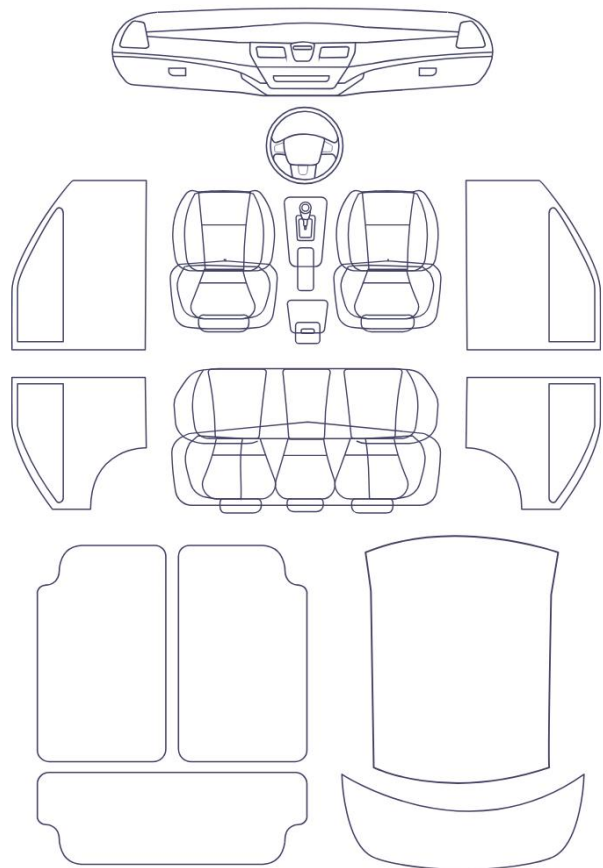
15 Schäden

13	Door / Front Right	Paint / Scratch / Scuff
14	Bumper / Front	Paint / Scratch / Scuff
15	Bumper / Front	Paint / Scratch / Scuff
