Expertise

Protocol number: 41657258  
Order No. / Reference: 25241643  
Inspection date: 23 Sept 2025

Manufacturer: Renault

Model: Trafic ENERGY dCi 120 L1H1 3,0t Komfort

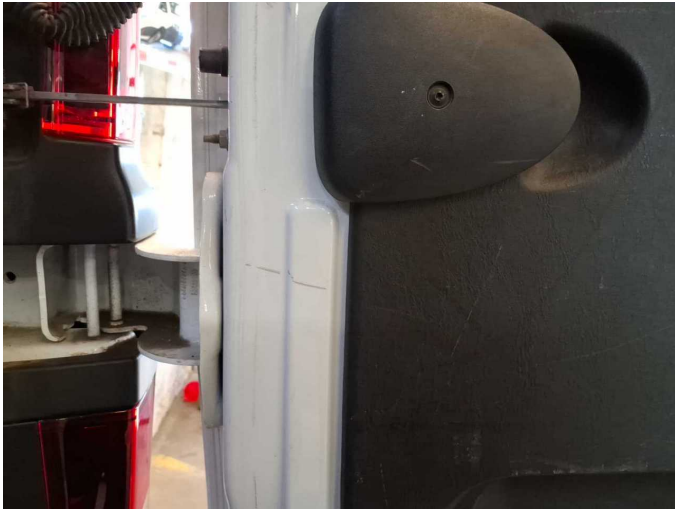
**Damage 14:** Interior: Cargo space division - Dent / paintcoat damage - Loss in value
